**Status Report of the Tevatron Alignment Task Force
and a
Report on Magnet Survey Activities During the
2003 Summer-Fall Shutdown**

**by the
Tevatron Alignment Task Force**

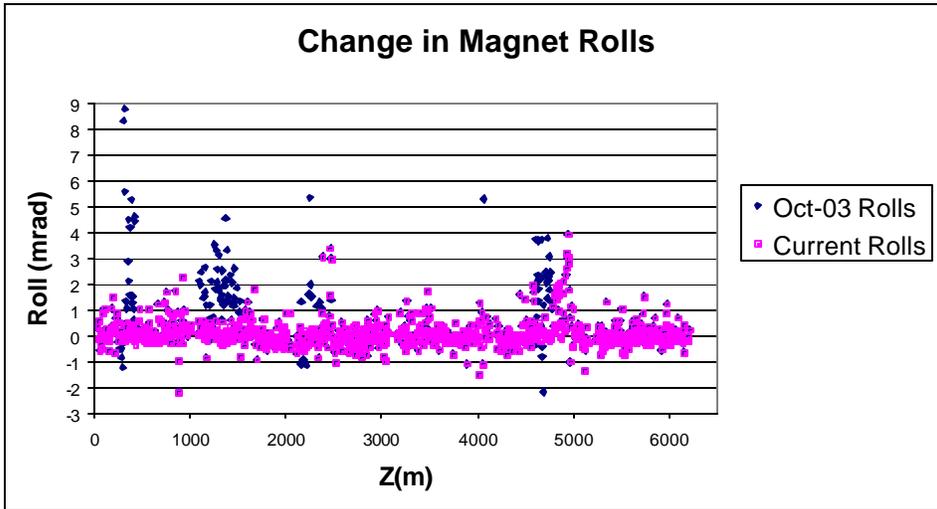
Figure 5a: Comparison of magnet rolls (Dipoles and Quadrupoles) around the entire Tevatron before and after the summer shutdown and the two December shutdowns. Current rolls are in purple, the corrected Oct-03 rolls are in dark blue. The origin is at A0.

Improvements in magnet roll during the shutdowns were striking. Figures 5a and 5b show a comparison of roll measurements before and after adjustment during the shutdown and the beam-off periods that followed. Many of the most troubling sections were corrected. A comparison of magnets with substantial rolls before the shutdowns and after is given in Table 2. In particular, all of the magnet rolls greater than 4 mrad have been eliminated. There are now 58 magnets with rolls greater than one mrad that should be corrected, compared to 151 before the shutdowns. The biggest remaining rolls are in A and E Sector. This work had an immediate impact on vertical corrector magnet settings, which had previously run close to capacity. Corrector currents are now running at much more reasonable levels as can be seen in Figures 6a and 6b.

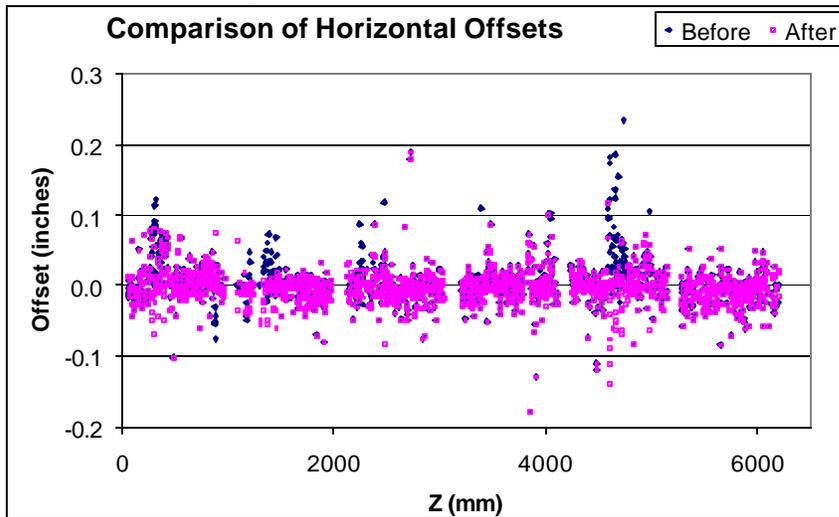
Figure 7: A comparison of horizontal offsets relative to the Murphy line. The blue points are measured offsets at the start of the shutdown, later corrected. The purple points are current offsets, including those corrected during the shutdown. The origin is at A0.

The results of the measurements are given in Figure 7. These data represent the first comprehensive measurements of horizontal offsets in the Tevatron since the initial installation. The results indicate that the magnets were relatively stable horizontally over

the years. Only two quadrupoles were sufficiently out-of tolerance that a specific effort was made to correct their offsets. The improvement in horizontal offsets evident in Figure 7 came about by systematically correcting the horizontals whenever any other work was done on a magnet, such as a roll correction or magnet stand replacement.

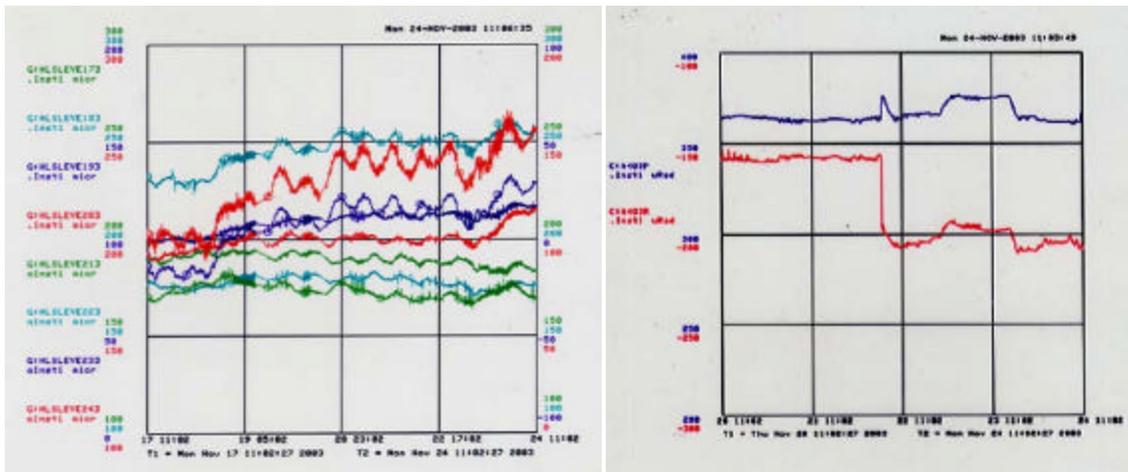
Figure 11b shows two measurements made by tilt monitors set on top of quadrupoles in the arcs. After a quench, one magnet is seen to recover back to its original position, while the other does not. Such changes may account, at least in part, for changes that occur in machine operation after a quench. We need to understand the cause of magnet motion during a quench.

During the shutdown, twenty-six hydrostatic level sensors (HLS) were installed in the tunnel, primarily in B-Sector. These were previously used in MI-8 and the Aurora mine for liner-collider ground-motion studies. They were placed in Sector-B, because this sector seems to be one of the most troublesome in the ring. Tilt monitors were also placed in sector B to cross-calibrate with the HLS. Figure 11a shows a some of the data available from the HLS in B-sector.

These measurements are suggestive but not conclusive. Additional HLS and tilt-monitors placed around the ring would provide a more complete picture of changes that take place. Do seasonal variations take place in parts of the ring, but not others; How do variations in mounting fixtures affect the way that magnets respond to quenches and other disturbances; What affects can be attributed to the magnet ramp, and are the effects uniform around the ring? Our goal is to measure real time motion in the entire ring to look for these correlations, and to compare them to accelerator simulations. Perhaps we'll be able to eliminate short term changes that occur in the Tevatron and the subsequent the need for retune of the Tevatron after brief periods of operation.

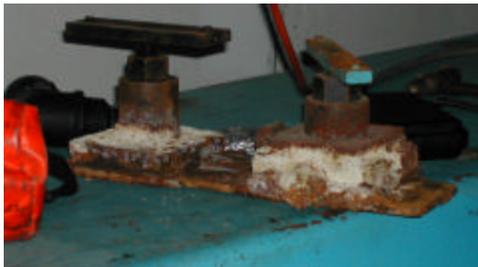
Magnet stands have suffered corrosion in areas where water accumulated during floods, or because of seepage through cracks in the tunnel concrete. The occurrence of the water in the tunnel has since been greatly reduced, but the affected stands are still in place. An example of a corroded stand is shown in Figure 12.

Figure 12: An example corrosion affecting a magnet stand in the Tevatron.

Sixty-one dipoles had new stands installed during the shutdown, in areas where the greatest damage was observed. A summary of magnet stand replacement by Tevatron location is given in Table 4. During the next shutdown, additional dipoles stands will be replaced, as well as affected quadrupole and spool-piece stands.

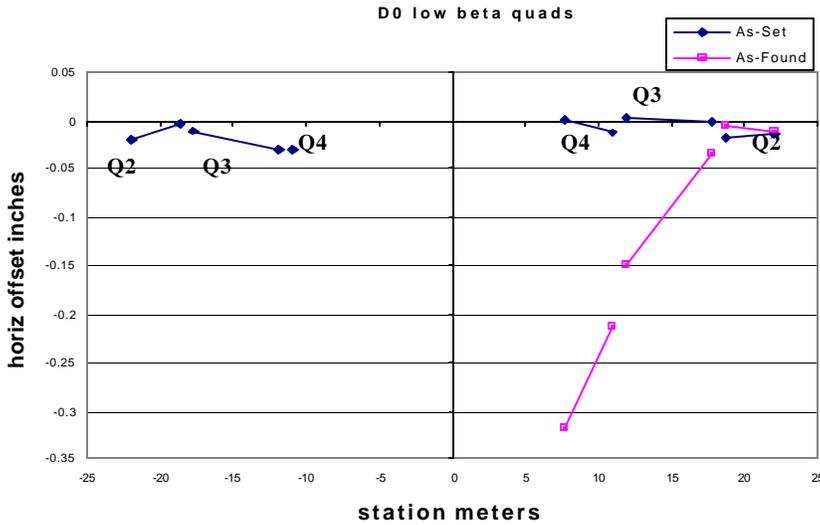
An accident that occurred several years ago involving the D0 LBQ girder caused a 0.25 inch horizontal displacement at one end of the girder. Recent aperture scans revealed a serious restriction at D0, making it imperative to correct the situation. In Figure 13a, we show the survey data of the LBQ before the shutdown (as-found) and after (as-set). It may be that this single ¼ inch correction did the most to open up the Tevatron aperture for this run. Craig Moore led the effort for this work.

Figure 13a: A ¼ inch horizontal correction was carried out at D0 on the upstream side of Q4. Initial (as-found) positions are shown compared to the corrected (as-set) positions.

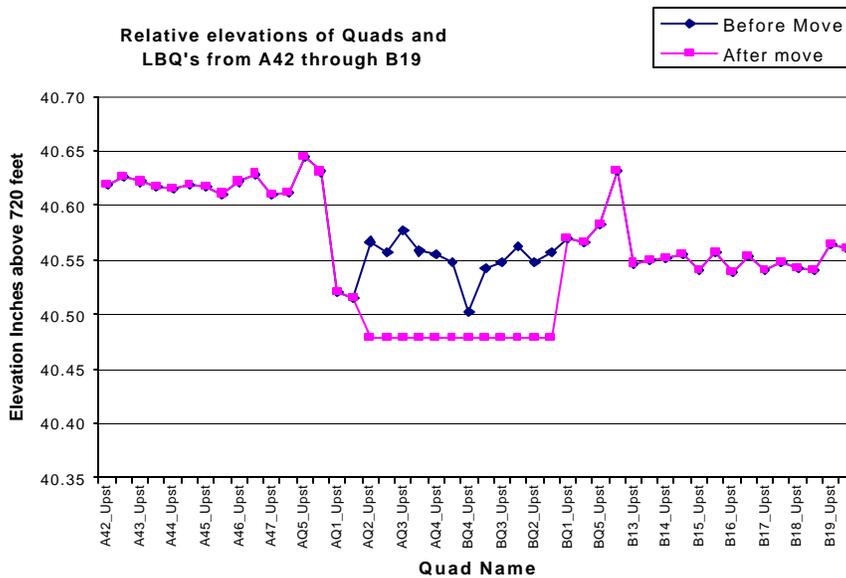
The month of December had many machine down days. We took the opportunity to adjust the vertical position of the IR at B0. The IR was about 6mm high at CDF, nearly falling off the edge of the detector acceptance. The solution was developed by a team lead by Vladimir Shiltsev, including Mike Syphers, Valery Lebedev, Norm Gelfand and Mike Martens. The correction involved moving the LBQ down by about 50 mils. This adequately satisfied CDF's requirements. The alignment changes are shown in Figure 13b.

Figure 13b: Vertical changes carried out at B0 to shift the IR down by about 5 mm, and back within the CDF acceptance.

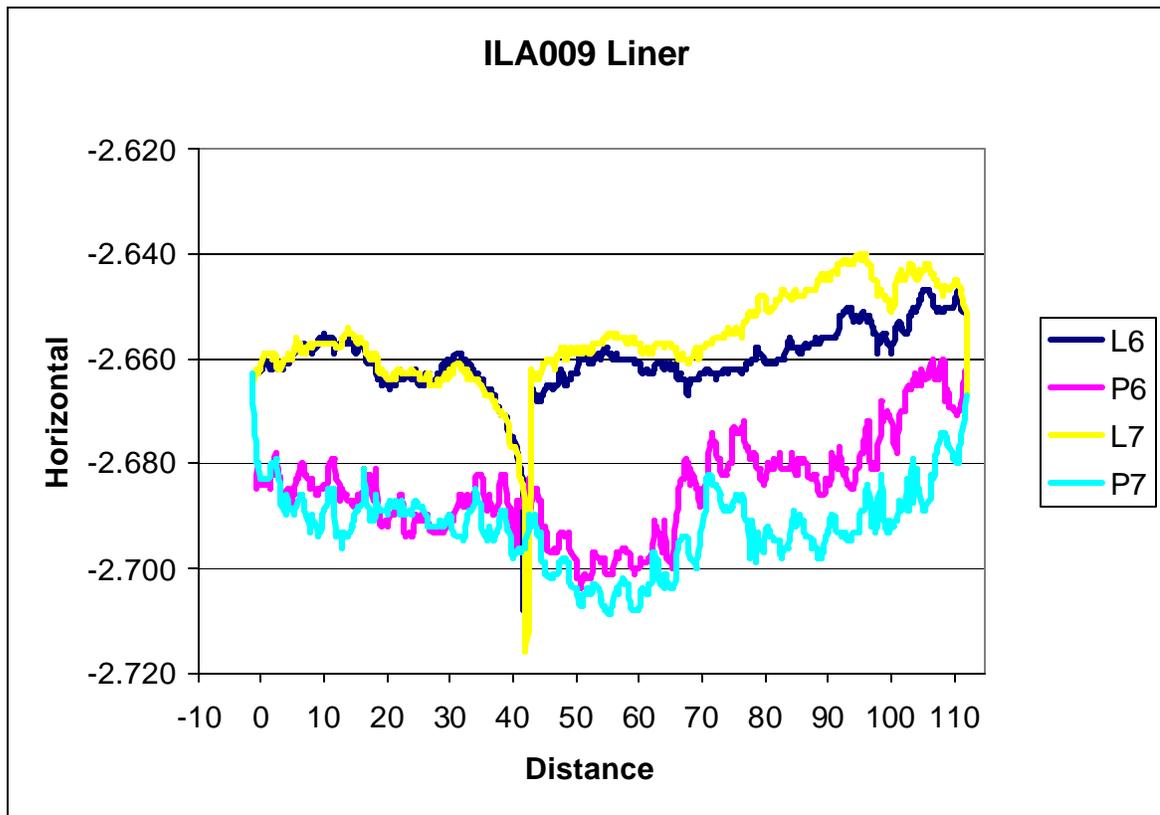
Figure 14: Survey data taken by the AMG of the liner position within one of the Lambertson magnets. P are the before liner measurements and L are measurements with with the liner. The number represents the sixth and seventh attempts on this magnet.

To install the liners the center two of the four F0 Lambertson magnets were removed from the beam line. The liners were then inserted into each of the four 3 meter long magnets. A spring loaded pull through target was developed as a tool to help AMG measure the fit of the liner in the magnet aperture. The measurement provided a check that the liner was pushed against the peak of the aperture as much as possible, and that there were no obstructions in the field free region to degrade the circulating beam. The target carried a corner reflector that was used by the Laser Tracker system. The target was both pulled and pushed through the Lambertson magnets before and after liner insertion. These data were compared to assure that there was no restriction in the aperture. Figure 14 shows a typical aperture scan with before and after data.

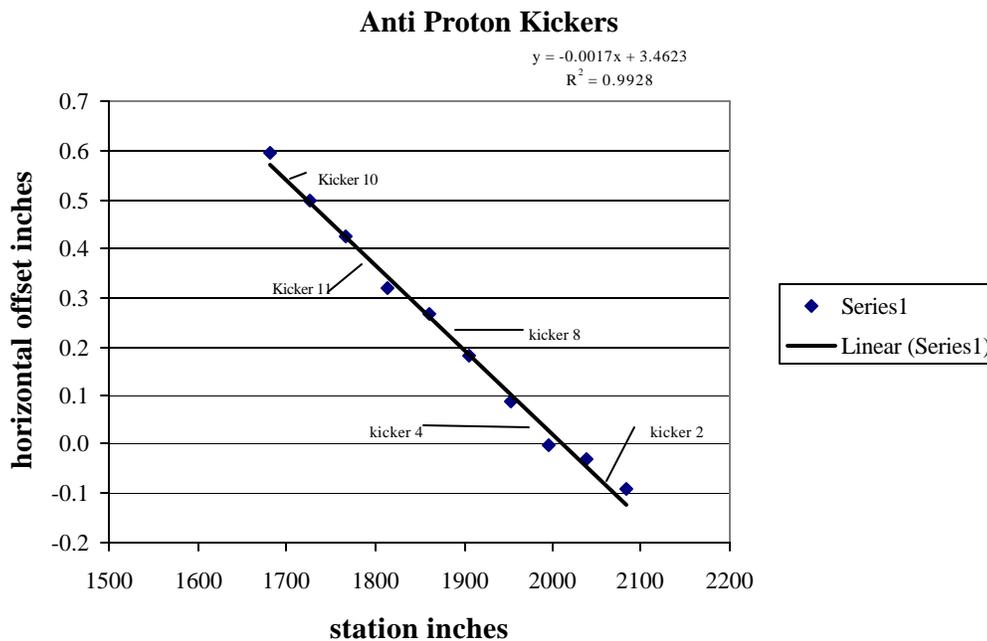
During the first part of Run II, aperture scans near A0 showed a restriction in the vicinity of the anti proton kickers. An optical survey revealed that the anti proton kickers were misaligned in the horizontal plane at the upstream end by 15 mm (0.6 inches). Figure 15 shows the deviation of the kicker alignment from an ideal horizontal line.

A study of survey data taken in 2000 and 2001 did not reveal this large discrepancy. All five kickers are mounted on a bedplate that was designed to move during the change from 800 GeV fixed target operations to colliding beam operations. Adjacent and to the radial inside were the bedplates for the fixed target extraction Lambertson magnets. Both systems were designed for easy movement during change over between these two running modes. It appears that sometime between March 2001 and October 2003 the bedplates for the Lambertson magnets were pushed into the bedplate for the kickers causing the offset.

Figure 15: Deviation of A0 kickers relative to an ideal horizontal line.

The bed plates for the Lambertson magnets were jacked up and placed on cribbing to immobilize them. The kicker girder was pushed back into the proper alignment and optical survey was used to realign each kicker on the correct position. Aperture scans in A0 indicate that the restriction has been successfully removed.
