PELLETRON VOLTAGE REGULATION PROBLEMS

H. Pfeffer
G. Saewert
3/4/08

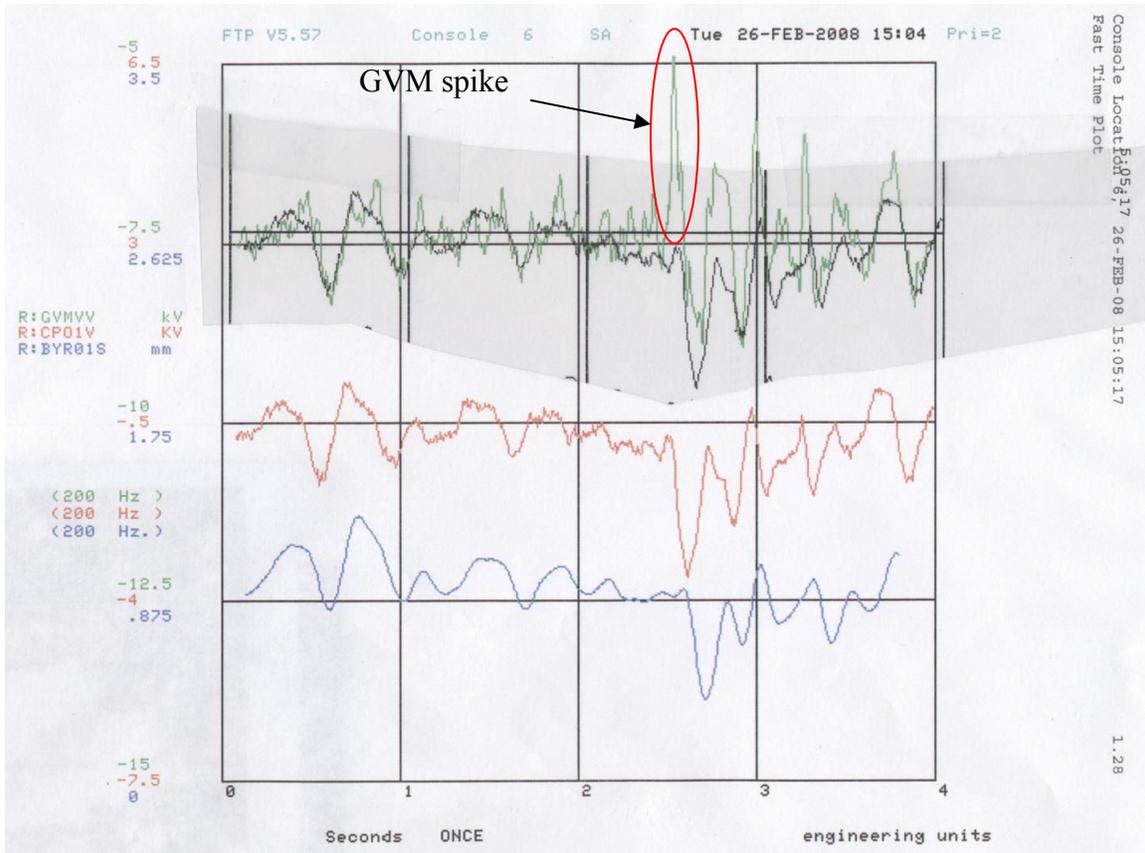
Fig.1, below, shows the three signals, monitored at 200 Hz. The action of the different signal processing causes slight time-shifts between the three signals.

The upper trace is a superposition of the GVMV and CP01V signals, created by making a transparency of the latter and shifting it to match the timing of the former.

The superposition shows that the two signals track for part of the trace and then the GVMV jumps up as the CPO1V goes down. Note that the BYR01S signal tracks the CPO signal, confirming that the terminal voltage really does go down. Our interpretation is that the GVM has generated a false positive spike which, through feedback, caused the corona-module to drive the terminal voltage downward.

These signals are typical of the kinds of transients that you see often if you fast-time-plot these channels.

1. We are creating composite GVM feedback signal by combining the GMV signal with the CPO signal in a way that uses the GVM output only below .016 Hz.

-
2. We will examine and re-habilitate the GVM mechanism in the dome when we next have access to it.
