CM1 Thermal Cycle

Diagnosis of Problem

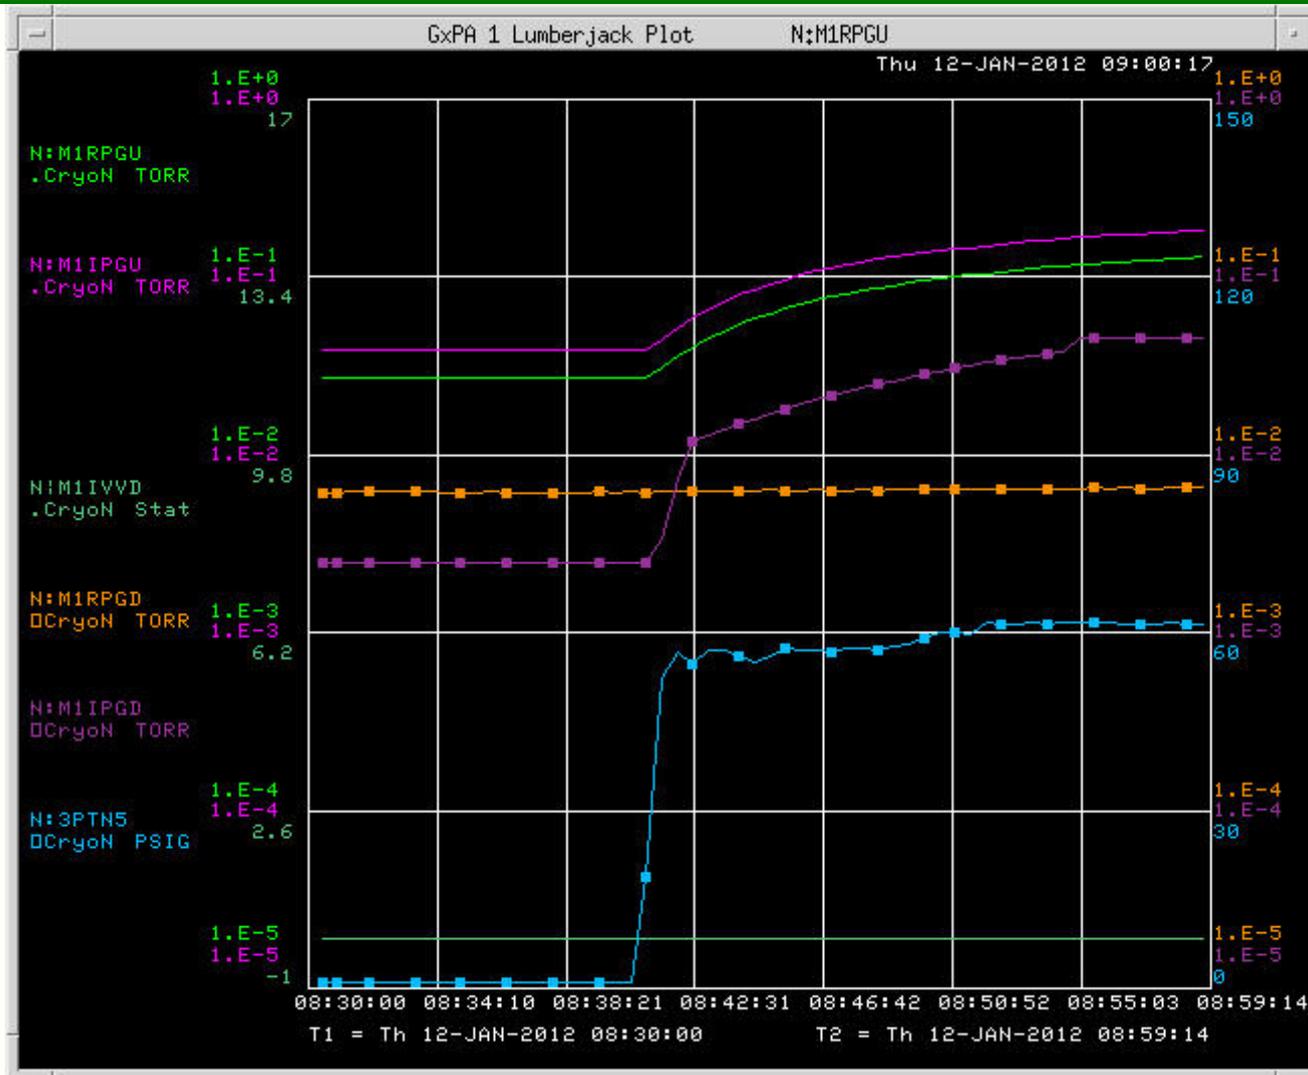
Pressurizing Nitrogen

- Both Helium circuits showed no response (Good)
- Nitrogen circuit showed a direct vacuum and RGA response
- Vacuum was worse at upstream end of CM1

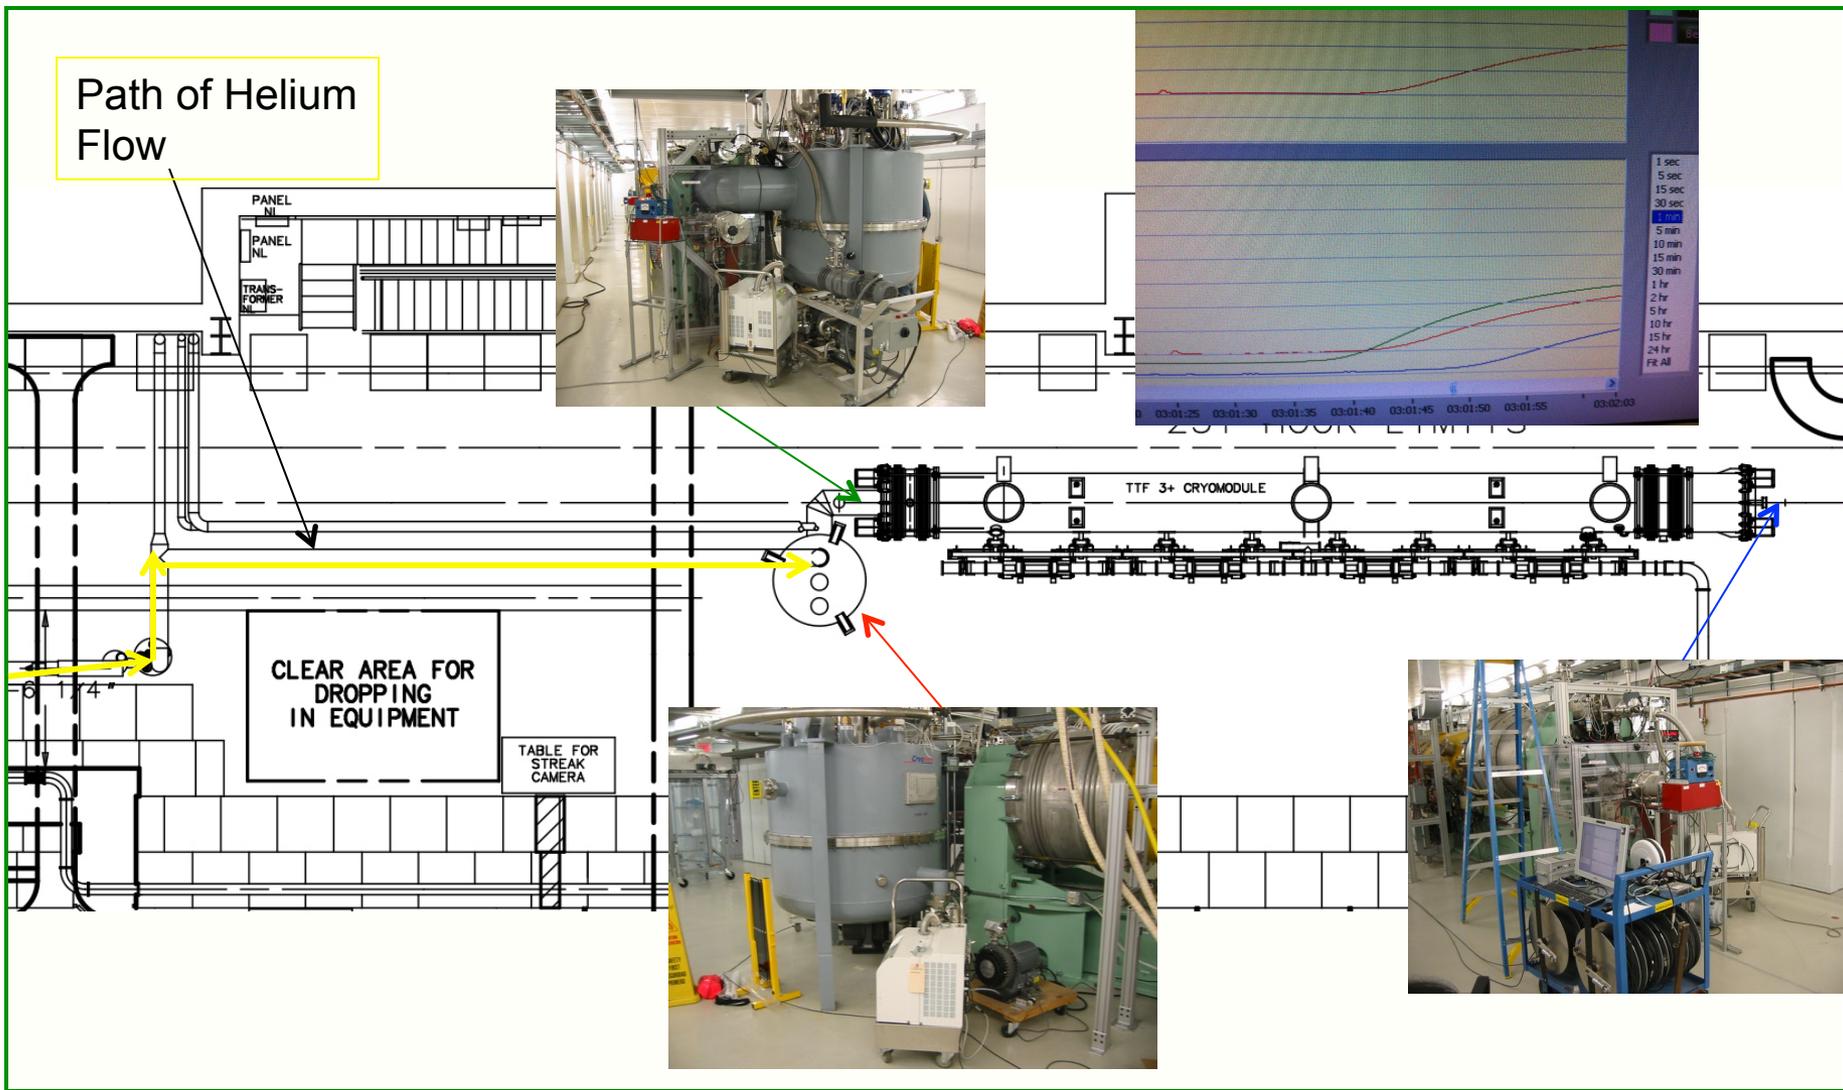
Leak Check of CM1

- **Next Step**
 - Since leak was big enough that there was no hope of recovering insulating vacuum and/or cooling down 80K shields, decision was made to warm up, locate leak, and repair.
- **Pinpoint Leak**
 - Involved Cryo, TEV, and NML vacuum experts in leak checking system.
 - At Room temp., first verified warm leak, then connected (3) leak detectors (upstream, downstream, and on feedbox) tied into TEV chart recording cart, to give real-time comparison of response by each detector.
 - Flowed trace amount of helium into Nitrogen circuit from upstream feedbox and monitored response on leak detectors.

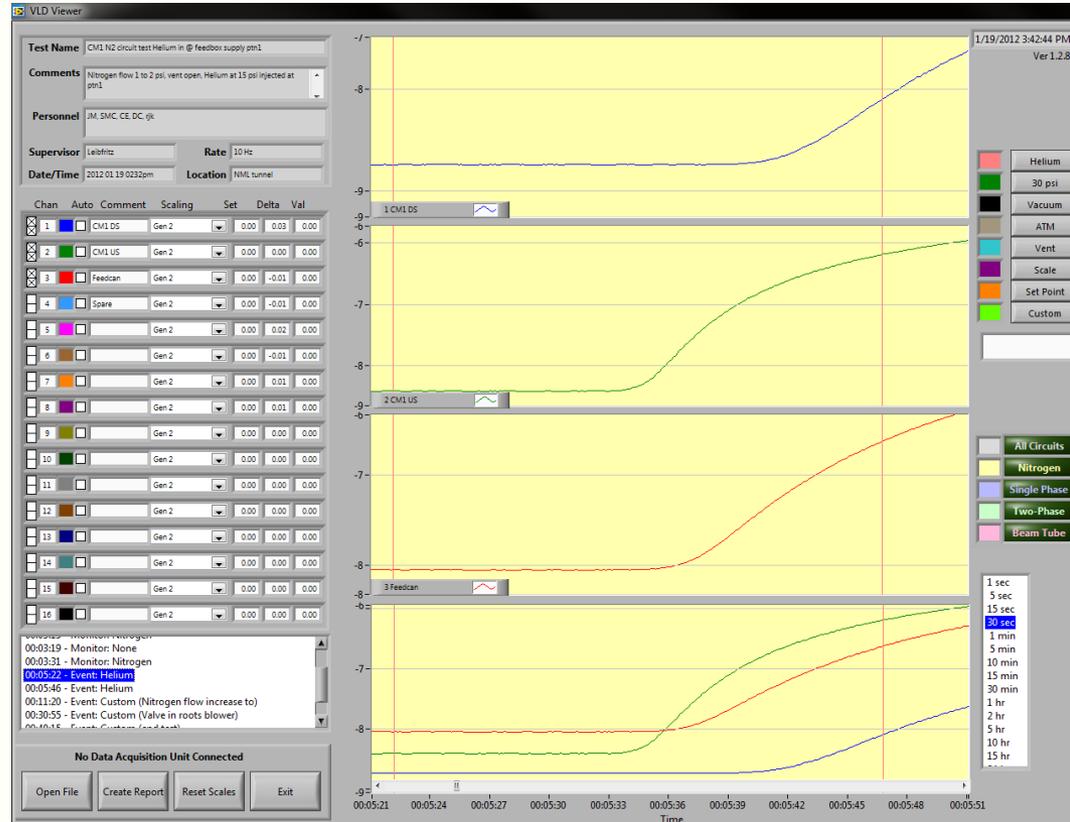
Plot of He Leak Check

- The leak detector test with helium showed the feed cap interface (green) responding first, followed by the feed can (red), and the end cap (blue). The delay is ~10 sec.

- **Leak check and vacuum readings were all consistent and point towards leak at upstream interconnect region, supply side (possibly weld, bellows, or feedthru?)**
- **Repair Plan**
 - **Isolate all gas sources ✓**
 - **Vent CM1 insulating vacuum ✓**
 - **Open upstream bellows ✓**
 - **Remove insulation and shields to expose Nitrogen interconnects**
 - **Inspect and leak check as necessary to find leak**
 - **Repair leak**
 - **Certify repair**
 - **Close up and cooldown?**
 - **Consider adding seals to interconnects in future?**
