# CM1 Thermal Cycle

# Repair – Update (1/27/12)

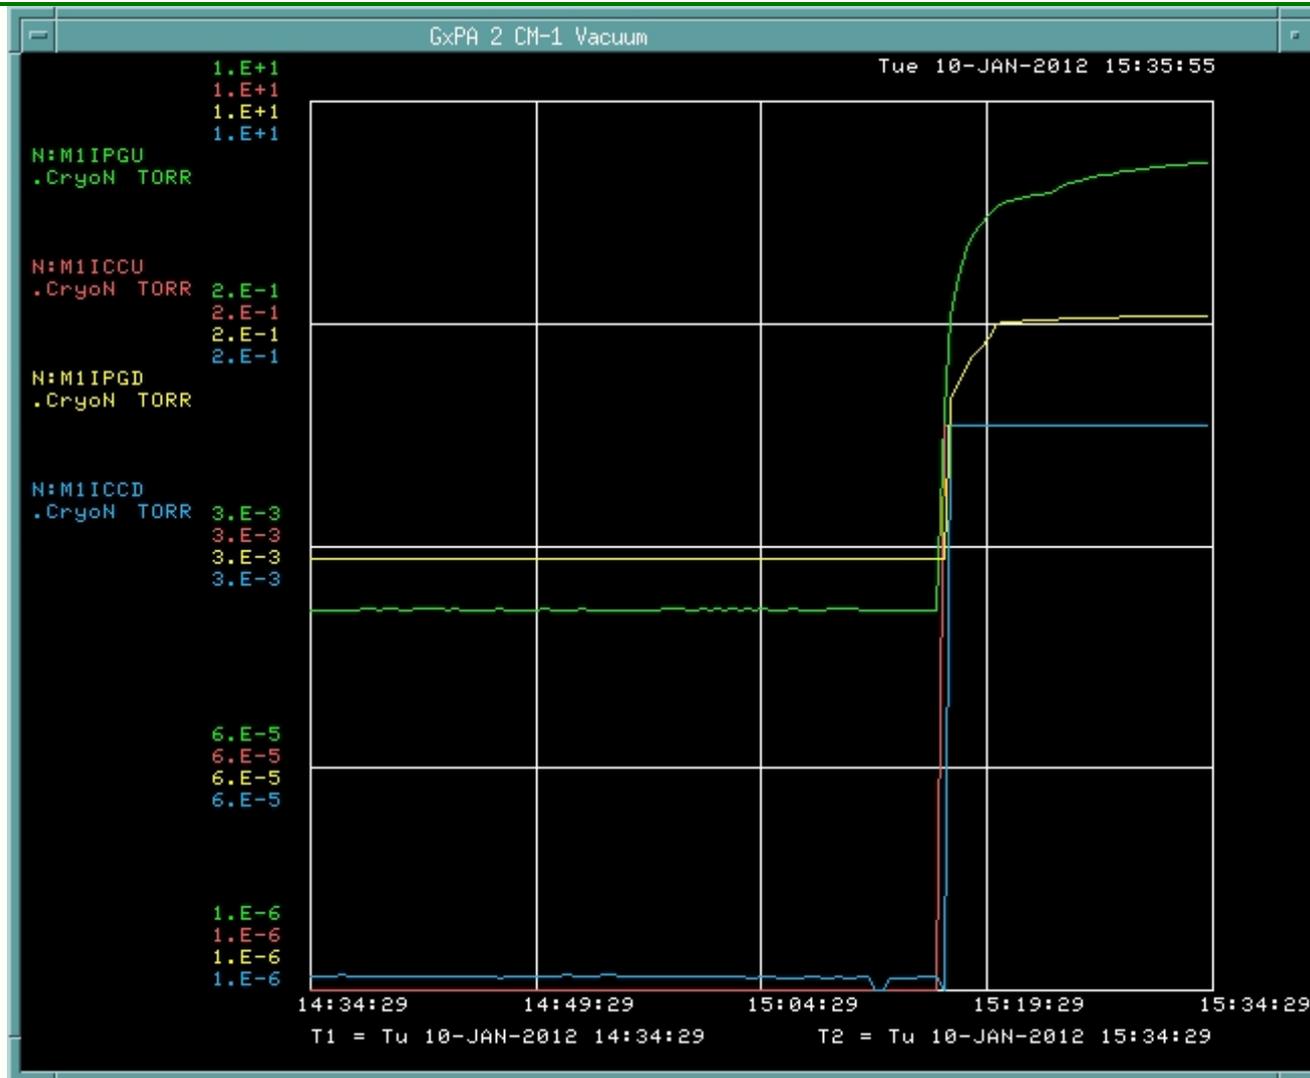
# Plot of Vacuum Event

- **CM1 Warmup**
  - 1/4/12 (Wed.) to 1/6/12 (Fri.) (~50 hours)
  - Verified turbo interlock system works
- **CM1 Cooldown**
  - Began 1/9/12 (Monday)
  - At 15:16 on 1/10/12 a vacuum burst occurred while Nitrogen Shields were at ~ 120K and the insulating vacuum suddenly declined from 1E-6 to 3 Torr.
  - Safety interlock system closed gate valves, protecting turbo pumps and RGA.

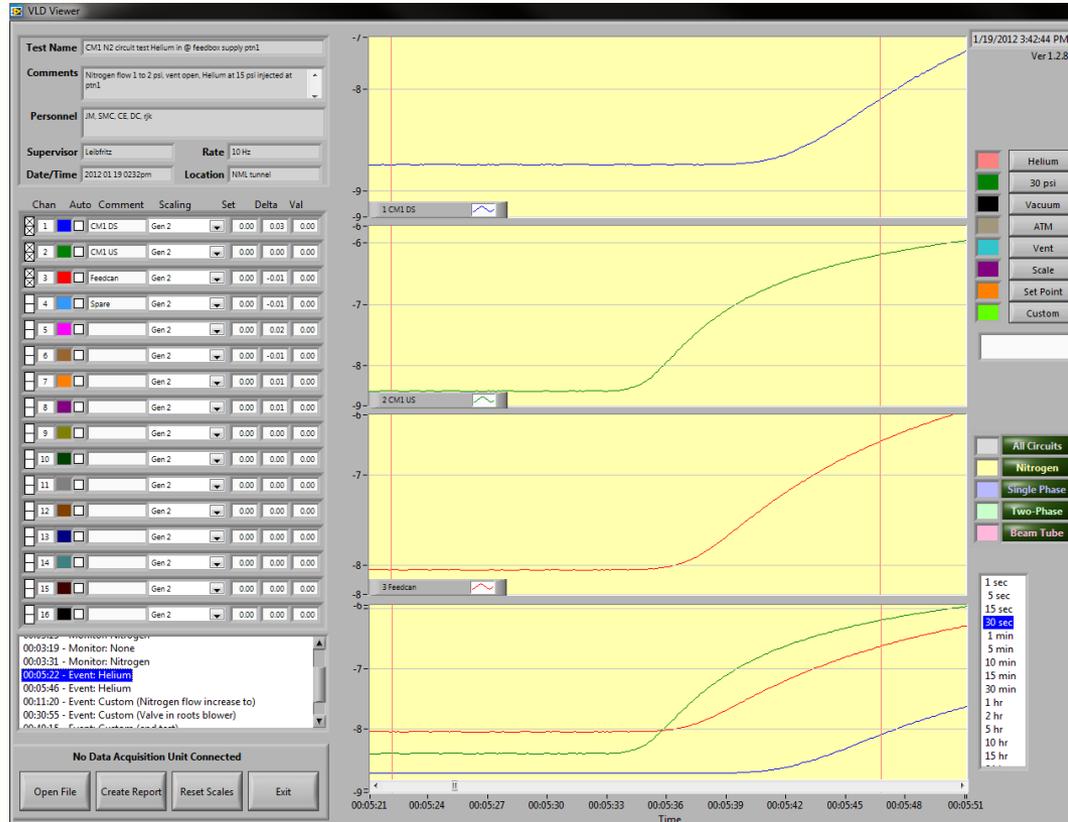
# Plot of He Leak Check

- The leak detector test with helium showed the feed cap interface (green) responding first, followed by the feed can (red), and the end cap (blue). The delay is ~10 sec.

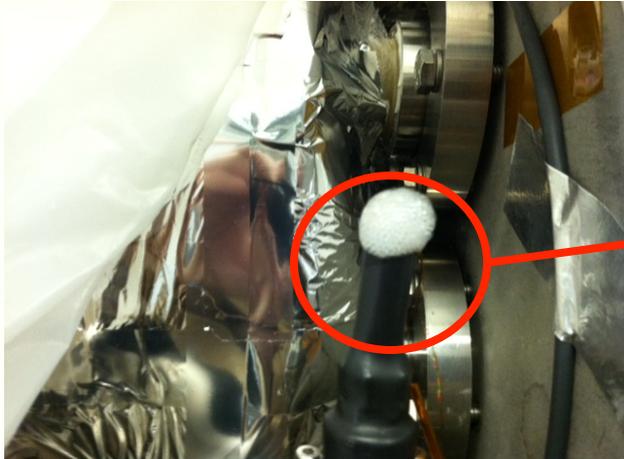
- **Large bellows on upstream end was opened and insulation and shields were removed.**
  - Initial visual inspection did not show any obvious problem.
  - Leak check of Nitrogen circuit by pressurizing with Nitrogen and using “Snoop” showed a leak at the supply side temperature sensor feedthrough.
- **Upstream Supply and Return temp. probes were removed and flanges blanked. New surface mounted sensors were installed at each location.**
- **Helium leak check was conducted to verify there were no leaks in Nitrogen circuit, and feedthru flanges were thermal shocked using liquid Nitrogen to verify they are leak tight.**

Leak indicated by bubbling "Snoop"
