Results of RFQ “fixes”

C.Y. Tan, J. Schmidt, B. Koubek,
D. Bollinger, P. Karns, R. Tomlin
16 May 2012

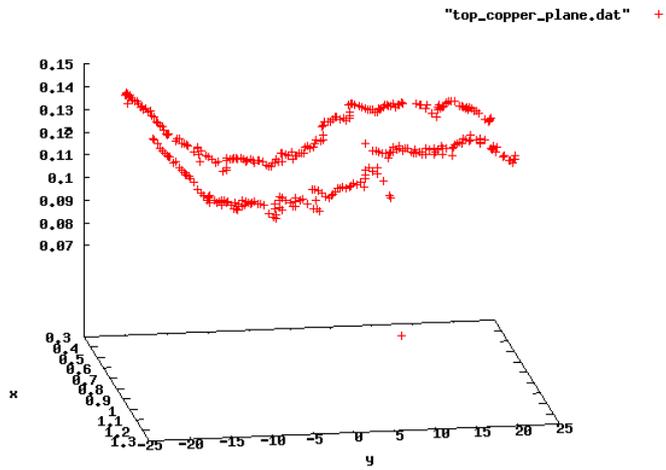
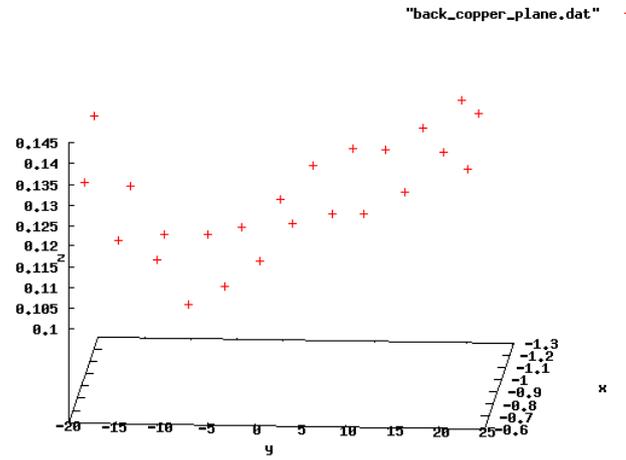
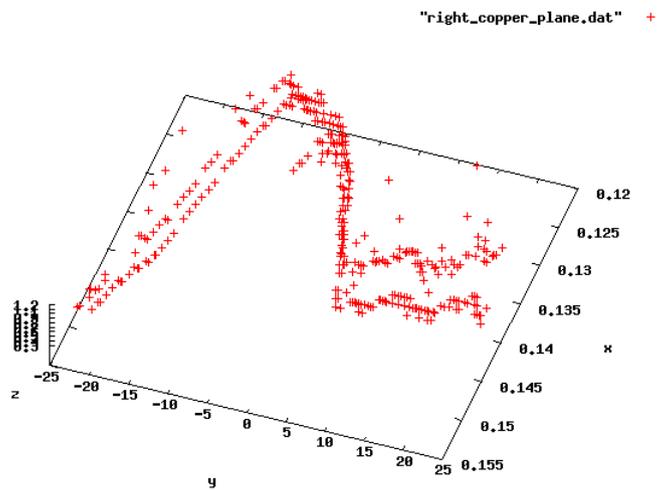
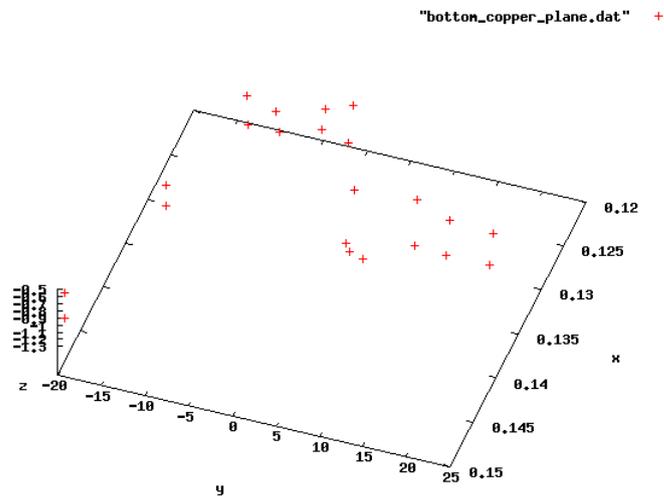
Survey of RFQ

Horz rods

Vert rods

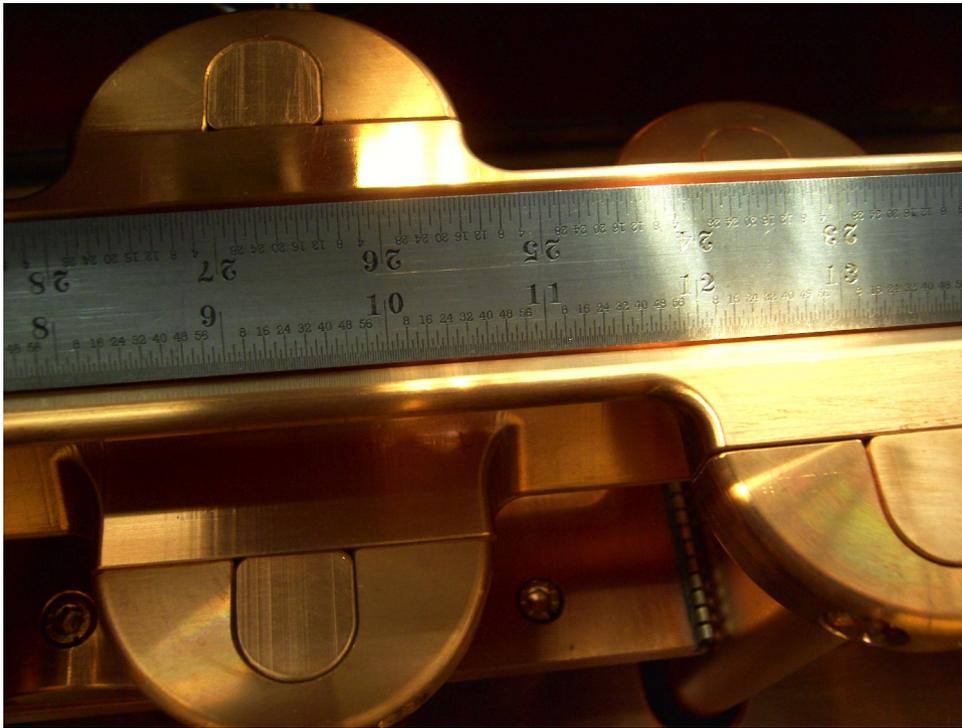
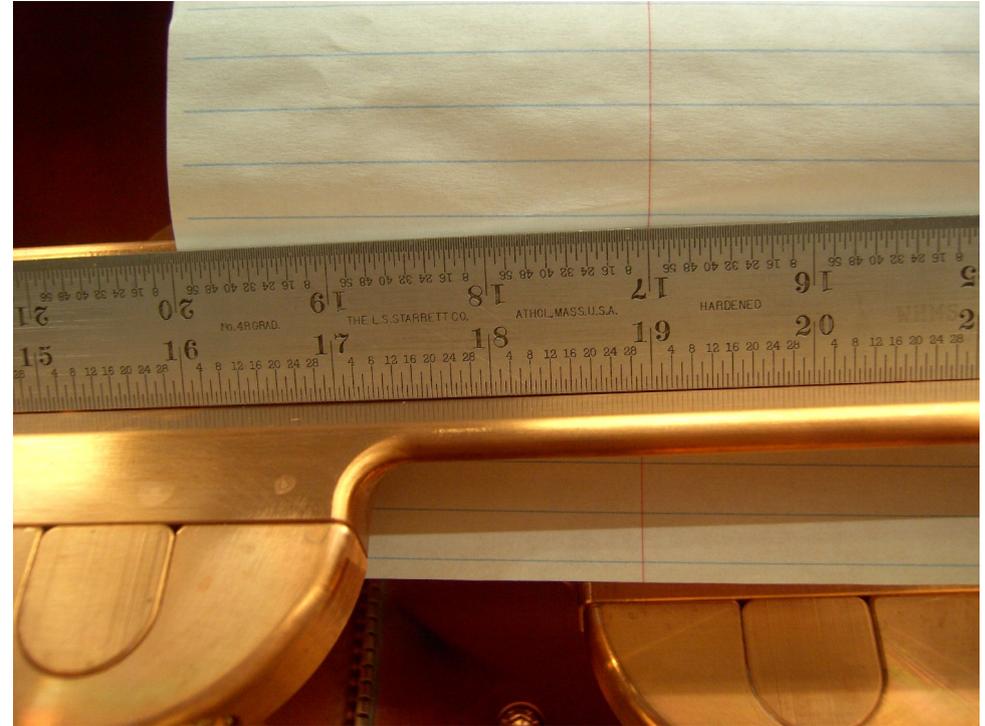
Reduced gap size by ~ 50% for both horz and vert rods that are visible by changing how much we screwed in the bolts of the stands.

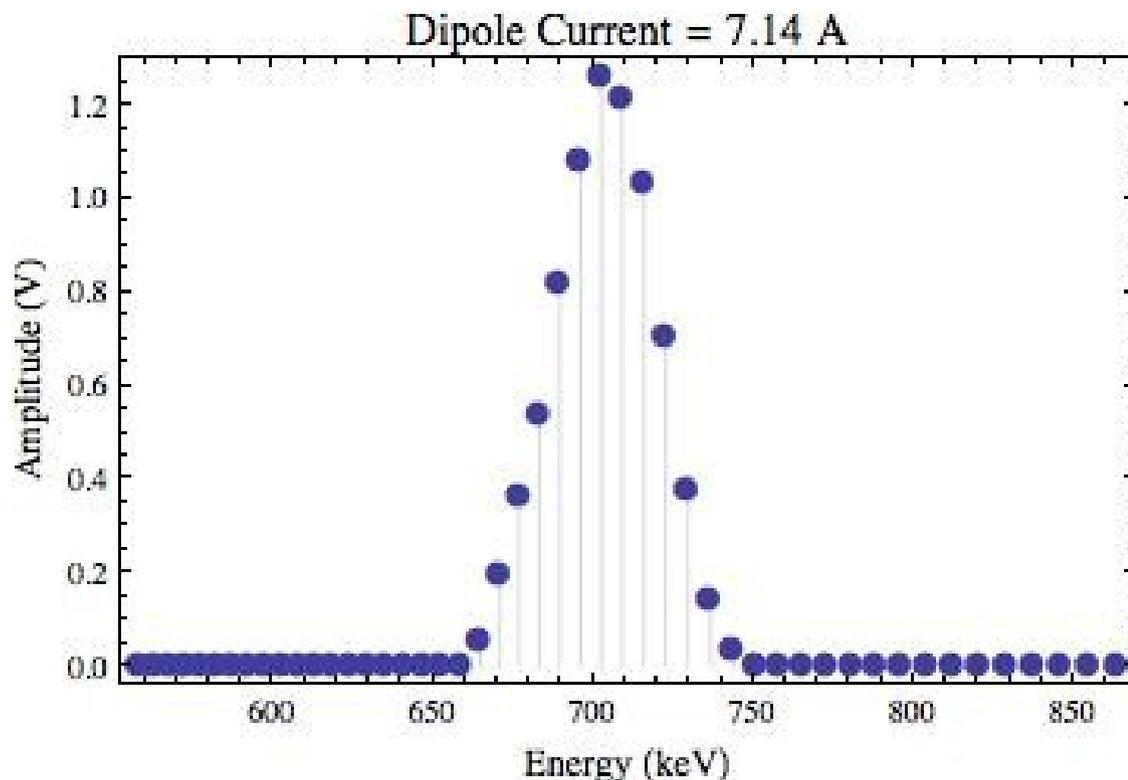
No Change in Energy!

702 keV @ 165 kW

Why????? I would have expected an energy change from my back of the envelope calculation. However, the calculation is for pencil beam and perhaps the effect is smaller because the beam fills the entire aperture? Needs further investigation.

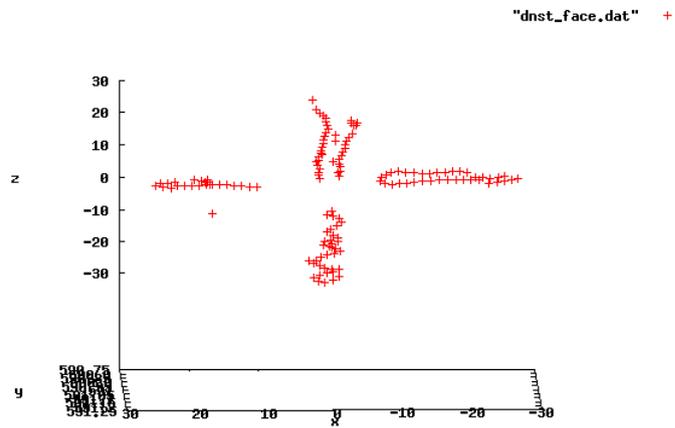
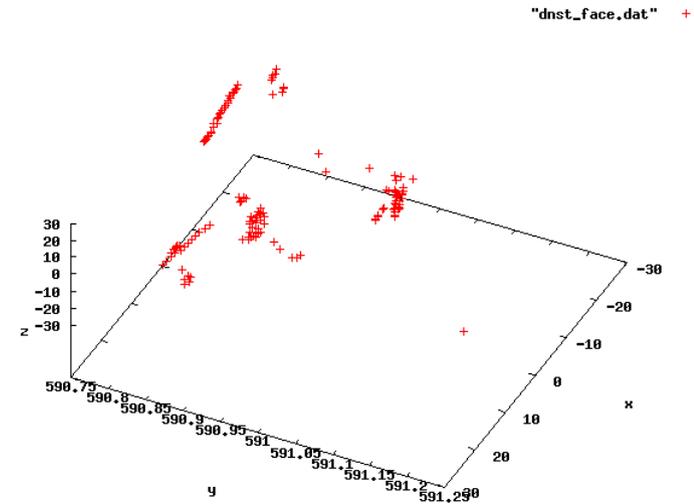
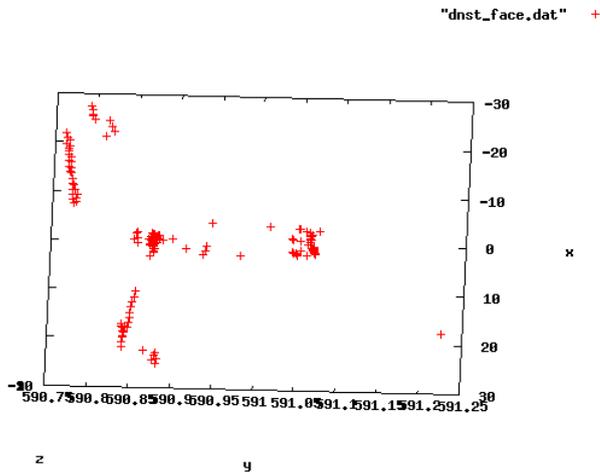
Longitudinally misaligned rods

~0.25 mm misalignment

- Straightened the stands by evenly tightening the bolts of the stands.
- Rods are straight and longitudinally aligned.
- Only one of the rods have dowel pins used to hold to the stands. Other 3 rods do not have dowel pins.

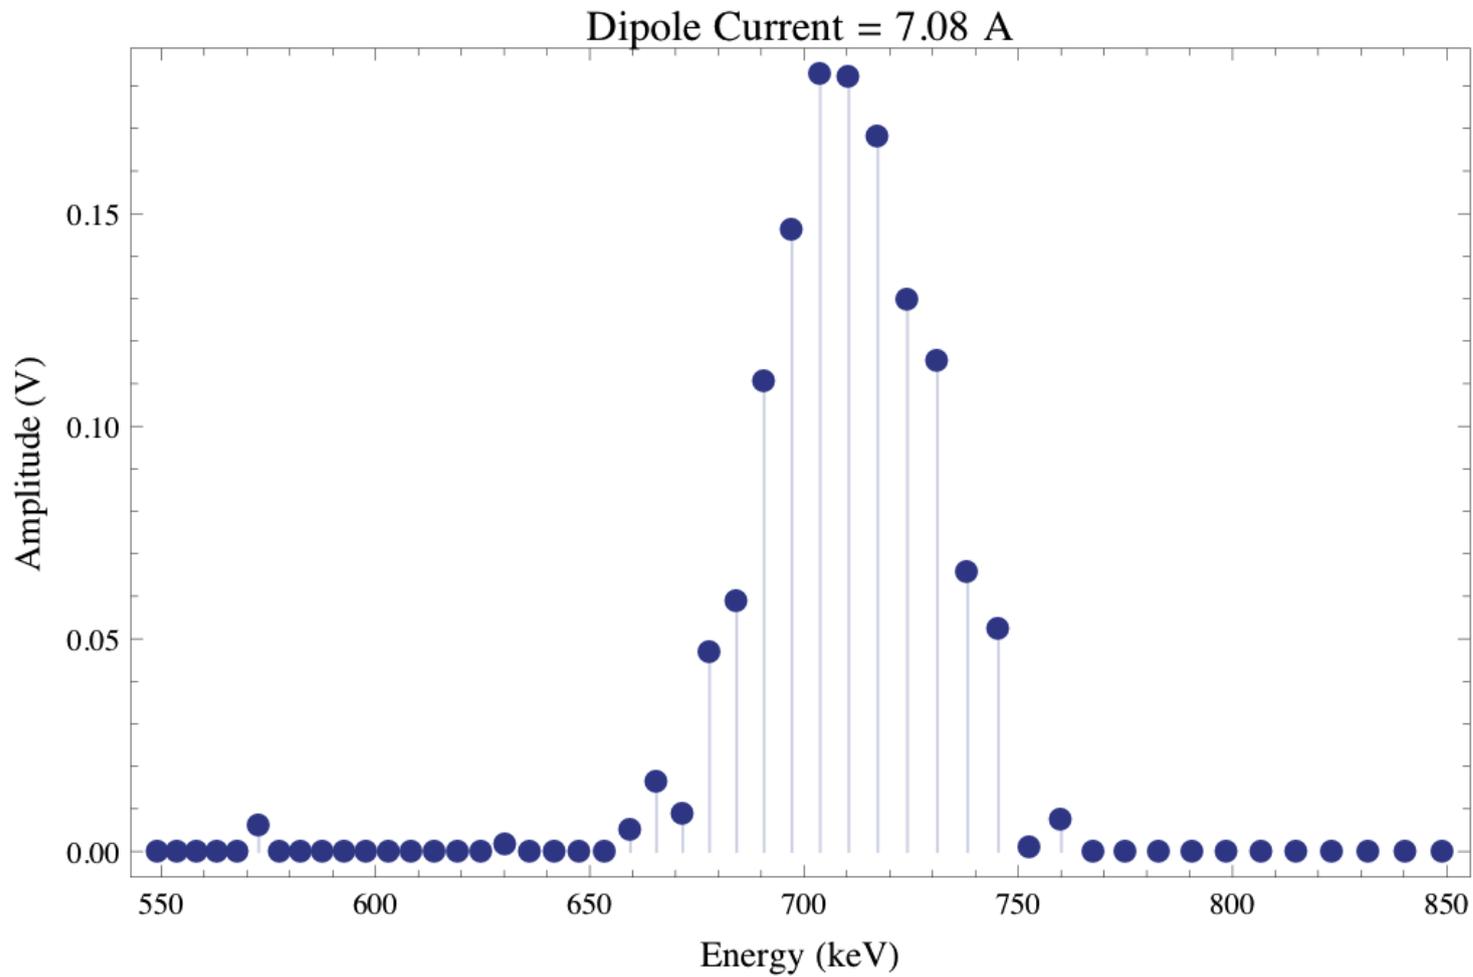
Energy increased by ~ 10 keV

712 keV @ 169 kW
