## Appendix G:

### Metallurgical Evaluations of Corroded Pipe Samples

**FERMI LABORATORY  
MAIN INJECTOR COOLING WATER SYSTEM  
CORROSION EVALUATION**

**December 5, 1997**

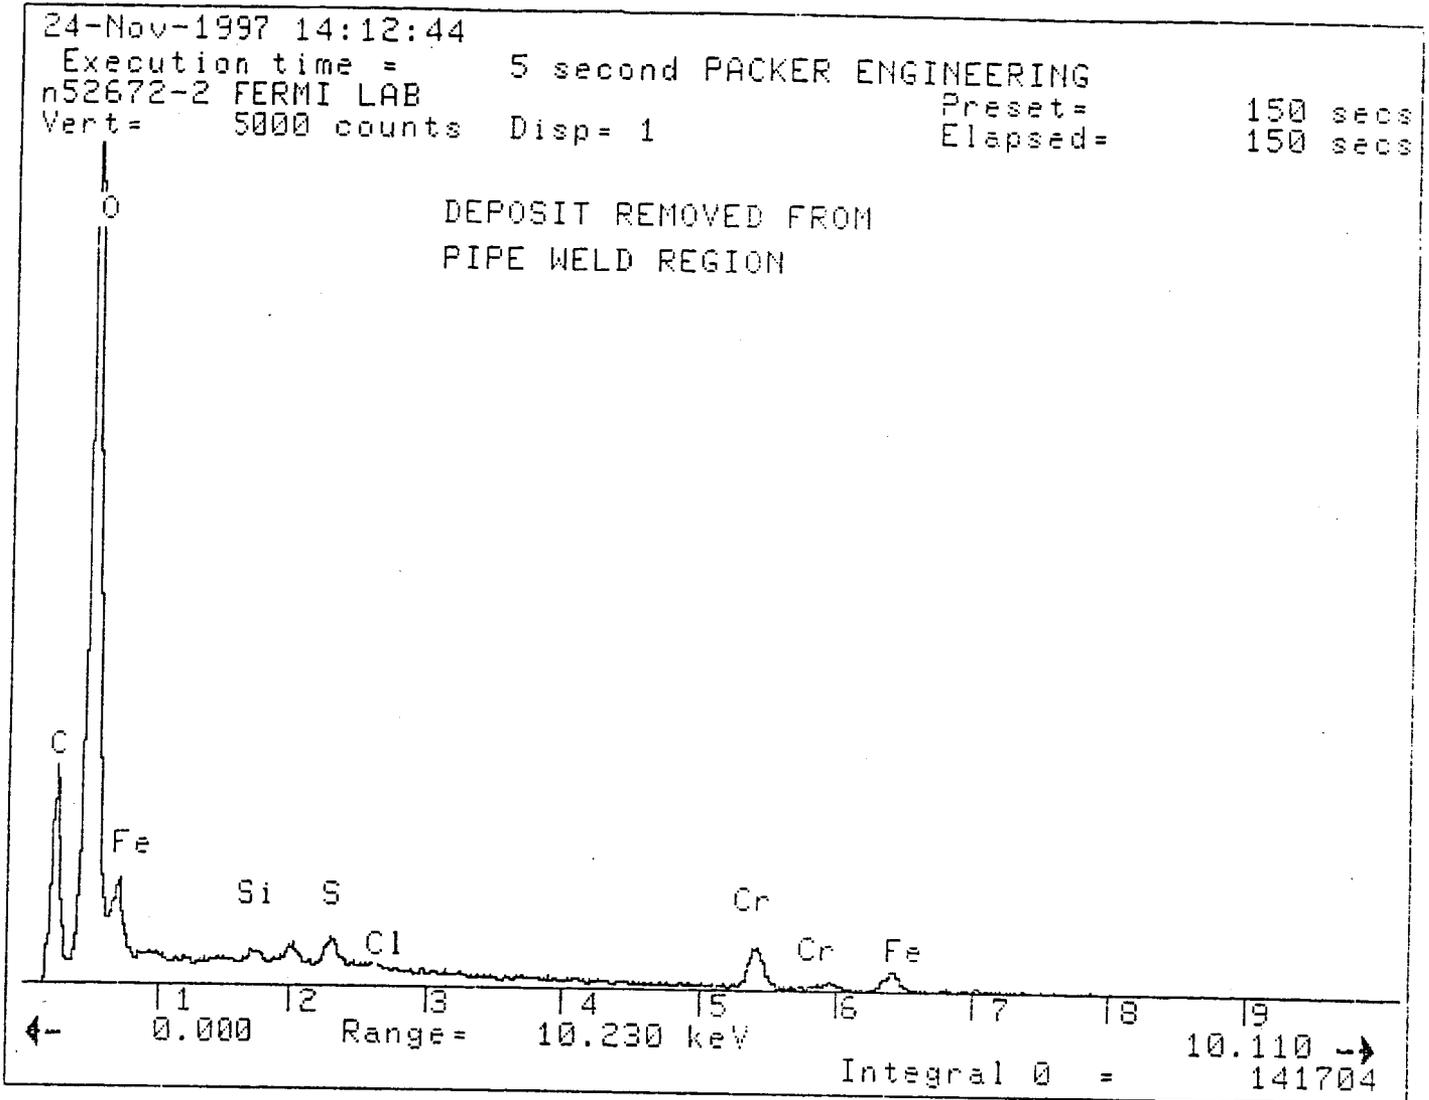
**Figure 1**

Bulk analysis of residue shown in Plate 14. Note the high oxygen and carbon content and the presence of sulfur.

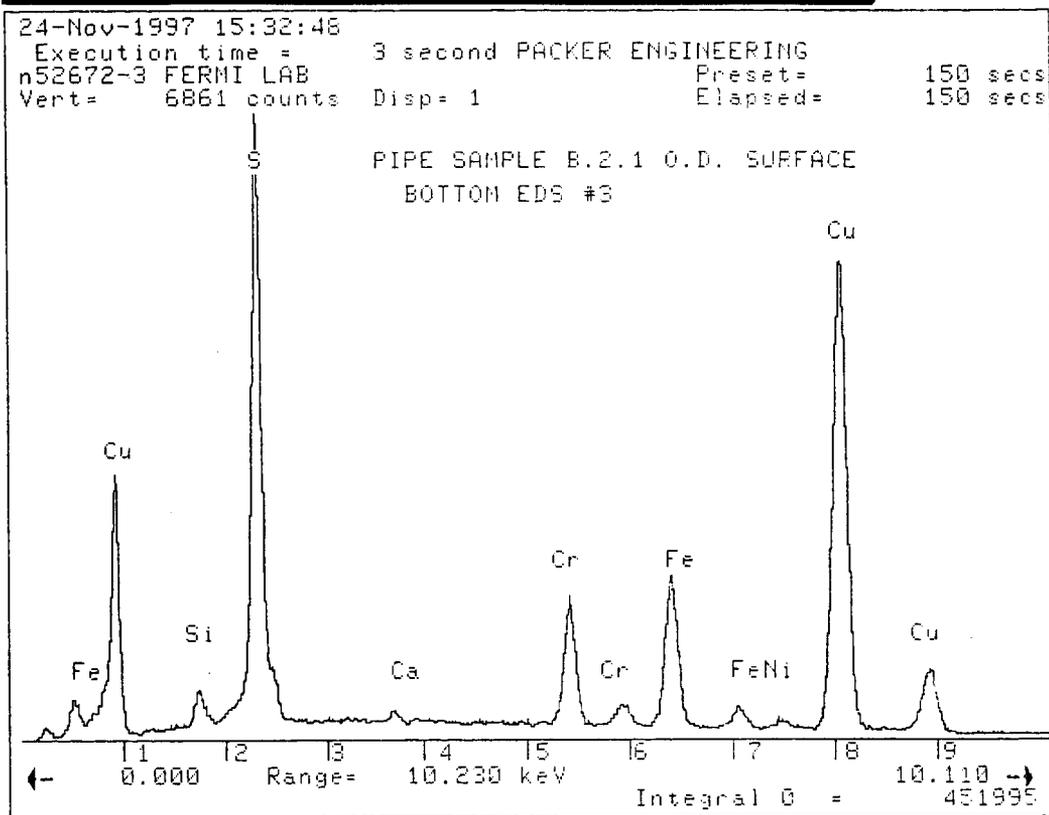
Figure 2

EDS elemental analysis of the growth indicated by the arrow in the photograph. Note the high sulfur content.

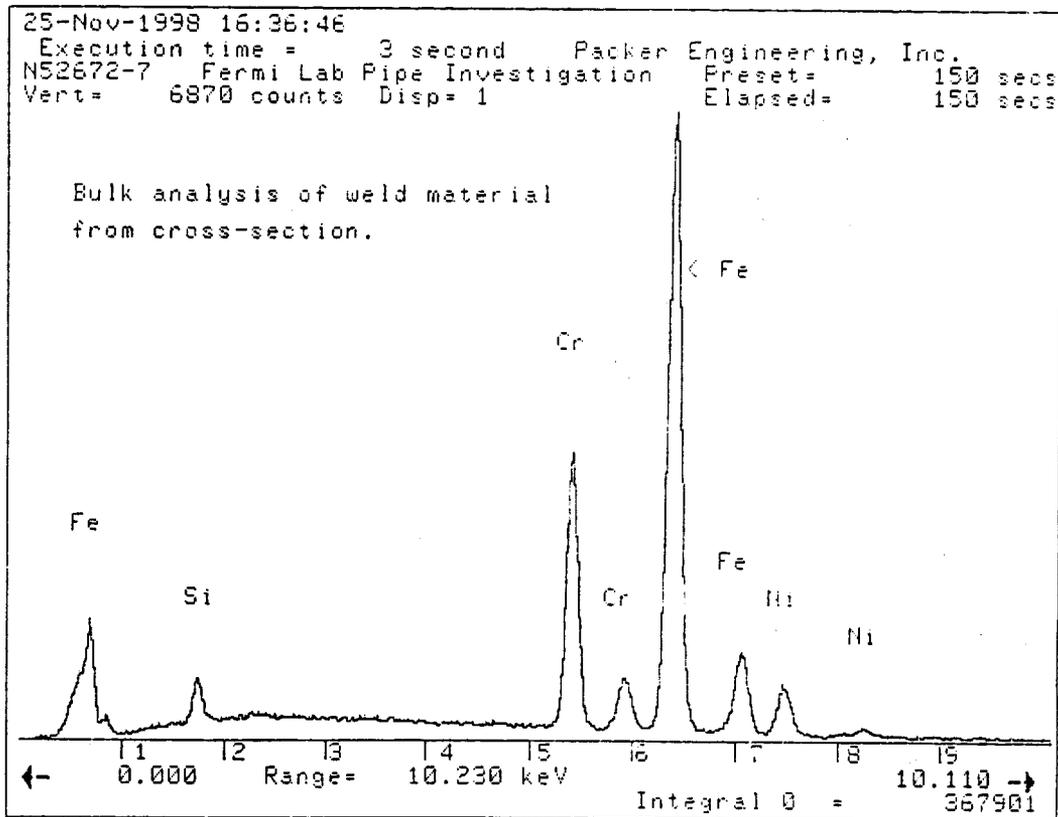
Semi-quantitative EDS analysis of the weld metal indicates that 308 weld rod was utilized, and the microstructure appears representative of acceptable quality material. Refer to Figure 3 for the weld analysis and to Plate 16 for typical microstructures.

Figure 3  
 Bulk analysis of weld metal.

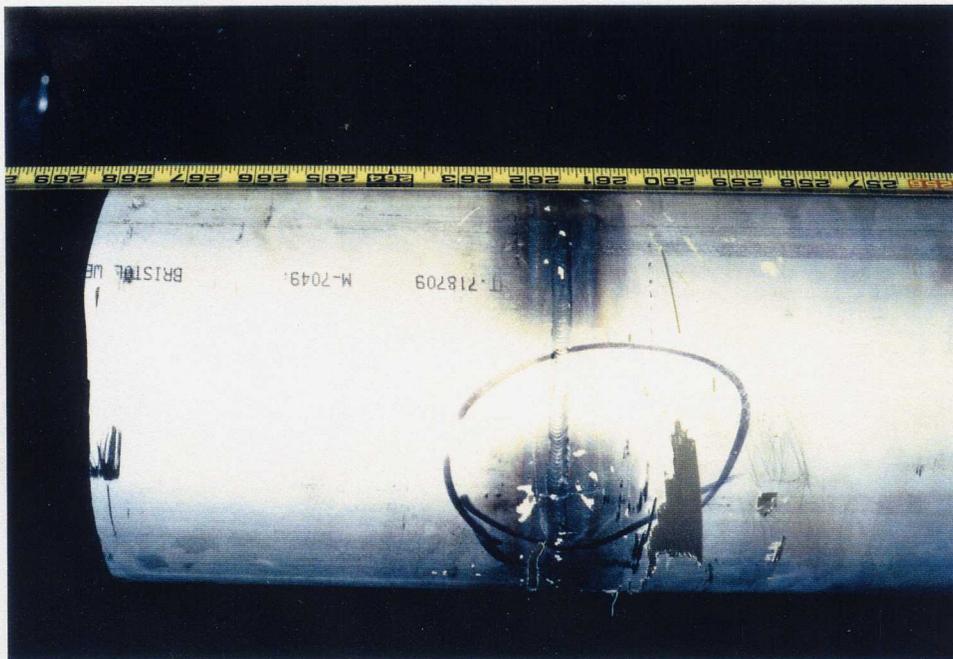
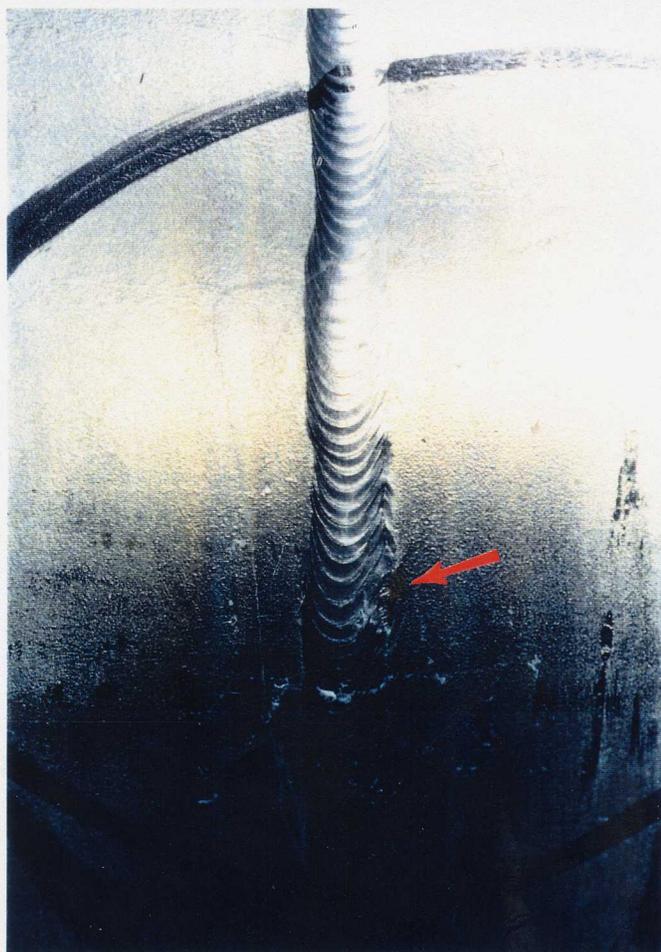
**Plate 2**  
View of a leaking weld  
shown at the arrow.

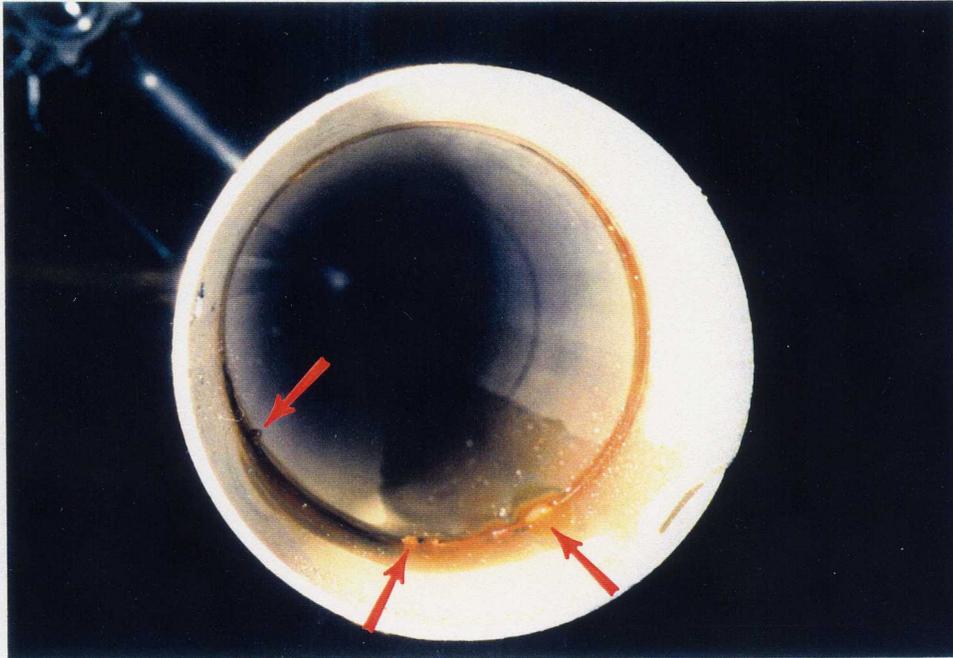
**Plate 3**

View of one weld in the as-received pipe showing corrosion nodules (at arrows).

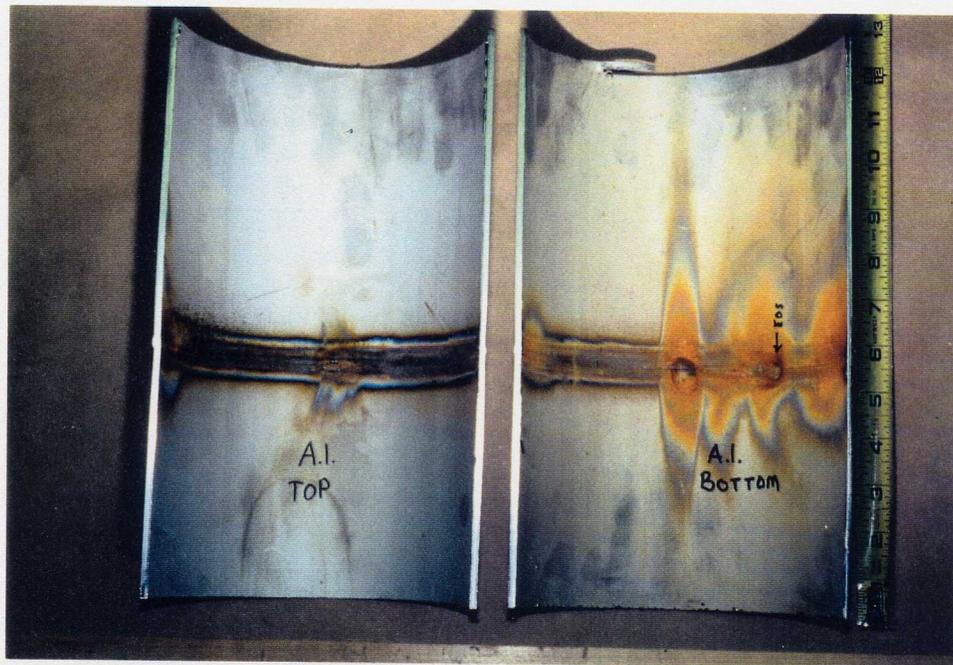
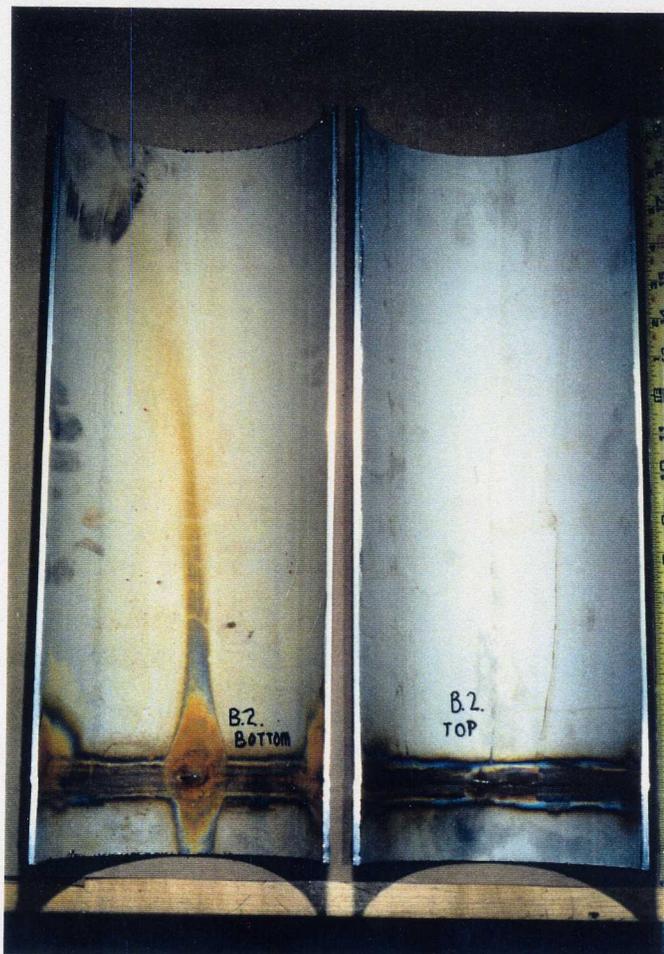
**Plate 4**

Plates 4 through 8 show the condition of the welds after the ID of the pipe was exposed. Both welds contained considerable heat tint from air oxidation during welding. Locations where tack welds were made became hotter, resulting in a wider band of heat tint. It was observed that the corrosion nodules were primarily at locations where tack welds were made, or where there was a lack of fusion. No corrosion nodules were found to be present on the base material away from the welds of the section examined.

Appearance of the two welds in the 6" pipe arbitrarily marked A1 and B2.

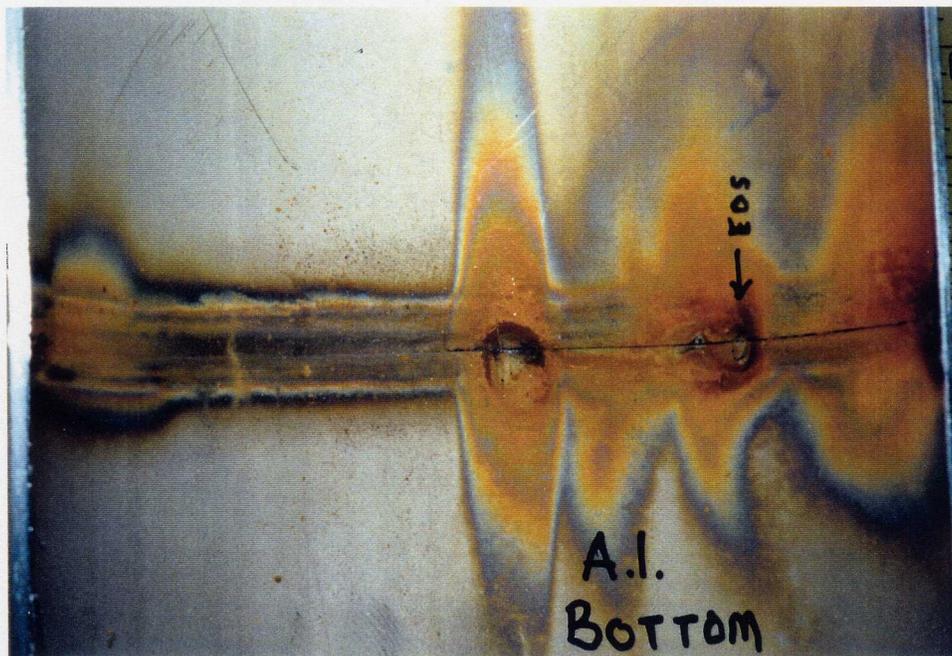
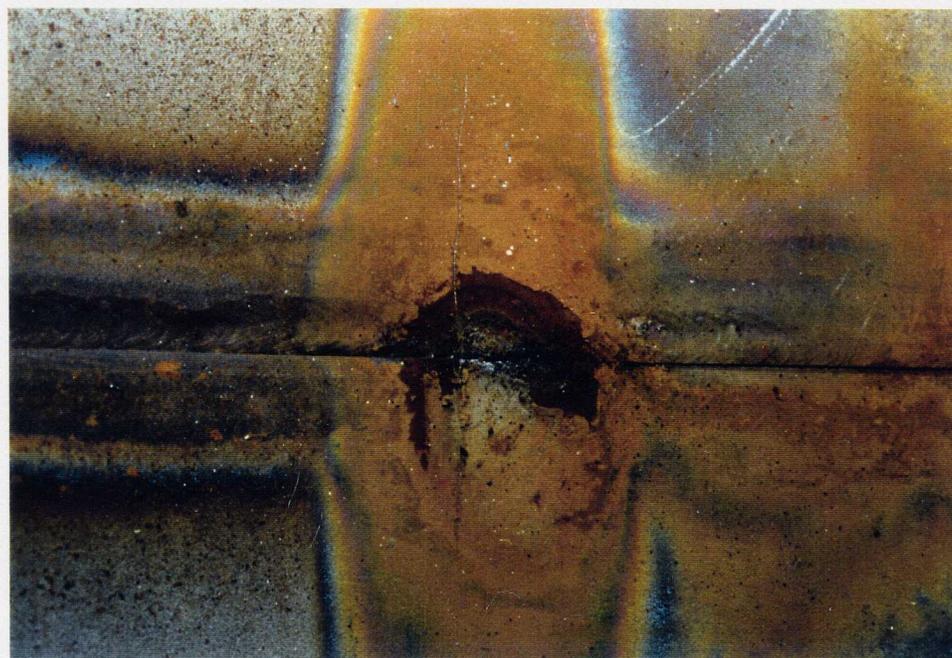
**Plate 5**

Plates 5 through 8 show the appearance of the areas where corrosion nodules are present. Note the lack of fusion on the right hand side of the weld.

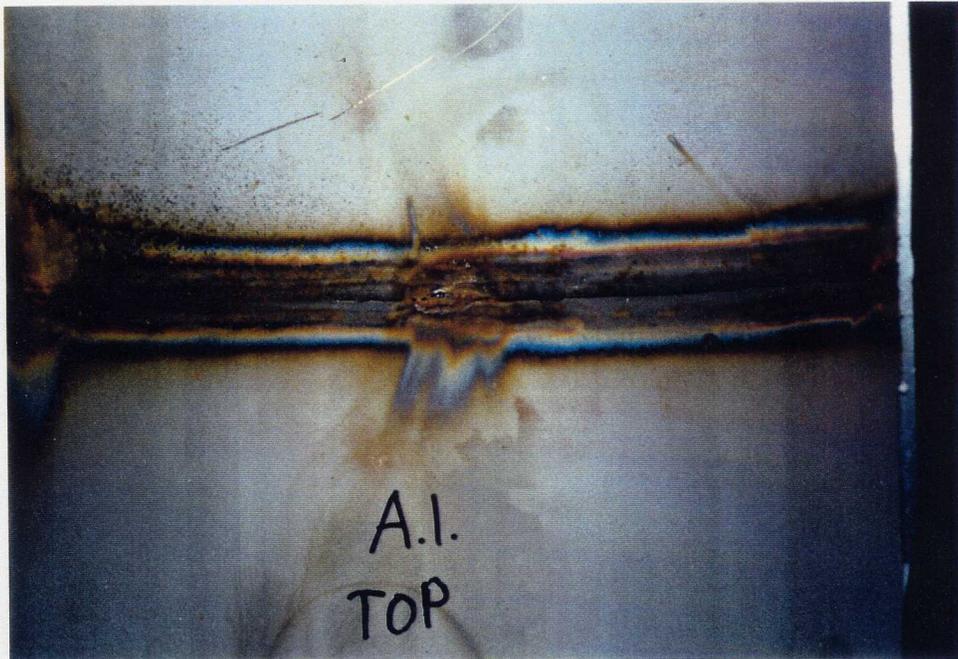
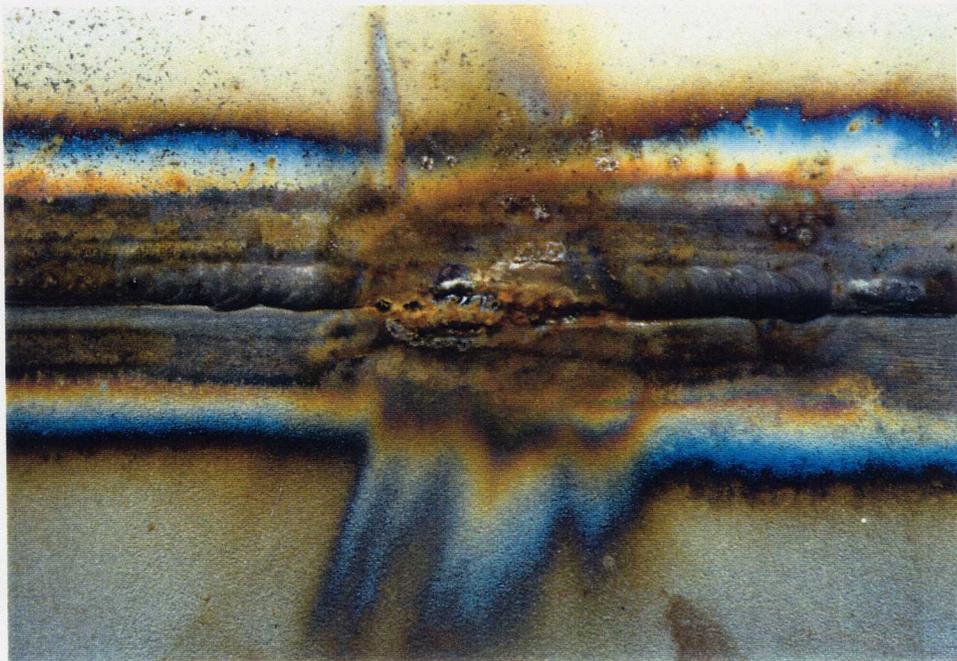
**Plate 6**

The appearance of another area where corrosion nodules are present.

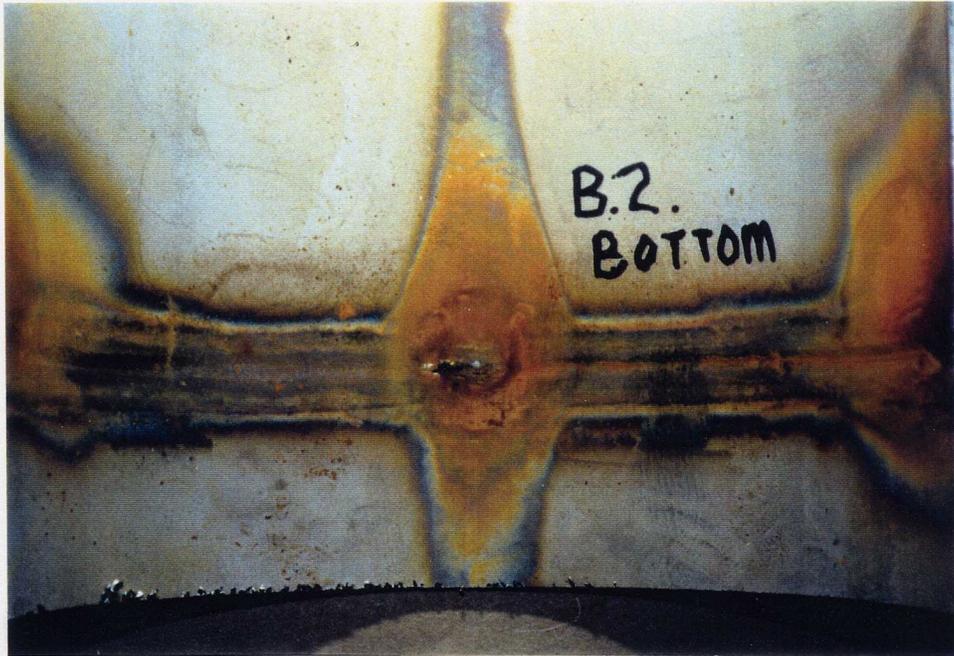
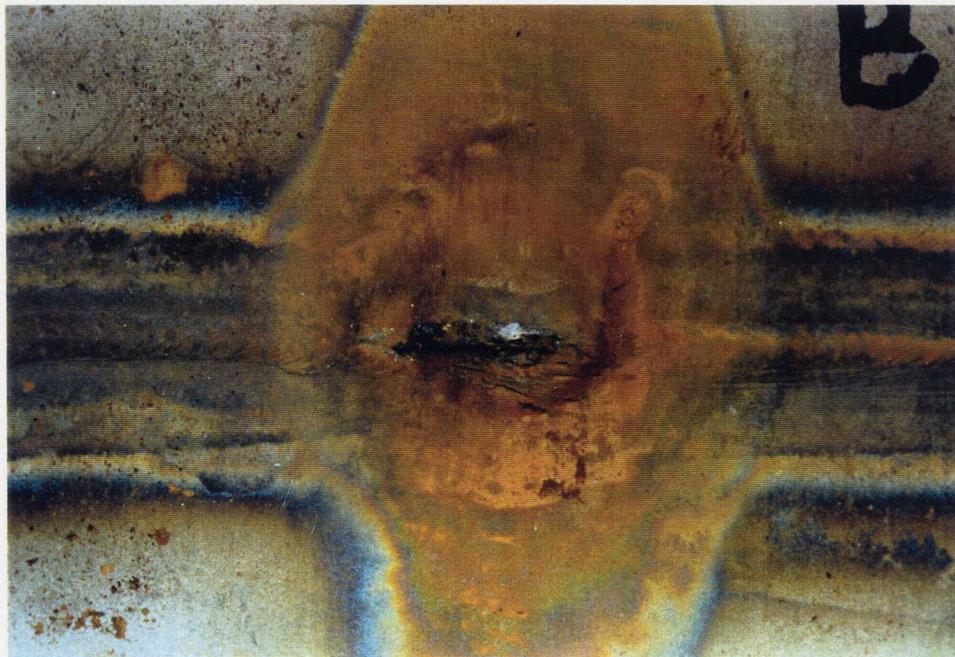
**Plate 7**

The appearance of another area where corrosion nodules are present.

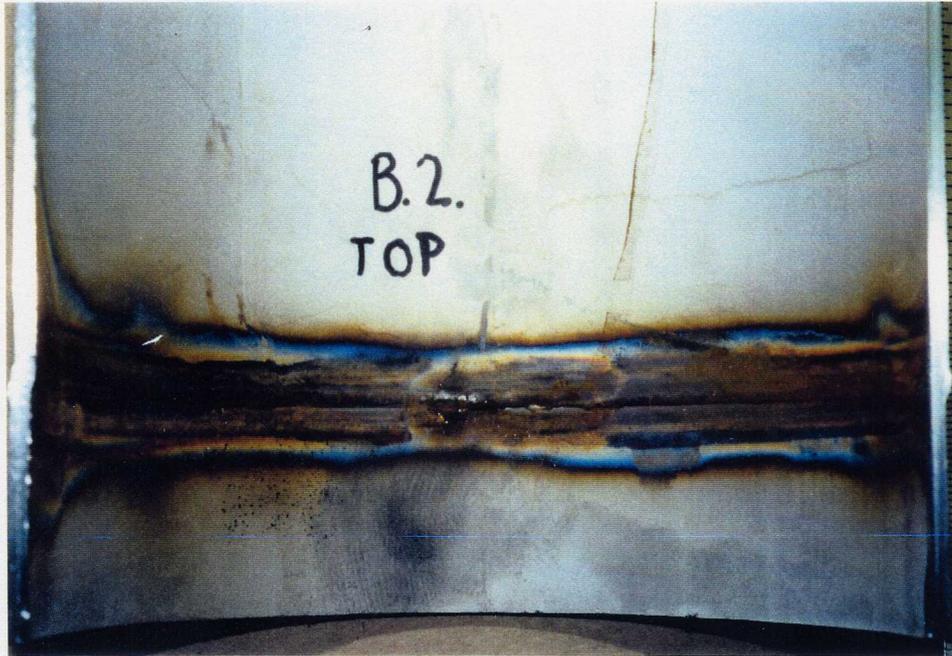
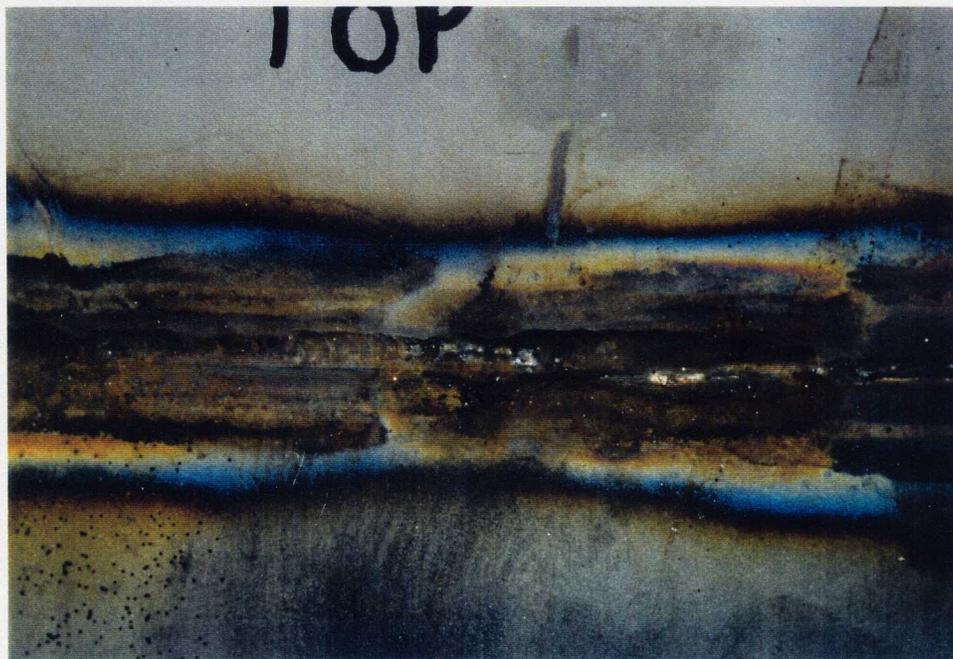
**Plate 8**

The appearance of another area where corrosion nodules are present.

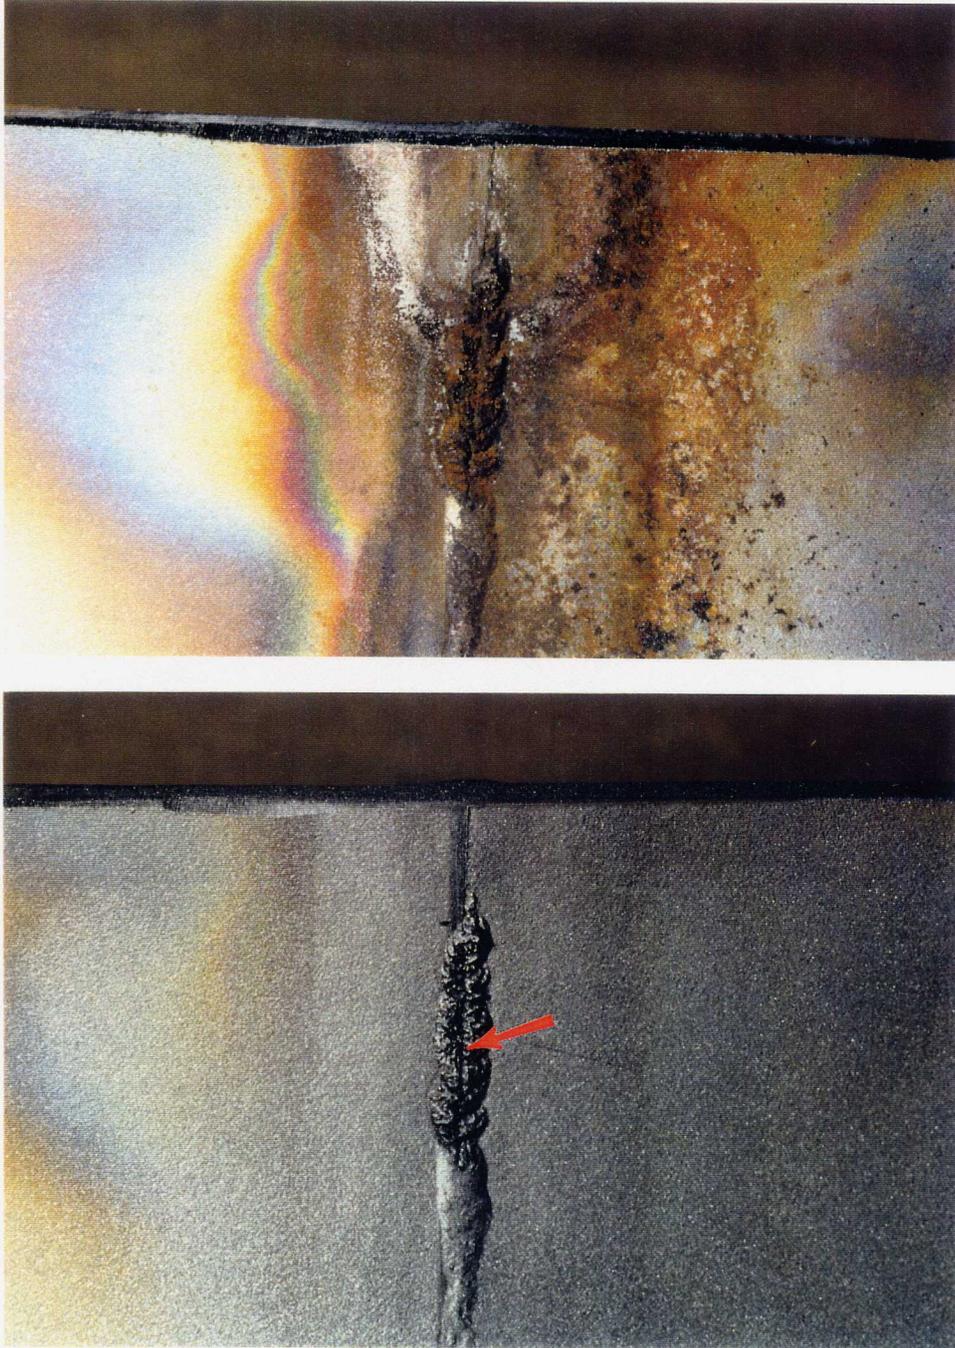
**Plate 9**

Several of the locations that contained nodules were lightly sandblasted to reveal the underlying metallic structure. It appears that the tack welds were not completely consumed by the butt weld leaving a rough surface or a crack. Refer to Plates 9 through 11.

Plates 9-11 contain before and after photographs of tack welds that were not consumed and had corrosion nodules on them. Note that during the examination, some of the nodules fell off. Also note crack at arrow.

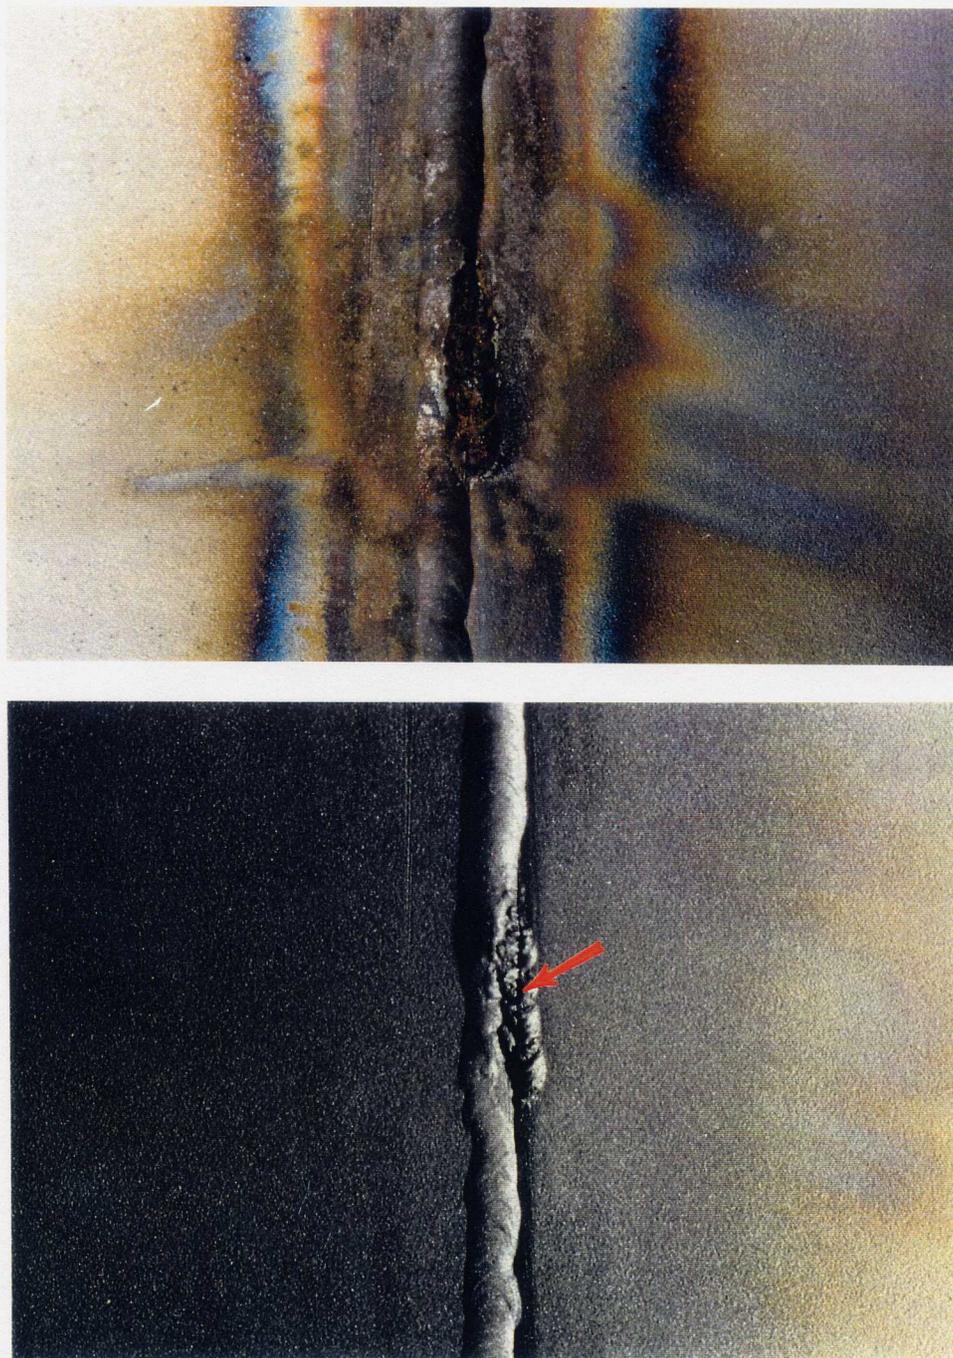
**Plate 10**

Another set of before and after photographs of tack welds that were not consumed and had corrosion nodules on them. Note that during the examination, some of the nodules fell off. Also note crack at arrow.

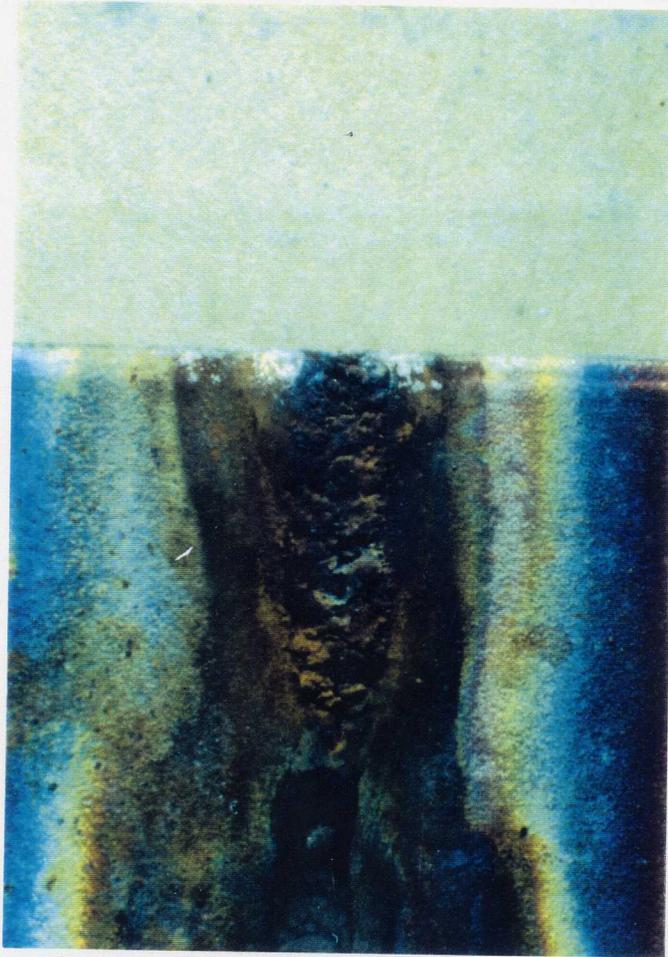
**Plate 11**

Another set of before and after photographs of tack welds that were not consumed and had corrosion nodules on them. Note that during the examination, some of the nodules fell off.

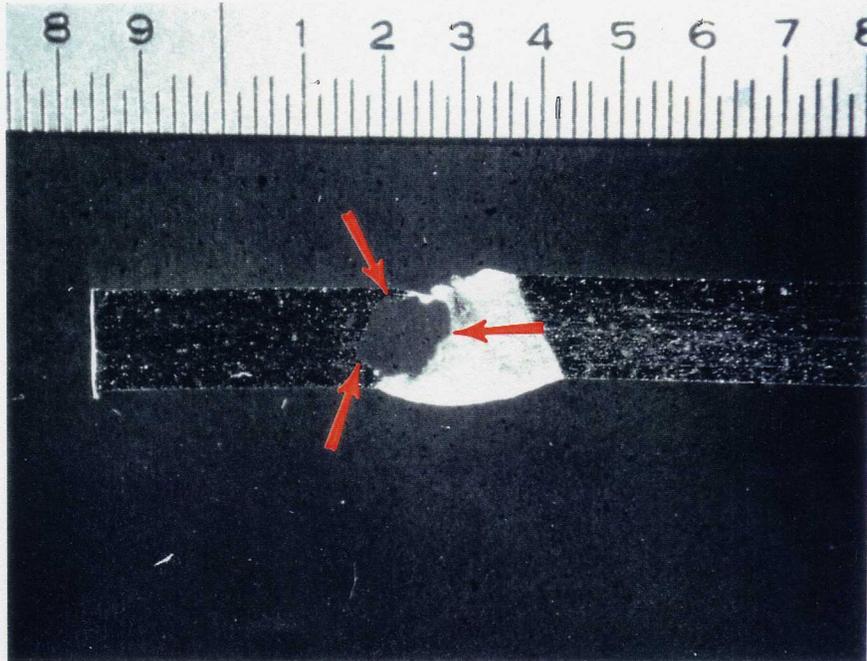
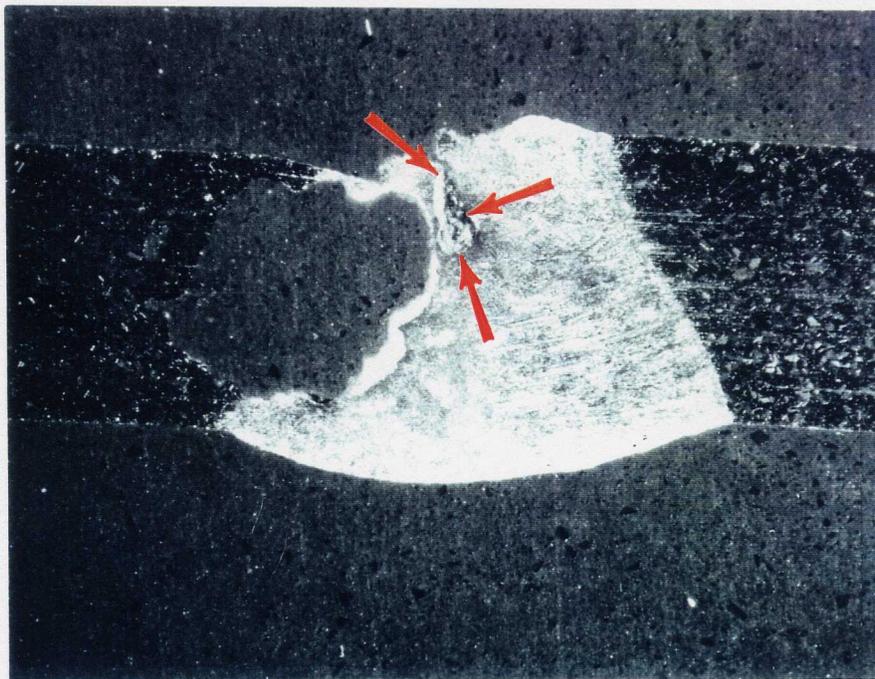
**Plate 12**

Typical cavities found at a module location. (Note that the large cavity filled with the surrounding mounting material when it was mounted for polishing.)

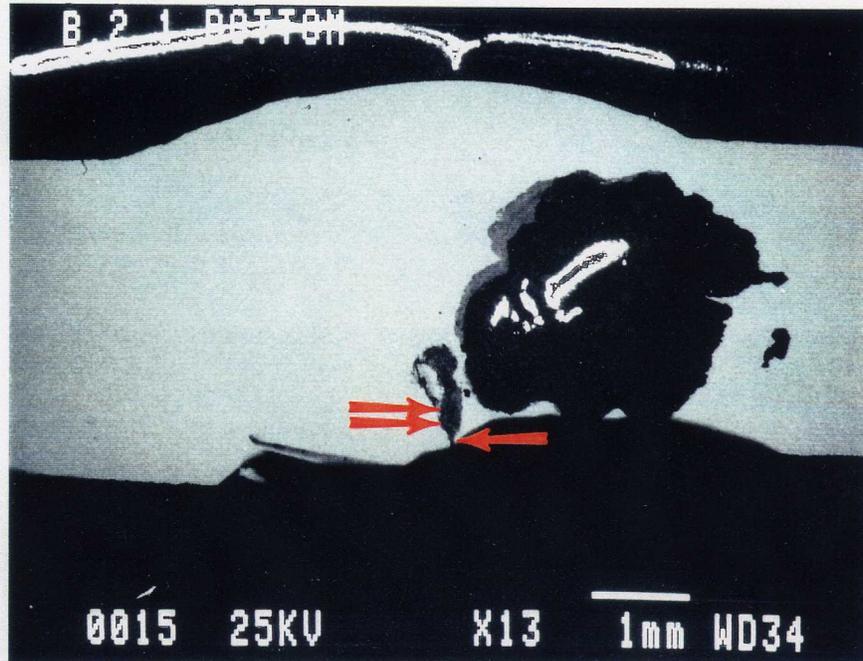
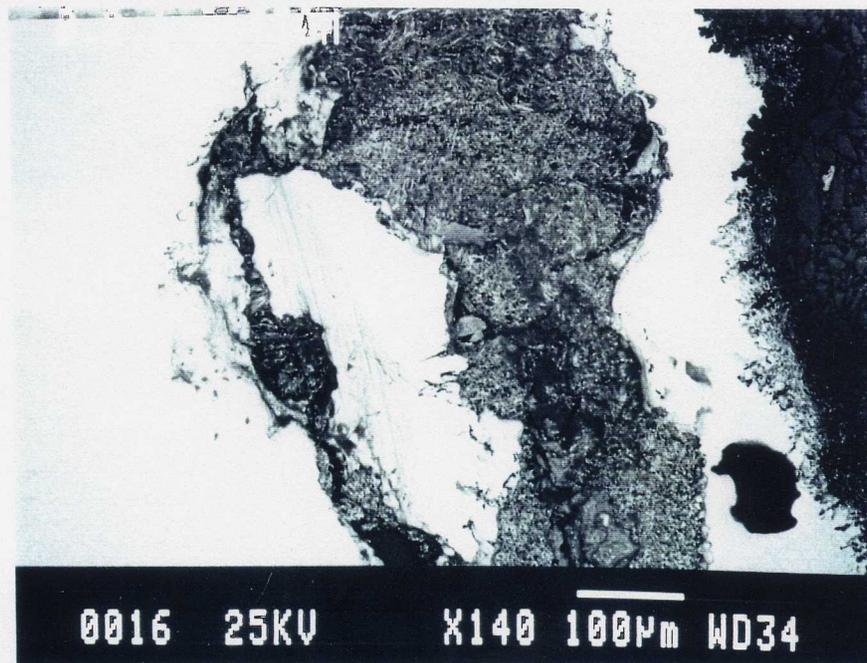
**Plate 13**

SEM photomicrographs of the cavities contained in Plate 12. Note the small tunnel-like entry at the single arrow into the cavity at the double arrows. This tunnel may have originally been a tack weld crack.

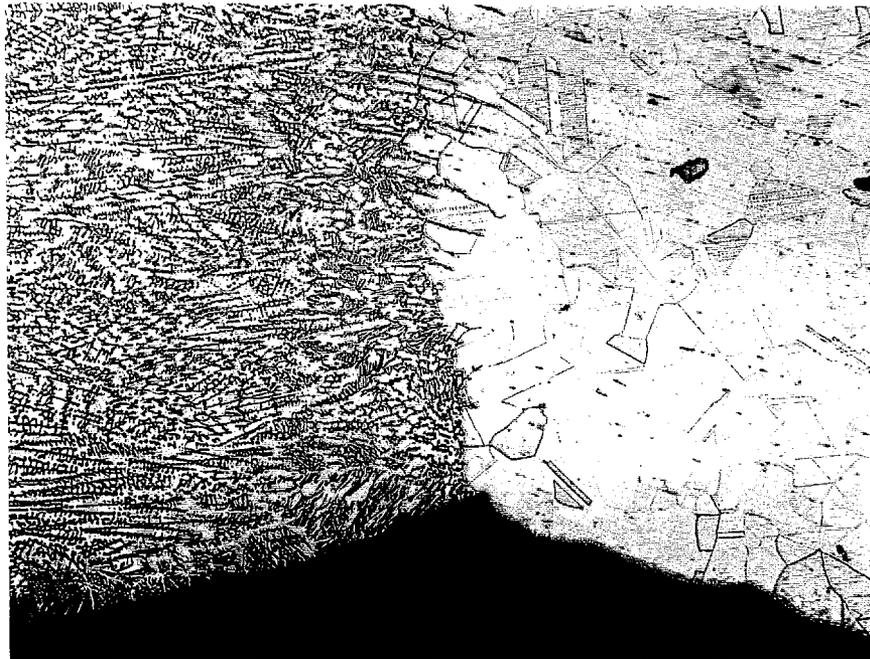
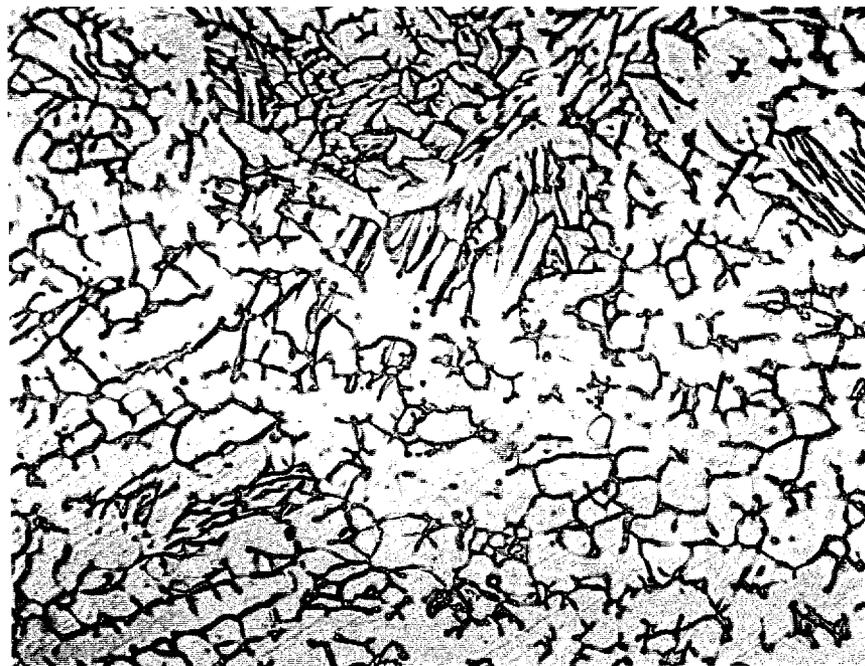
**Plate 16**

Representative microstructure of weld and base material (top) and weld (bottom). The base material consists of equiaxed grains of austenite and the weld consists of ferrite in a matrix of austenite. Both are representative of acceptable quality material.

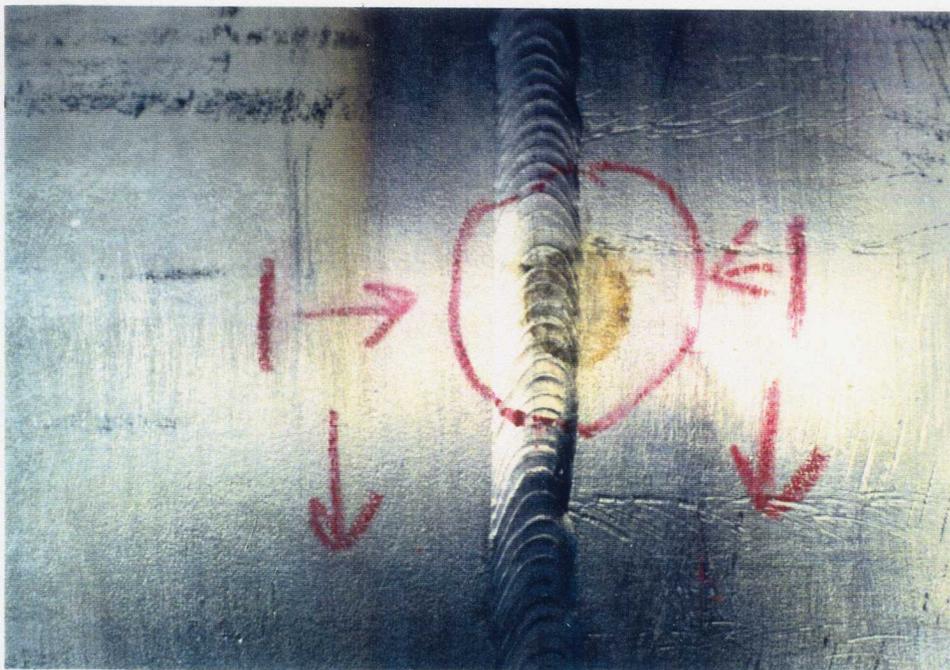
Figure 2  
Region One Showing a Brown Deposit  
On the External Surface of the Weld

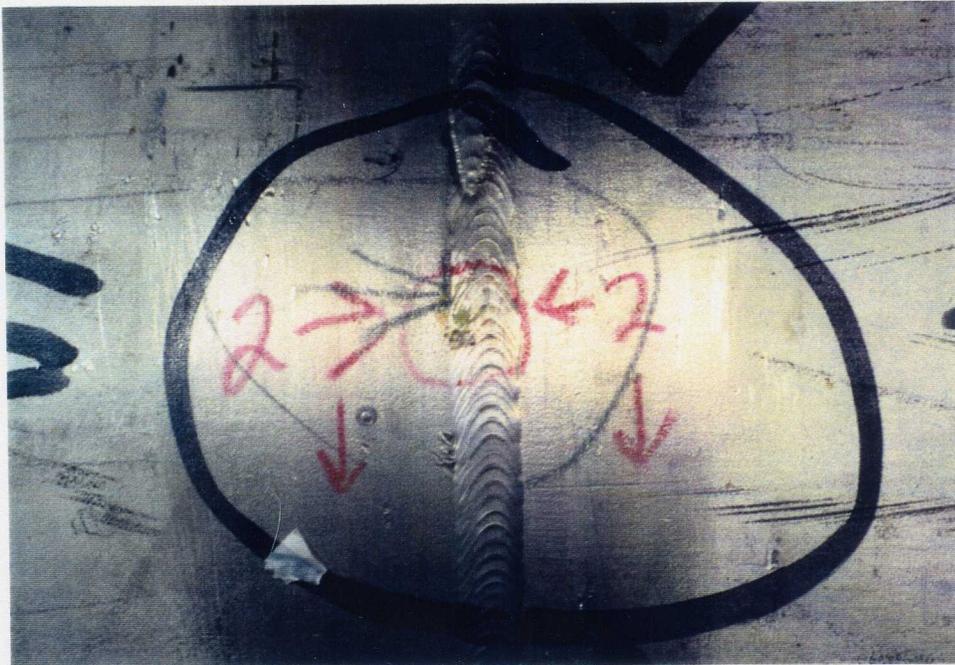
Figure 3  
Region Two Showing Small Deposit Spots

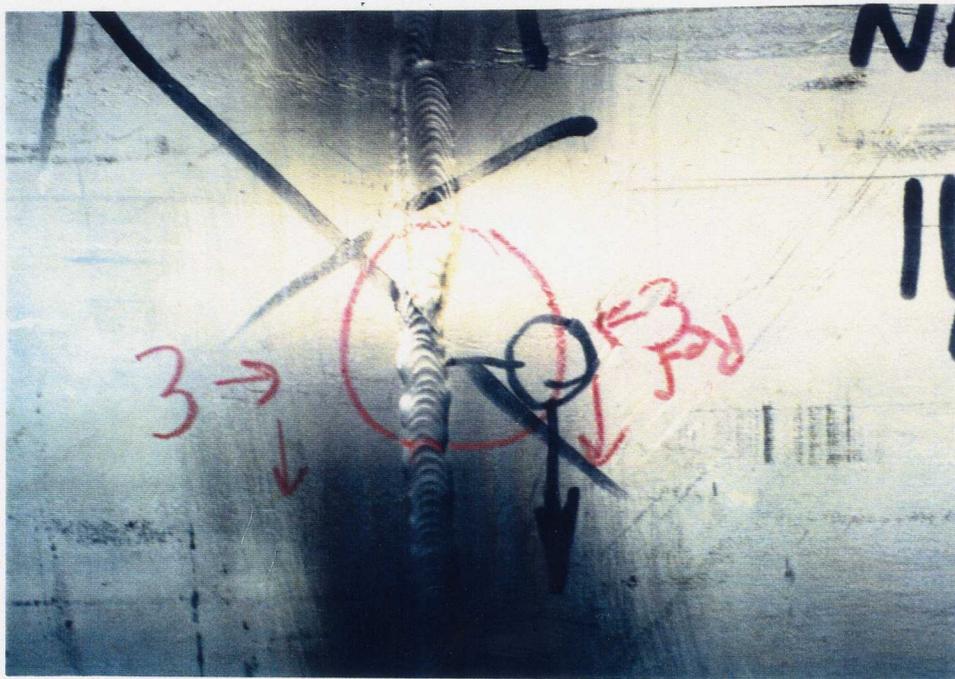
Figure 4  
Region Three Showing a Narrow Deposit Strip  
At the End of an Overlapping Weld

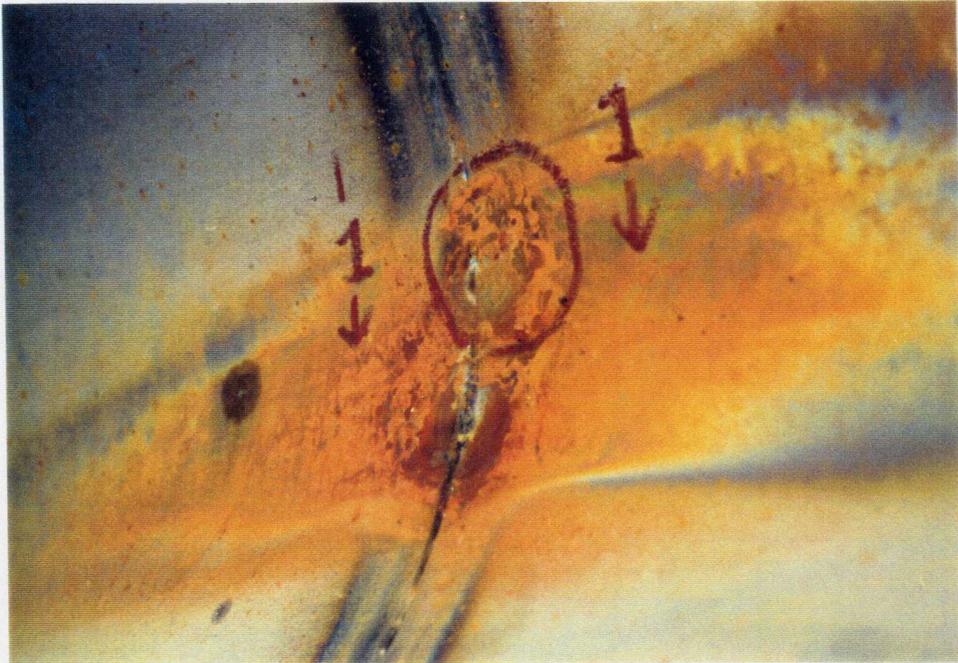
Figure 6  
Region One Showing Misalignment of Pipes  
At the Circumferential Weld

Thus, remedies for corrective action must address these factors. First, defects such as misalignment of the pipe and fissures should be prevented during the welding process. Such defects provide sites for concentration of corrosive species in the water. Imperfections in the weld such as excessive heat tint may be minimized by properly using a nitrogen blanket during welding, chemically cleaning the surfaces after welding (highly recommended), and reducing the heat input during welding. Reducing the heat input should also be beneficial in reducing segregation and excessive formation of ferrite in the microstructure of the fusion zone of the weld. Note that the longitudinal seam of the pipe, which utilizes a multipass welding operation with lower heat

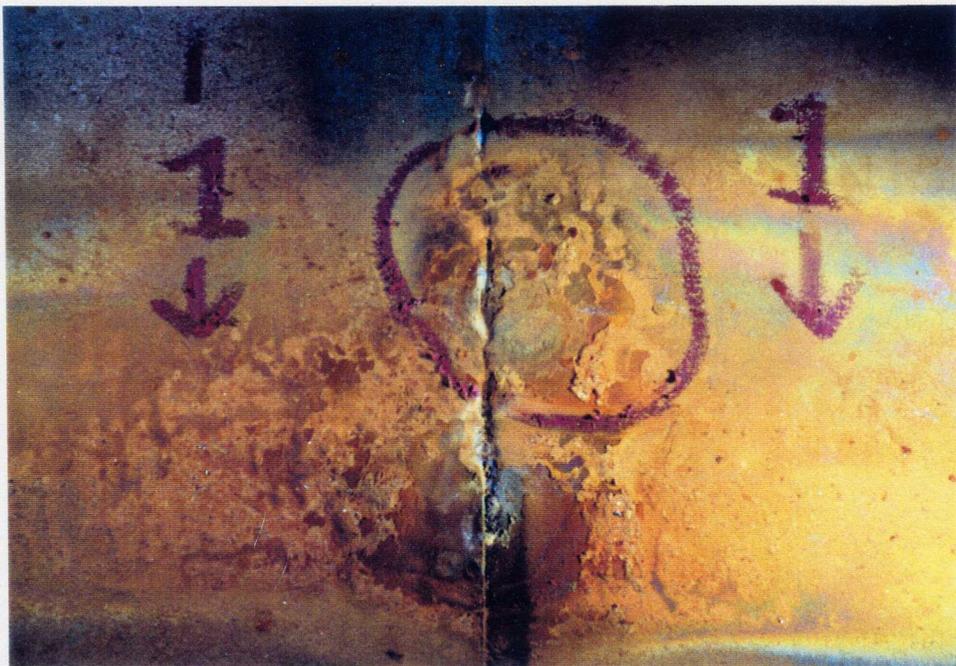
Figure 7  
Region One Showing Corrosion Products
