## Appendix G:

### Metallurgical Evaluations of Corroded Pipe Samples

**FERMI LABORATORY  
MAIN INJECTOR COOLING WATER SYSTEM  
CORROSION EVALUATION**

**December 5, 1997**

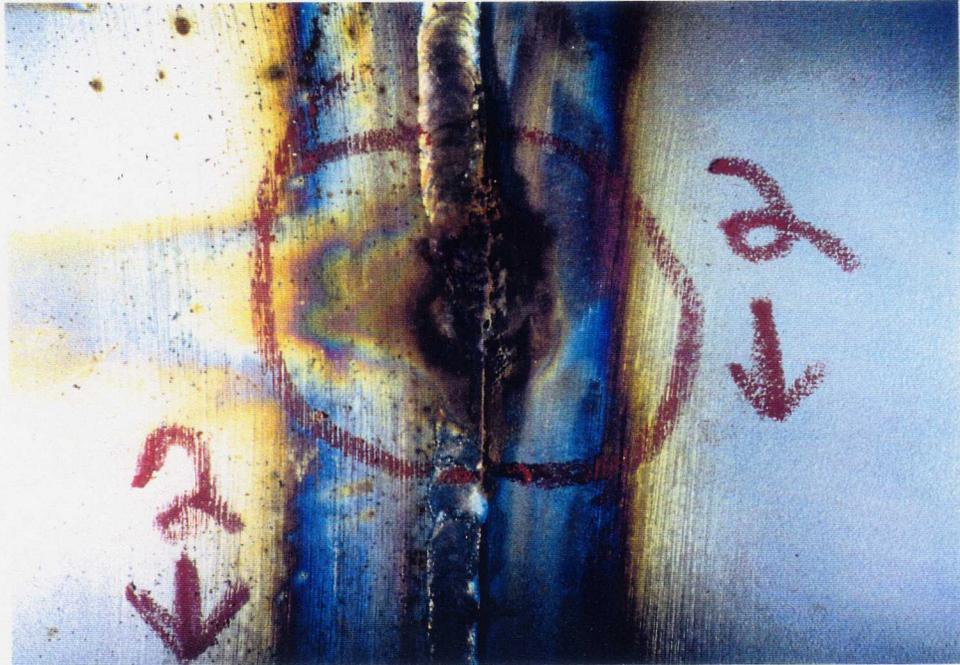
A corroded nodule is present on the internal surface of region two, Figures 8 and 9. Small specks of material are present on the side of the weld adjacent to weld 428, Figure 8. The corrosion products on the nodule are porous and easily removed by scraping with a sharp pick. The underlying material of the nodule is very hard. The surface beneath the nodule contains many fissures, Figure 10. The pipes are misaligned as much as 0.050" in this region.

Figure 8  
Region Two Showing a Corrosion Nodule

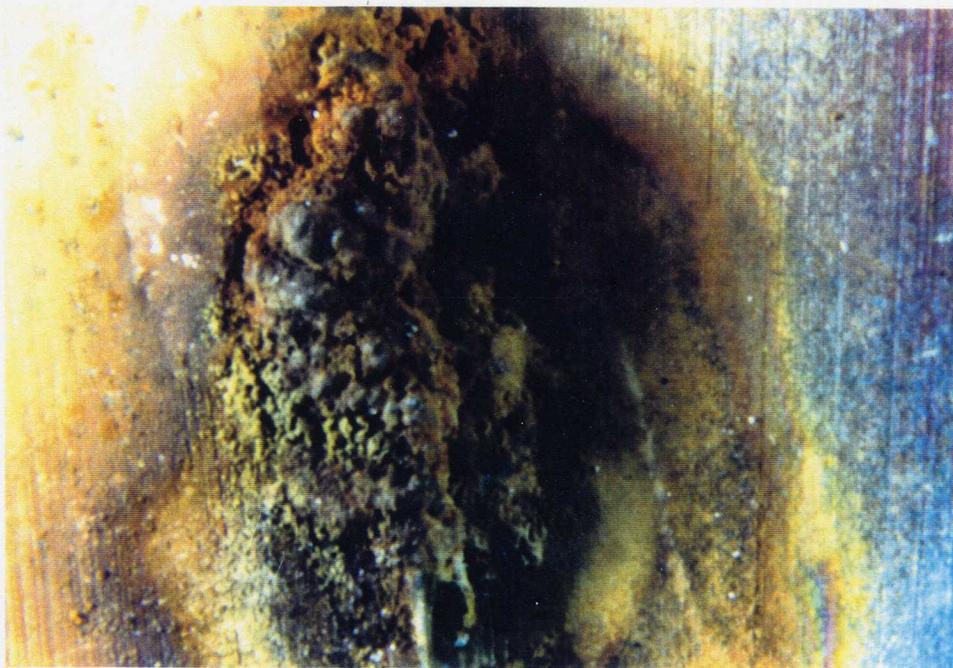
Figure 9  
Close-up of Corrosion Nodule in Region Two  
Magnification: 6X

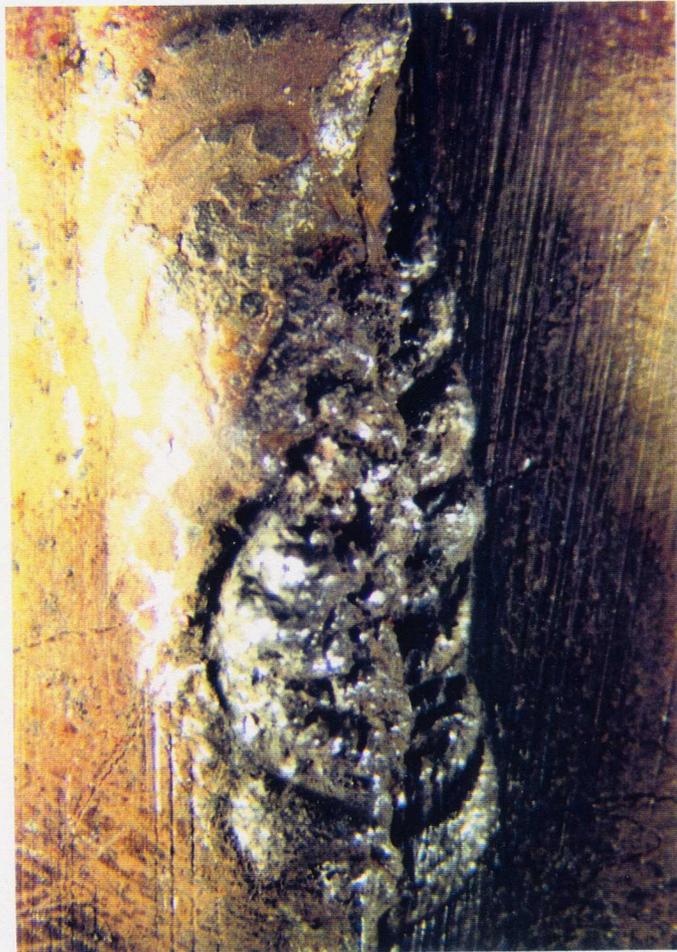
Figure 10  
Close-up of Corrosion Nodule in Region Two After Cleaning  
Magnification: 6X

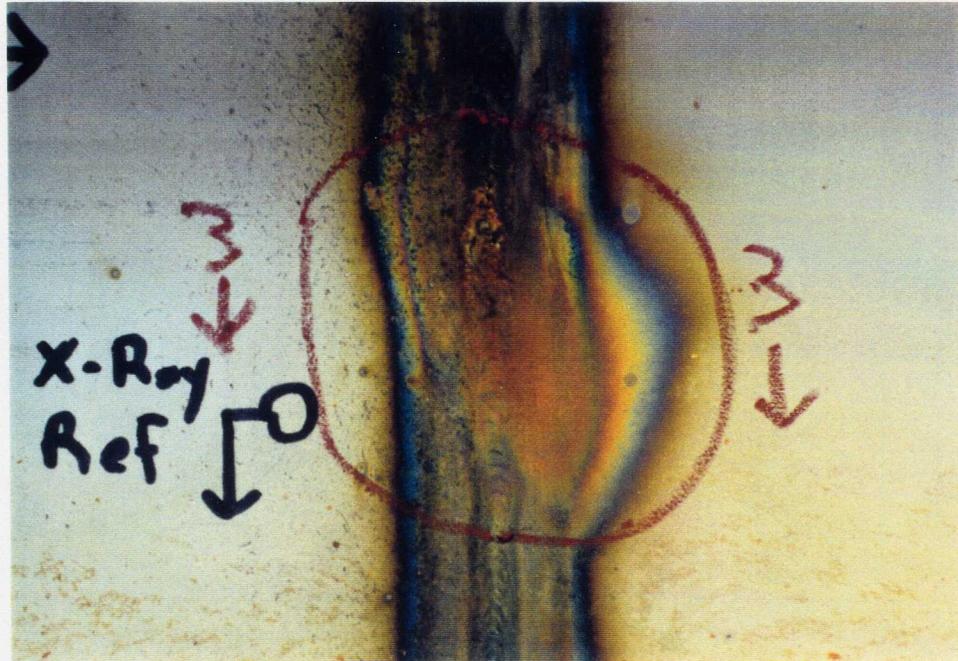
A thin layer of brown corrosion products overlies an area near the circumferential weld in region three, Figure 11. Specks of material, similar to those observed in region two, were confined to one side of the weld. These specks of material are largely isolated to areas where corrosion has occurred. A circumferentially oriented fissure, approximately 1/2" long, runs along the weld centerline, Figure 12. The fissure is present beneath the overlapping weld observed on the external surface. When examined under a low power stereomicroscope fan-shaped striations strongly resembling dendrites paralleling the internal surface are visible on the weld bead, Figure 13. The striations are observable at most locations along the internal surface weld not obscured by corrosion products. The misalignment of the pipes in region three was as much as 0.055".

Figure 11  
Region Three Showing Corrosion at Weld

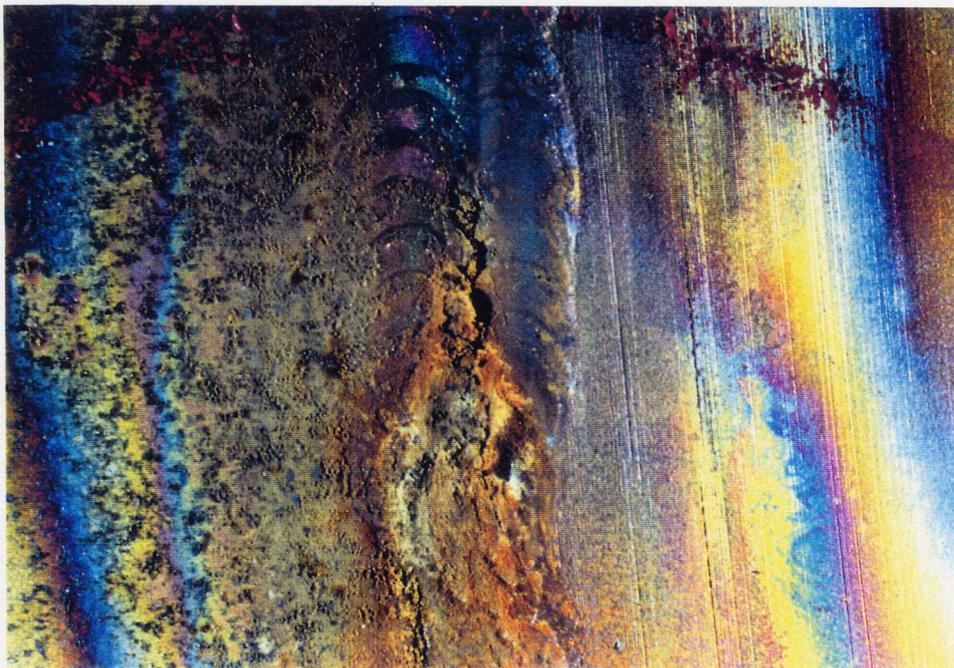
Figure 12  
Close-up of Region Three Showing Crevice Present Between Welds

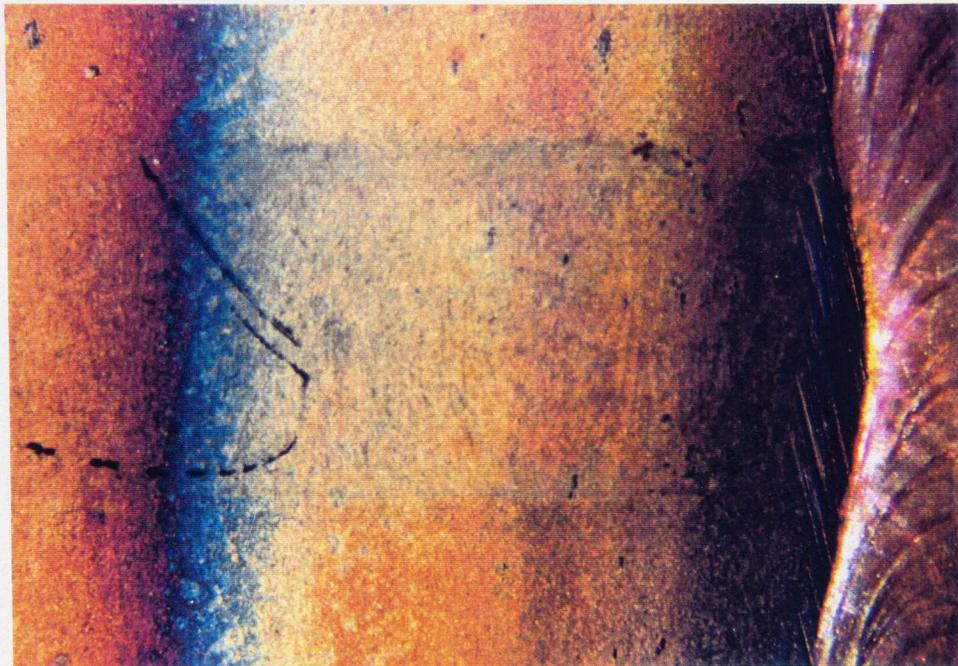
Grinding marks are present at scattered locations along the circumferential weld, Figure 14. Grinding may have been used to clean off possible contaminants prior to welding. No corrosion was observed at the grinding marks.

Figure 14  
Coarse Grinding Marks Along Circumferential Weld  
And Longitudinal Weld Seam

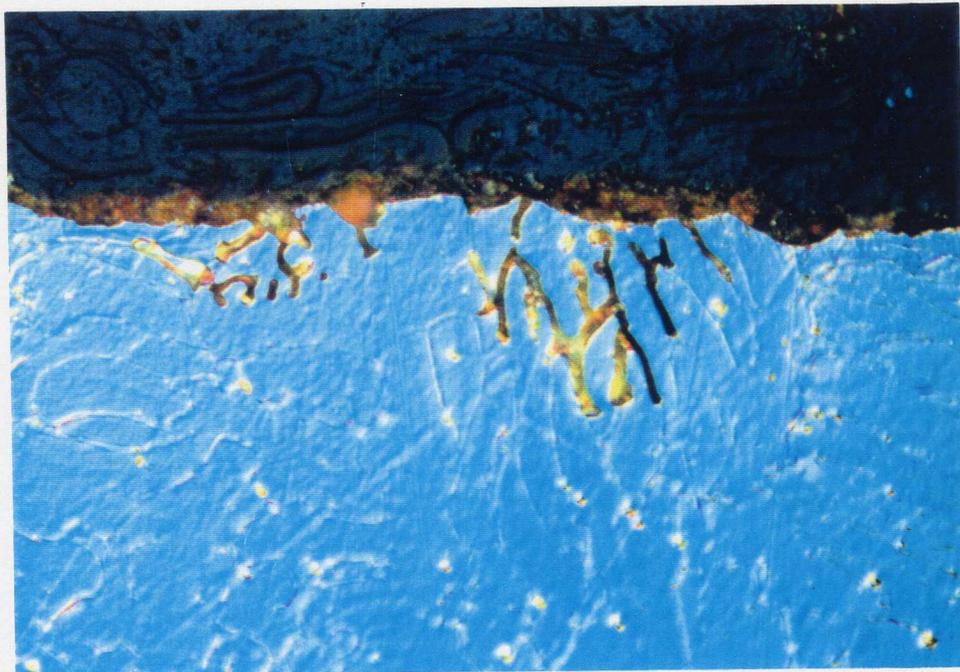
Figure 24  
Close-up of Dendritic Attack Along the External Surface  
Magnification: 1000X Etchant: Electrolytic Oxalic  
Differential Interference Contrast

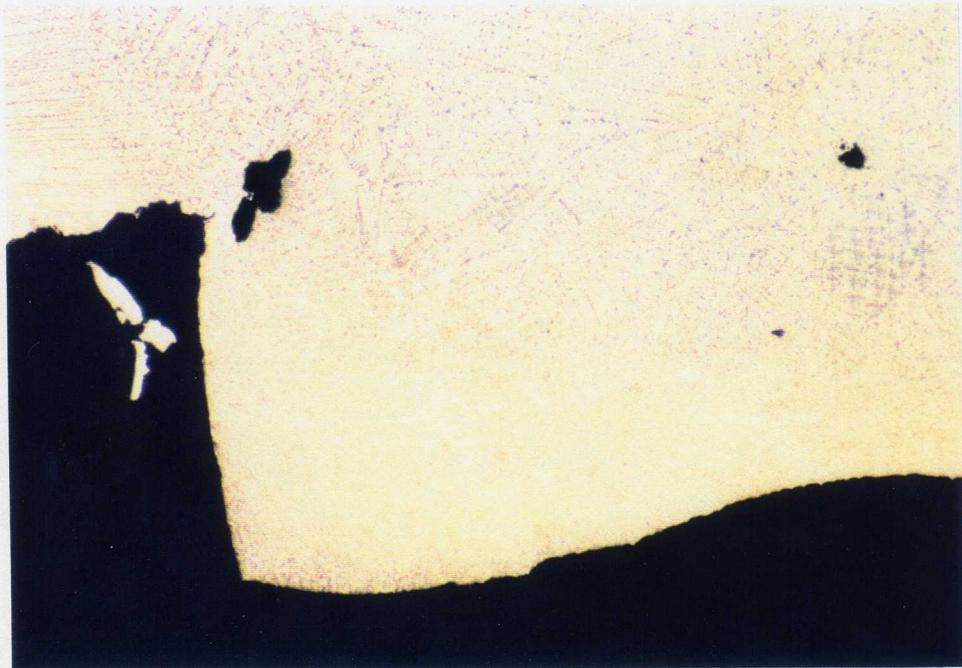
Figure 25  
Internal Surface of Circumferential Weld Showing Misalignment,  
Incomplete Fusion, and Small Cavities in Region One  
Magnification: 25X      Etchant: Electrolytic Oxalic

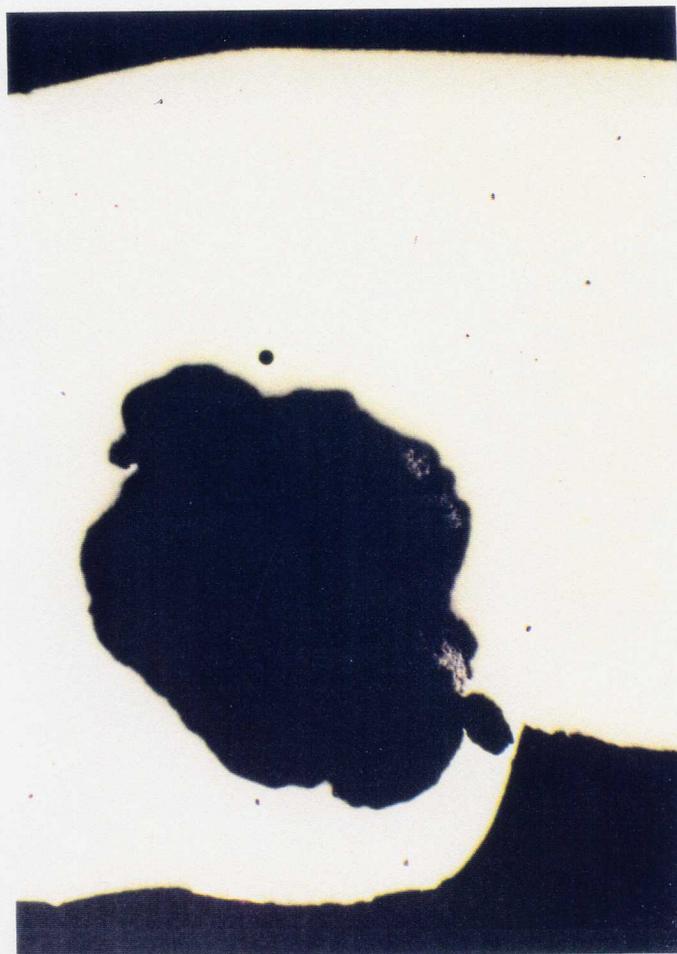
Figure 26  
Pit Located in Region One  
Magnification: 25X      Etchant: Unetched

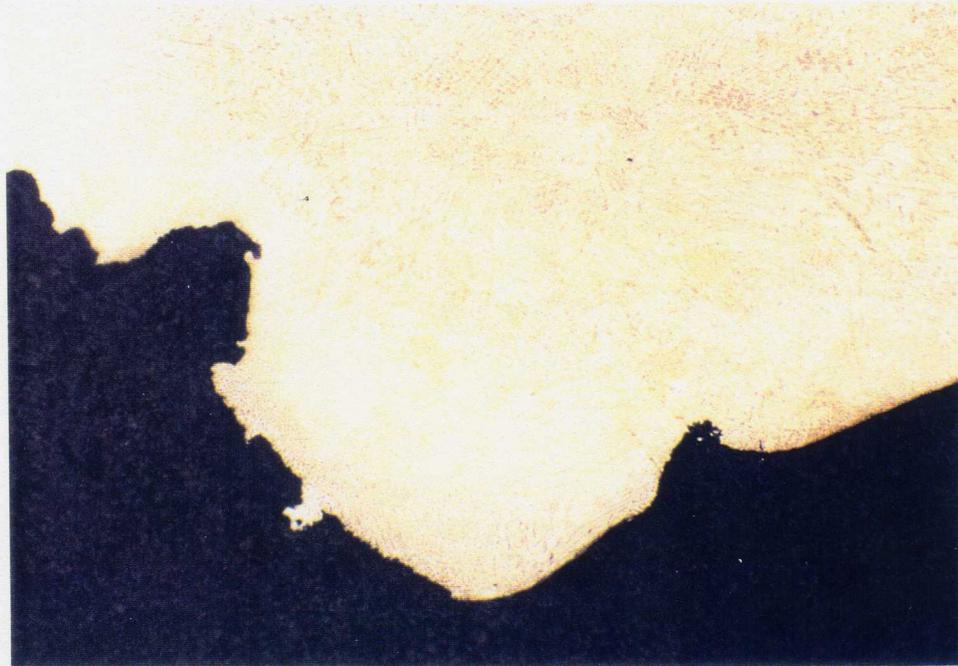
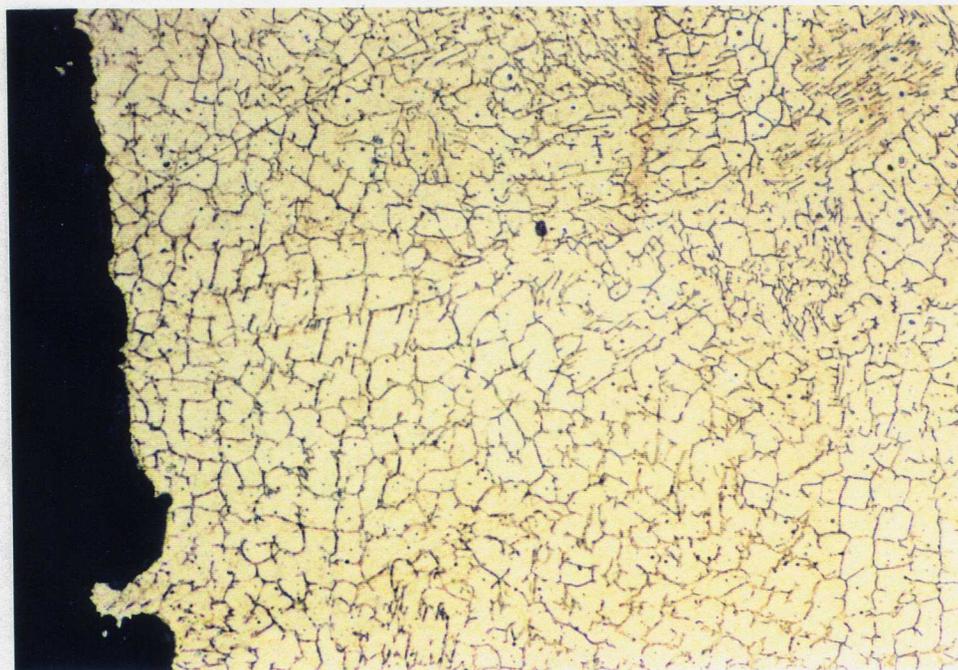
The nodule on the internal surface in region two is dendritic, Figures 28 and 29. No cavities are observed in this cross section. The surface profile shows that the nodule has some smooth, wide fissures scattered along its contour. A longitudinal section near the nodule shows a very large pit that extends nearly 90% through the thickness of the weld from the internal surface, Figure 30. The pit is filled with remnants of the interdendritic phase, Figure 31.

Figure 28  
Cross-Section of the Nodule Located on the  
Internal Surface in Region Two  
Magnification: 25X Etchant: Electrolytic Oxalic

Figure 29  
Microstructure Present Along the Edge of the Nodule  
Showing an Interconnected Dendritic Phase  
Magnification: 200X Etchant: Electrolytic Oxalic

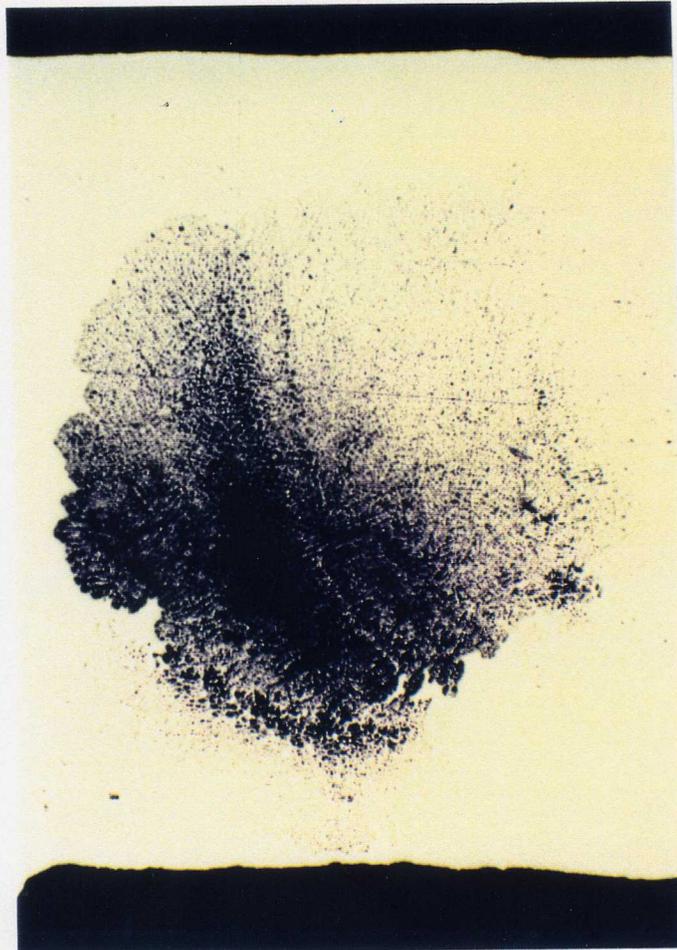
Figure 30  
Pit Located in Region Two  
Magnification: 25X      Etchant: Unetched

Figure 31  
Microstructure in the Pit Region Showing Preferential  
Attack of the Dendritic Phase  
Magnification: 200X      Etchant: Unetched

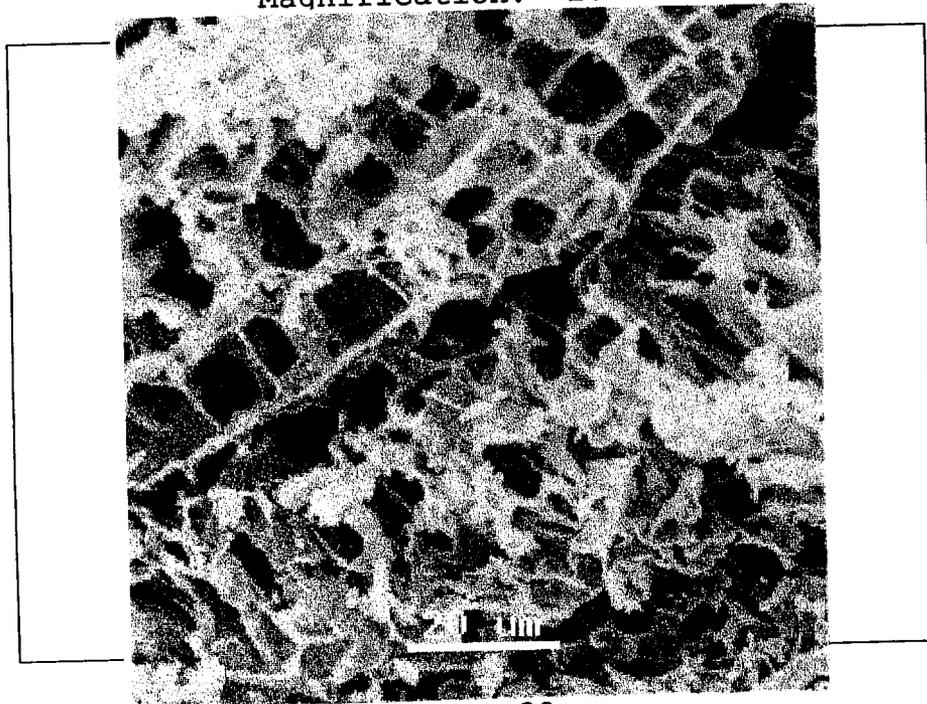
Figure 37  
SEM Photo of Interdendritic Remnants Present  
Inside Pit Located in Region One  
Magnification: 200X

Figure 38  
Higher Magnification of Figure 37  
Magnification: 1000X
