WBS 1.3.4.8 Tevatron Alignment

Ray Stefanski

January 21, 2004

Tevatron Alignment Task Force

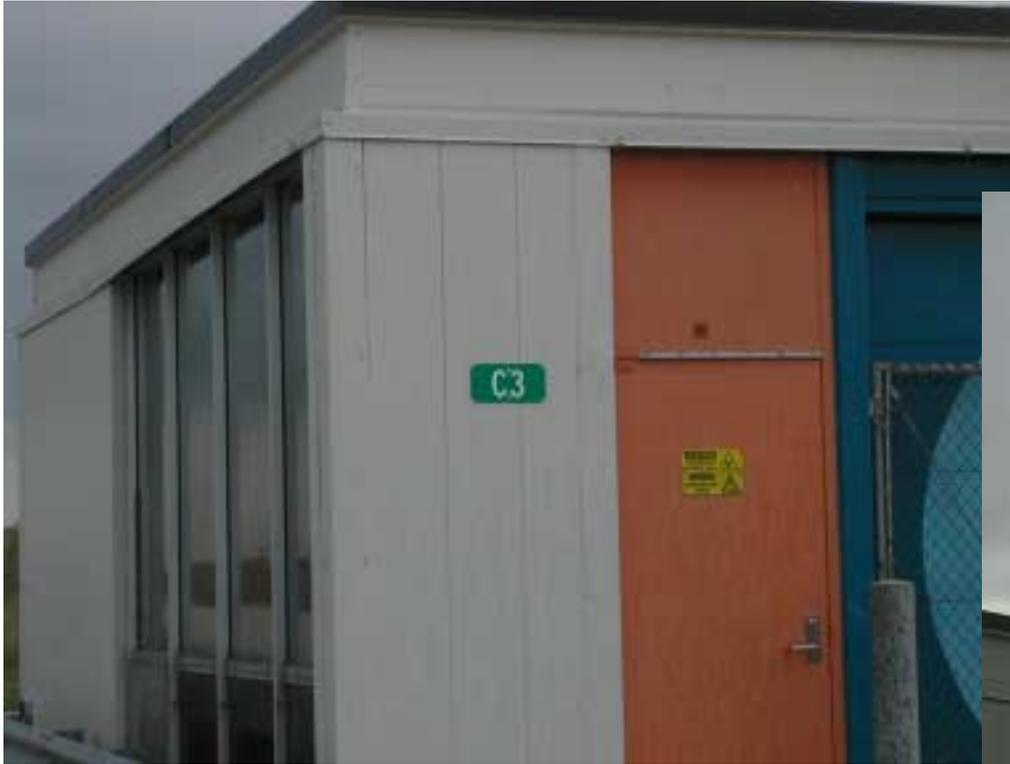
Tower installtion for the TevNet Measurements

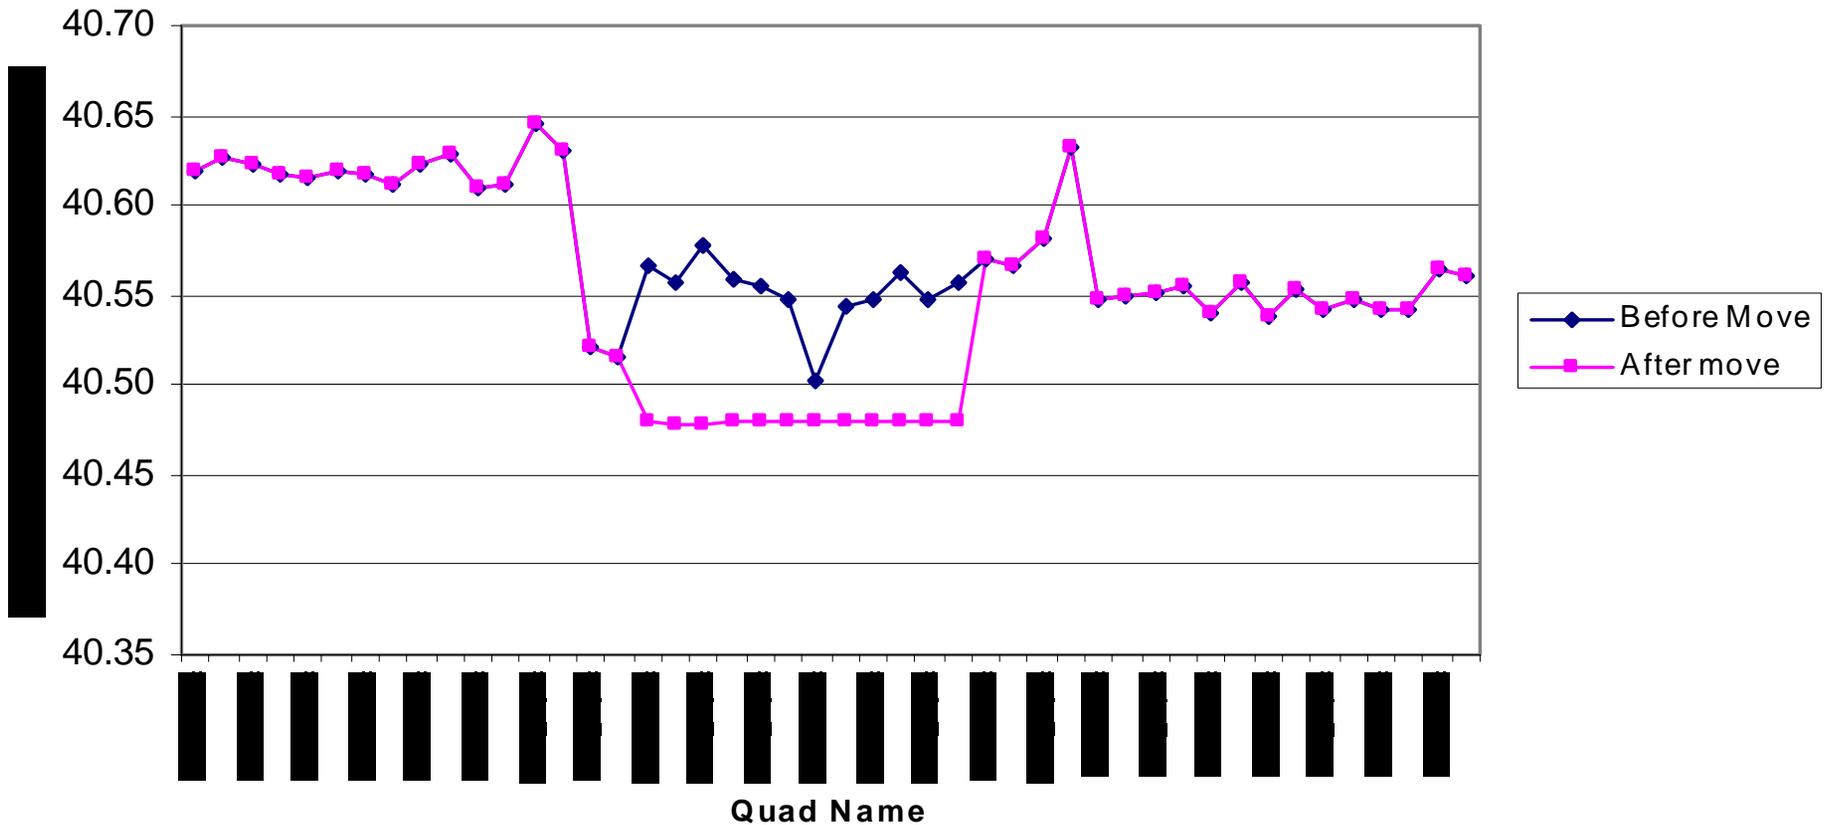
CDF LBQ corrections

Relative elevations of Quads and LBQ's from A42 through B19

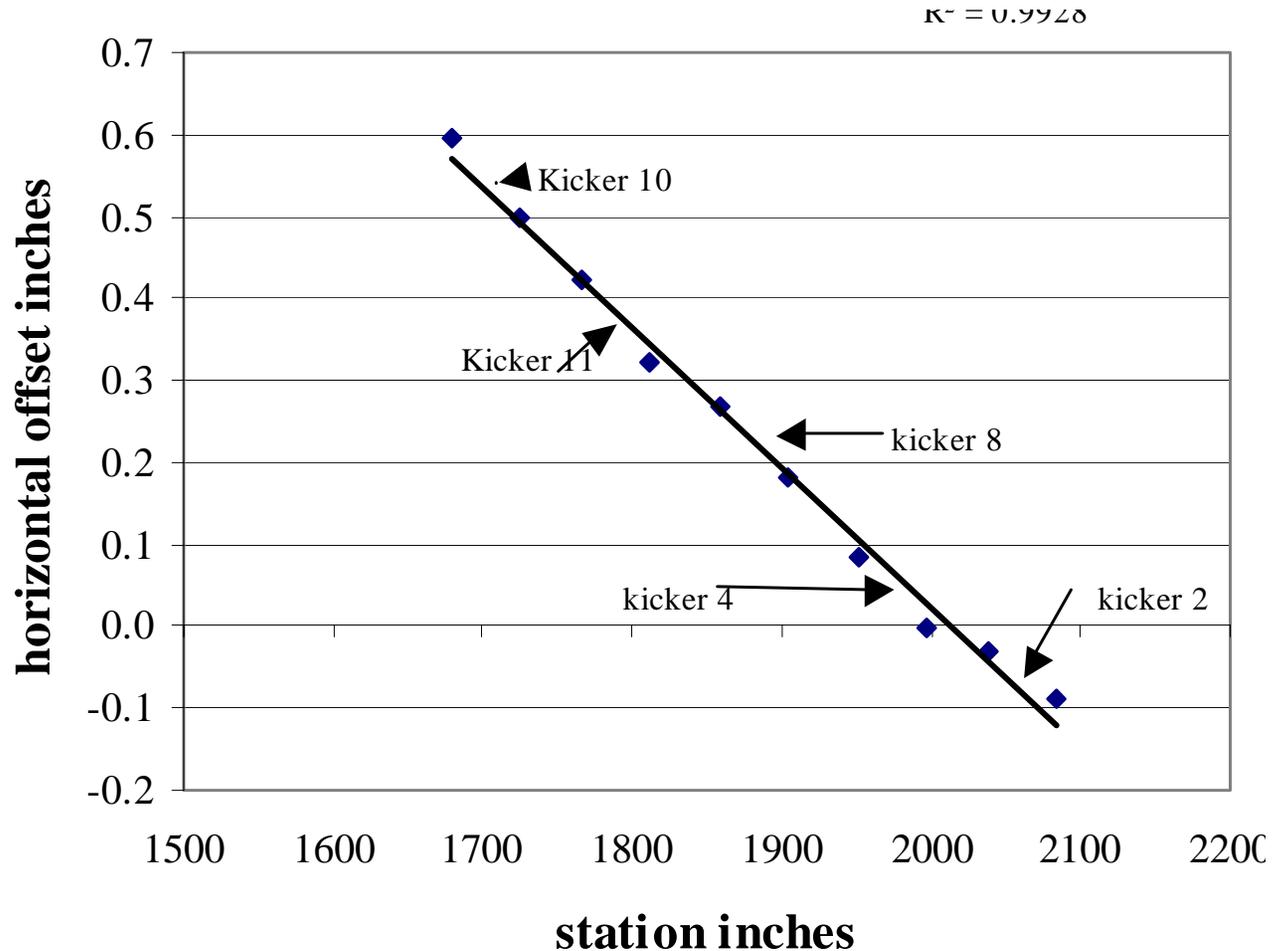
Pbar Kicker misalignment

All five kickers were mounted on a bedplate that was designed to move during the change from 800 GeV fixed target to colliding beam operations. Adjacent and to the radial inside were the bedplates for the fixed target extraction

Lambertsons. Both systems were designed for easy movement during change over between these two running modes.

It appears that sometime between March 2001 and October 2003 the bedplates for the Lambertsons were pushed into the bedplate for the kickers causing the offset.

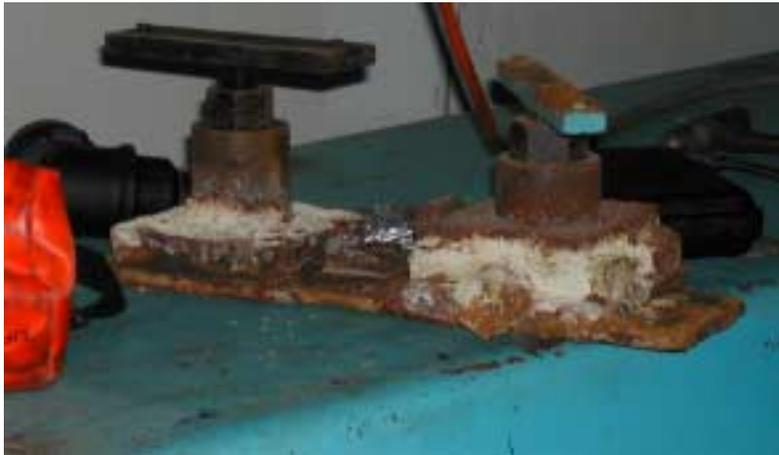
Magnet Stand Replacement

A-1	2	D-1	0
A-2	15	D-2	0
A-3	0	D-3	0
A-4	0	D-4	2
A-Sector	17	D-Sector	2
B-1	15	E-1	0
B-2	5	E-2	12
B-3	0	E-3	5
B-4	0	E-4	1
B-Sector	20	E-Sector	18
C-1	1	F-1	0
C-2	1	F-2	0
C-3	2	F-3	0
C-4	0	F-4	0
C-Sector	4	F-Sector	0
		All	61

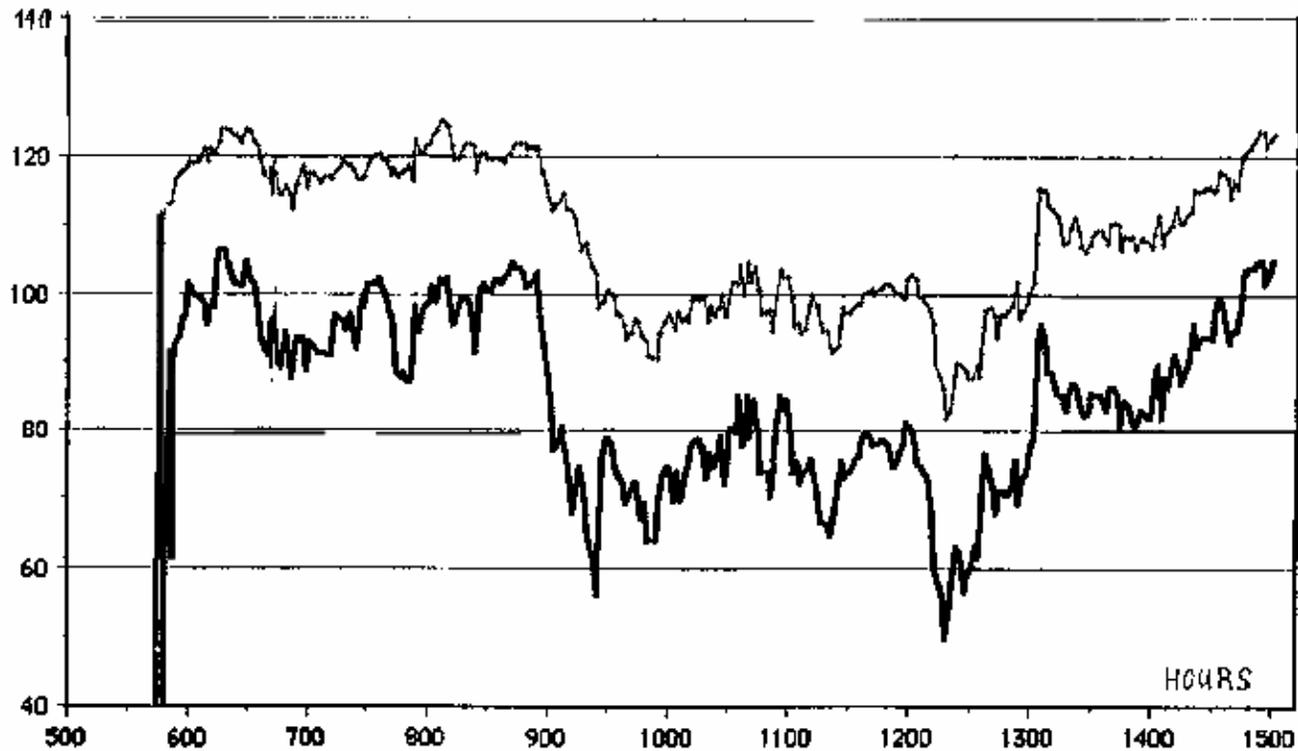
Fig. 10 Response of two Tiltmeters during a 38 Day Run

Hans Jostlein's measurements with tilt meters at D0, 1990

Readback from Two Tiltmeters on a Common Support Over a 38 Day Period.

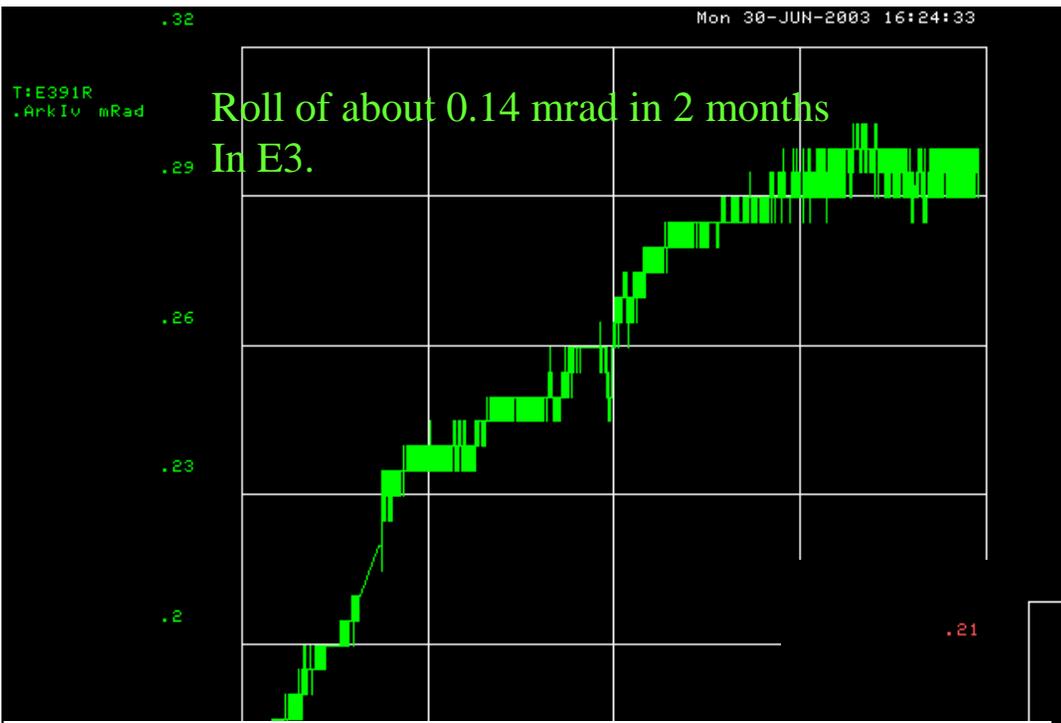
Tilt Monitors located in the Tev tunnel indicate that long term changes do occur. Discrete short term motion can also be seen.

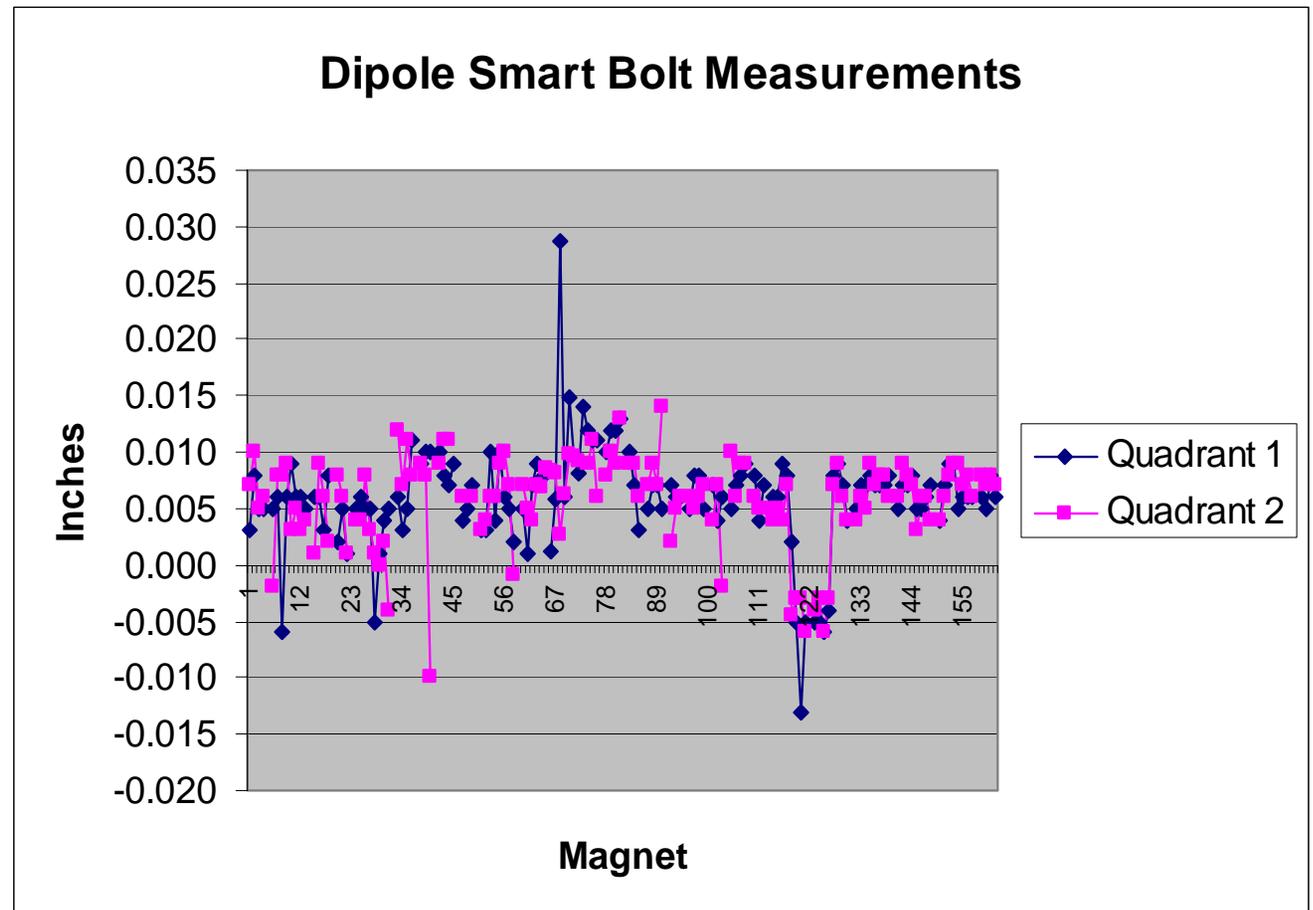
106 dipole magnets near the low beta regions were modified for cryostat movement. By concentrating on the magnets that have no nearby skew-quad correctors, the coupling can be reduced by 75 %. Virtually all dipoles were measured in the Tevatron to establish a baseline: to detect future movement if it occurs. Some dipoles show unusual behavior, as if the anchor bolt is broken.

Suspicious magnets are being studied to develop an understanding of this phenomenon.
