**Status Report of the Tevatron Alignment Task Force  
and a  
Report on Magnet Survey Activities During the  
2003 Summer-Fall Shutdown**

**by the  
Tevatron Alignment Task Force**

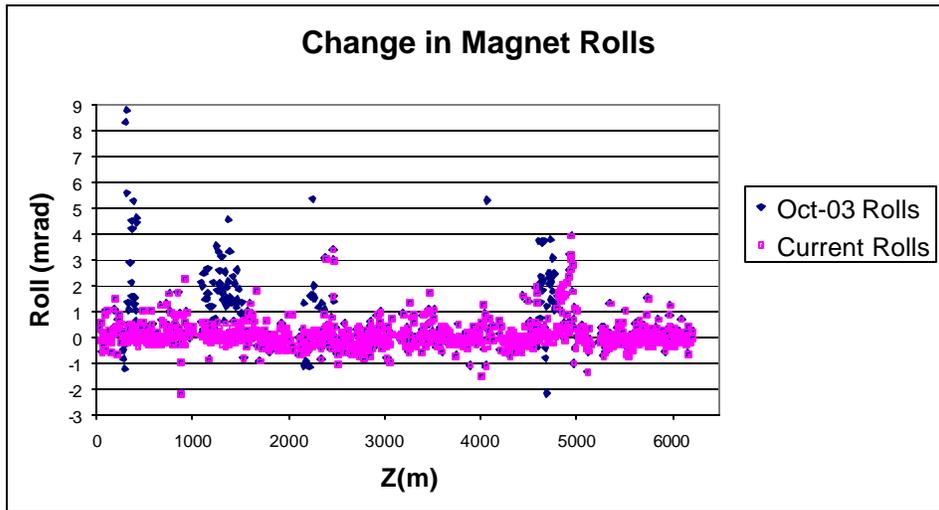
Figure 5a: Comparison of magnet rolls (Dipoles and Quadrupoles) around the entire Tevatron before and after the summer shutdown and the two December shutdowns. Current rolls are in purple, the corrected Oct-03 rolls are in dark blue and are seen only for measurements that changed during the shutdown. The origin is at A0.

Improvements in magnet roll during the shutdowns were striking. Figures 5a and 5b show a comparison of roll measurements before and after adjustment during the shutdown and the beam-off periods that followed. Many of the most troubling sections were corrected. A comparison of magnets with substantial rolls before

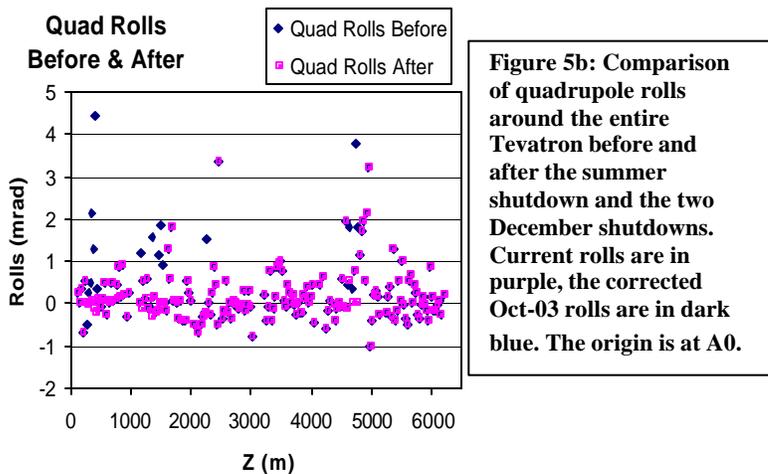
Figure 5b: Comparison of quadrupole rolls around the entire Tevatron before and after the summer shutdown and the two December shutdowns. Current rolls are in purple, the corrected Oct-03 rolls are in dark blue. The origin is at A0.

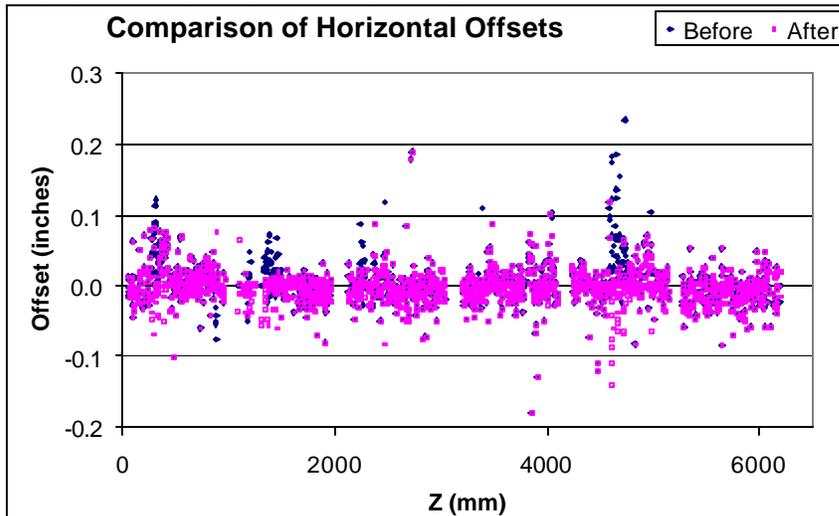
**Figure 7: A comparison of horizontal offsets relative to the Murphy line. The blue points are measured offsets at the start of the shutdown, later corrected. The purple points are current offsets, including those corrected during the shutdown. The origin is at A0.**

The results of the measurements are given in Figure 7. These data represent the first comprehensive measurements of horizontal offsets in the Tevatron since the initial installation. The results indicate that the magnets were relatively stable horizontally over

the years. Only two quadrupoles were sufficiently out-of tolerance that a specific effort was made to correct their offsets. The improvement in horizontal offsets evident in Figure 7 came about by systematically correcting the horizontals whenever any other work was done on a magnet, such as a roll correction or magnet stand replacement.

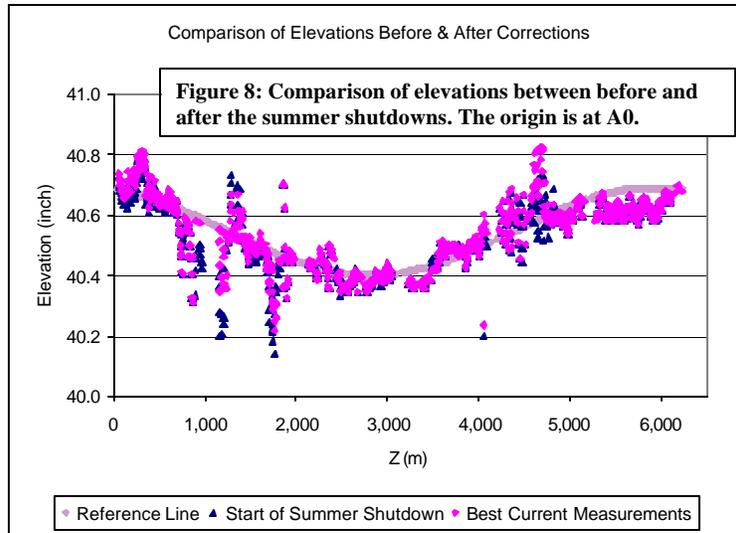
variations, so that magnets sit on a common line within several Tevatron magnet cells. A before - after comparison is shown in Figure 8. Some improvement in global variations around the ring is seen in this plot, but because the corrections are local, the curves appear very similar.

Global elevation corrections will not be carried out until the TevNet results are available and orbit simulations are done to determine the sensitivity of the Tevatron orbit to variations in magnet elevations. Based on operating experience since the shutdown, we might suspect that magnet

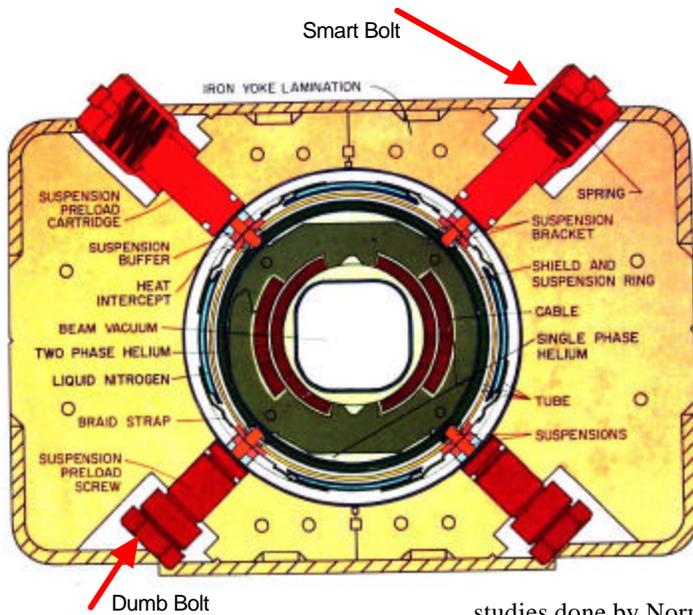
The horizontal and vertical betatron oscillations in the Tevatron were strongly coupled, requiring the skew-quadrupole correction circuits to run at about 60% of the maximum current. Don Edwards and Mike Syphers reported beam measurements that showed the source of the coupling to be distributed fairly uniformly around the ring, rather than concentrated in one or a few locations. Their analysis of several different measurements concluded that the strength of the coupling was consistent with a skew-quadrupole component in each dipole of approximately one “unit” (parts in  $10^4$  at one inch). A measurement that was also confirmed by the Technical Division, in that one unit of skew-quadrupole component could be attributed to a settling of the cryostat over time.

Figure 9: A cross-sectional view of a Tevatron dipole. The smart bolts are located at the upper corners and are spring loaded. Dumb bolts are located at the lower corners and are not spring-loaded. Three mil shims were placed at the dumb bolt ends to correct for the vertical settling of the cryostat

During the shutdown, 106 dipoles were re-shimmed to remove the skew-quad component of magnetic field. The corrected dipoles corrected are distributed on either side of the intersection regions, namely from A44-2 through B19-5 and from A44-2 through D19-5. The end points on these lists are half way between the last remaining skew quad corrector and the first missing skew quad-corrector. By Norman Gelfand's

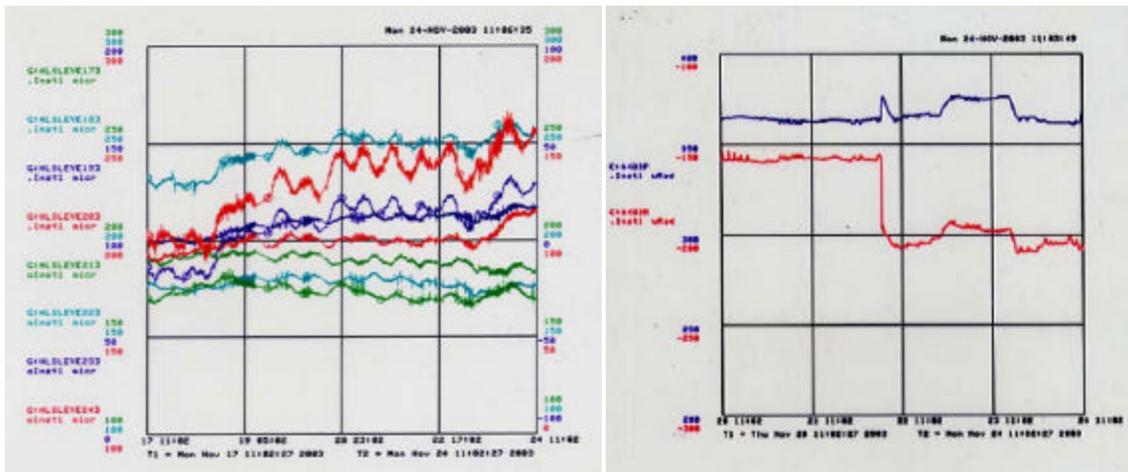
Figure 11b shows two measurements made by tilt monitors set on top of quadrupoles in the arcs. After a quench, one magnet is seen to recover back to its original position, while the other does not. Such changes may account, at least in part, for changes that occur in machine operation after a quench. We need to understand the cause of magnet motion during a quench.

Figure 11a (left) and 11b (right): Examples of HLS and tilt-meter data taken after installation of these devices in the summer shutdown. Figure 11a shows the response of the HLS in different parts of B-Sector in a one-week period Figure 11b shows one of the tilt monitors responding to a local disturbance probably a magnet-quench.

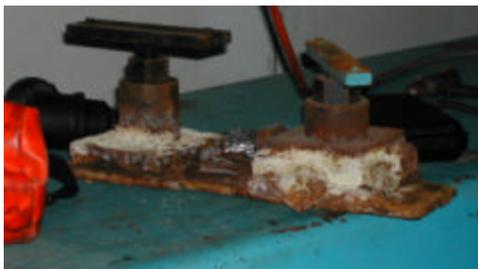
**Figure 13: An example corrosion affecting a magnet stand in the Tevatron.**

Magnet stands have suffered corrosion in areas where water accumulated during floods, or because of seepage through cracks in the tunnel concrete. The occurrence of the water in the tunnel has since been greatly reduced, but the affected stands are still in place. An example of a corroded stand is shown in Figure 13.

Sixty-one dipoles had new stands installed during the shutdown, in areas where the greatest damage was observed. A summary of magnet stand replacement by Tevatron location is given in Table 4. During the next shutdown, additional dipoles stands will be replaced, as well as affected quadrupole and spool-piece stands.

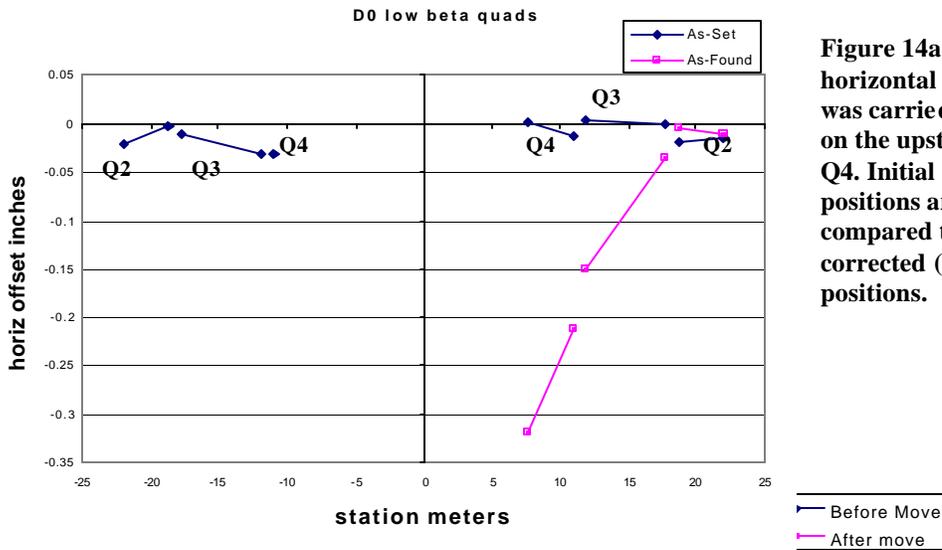
An accident that occurred several years ago involving the D0 LBQ girder caused a 0.25 inch horizontal displacement at one end of the girder. Recent aperture scans revealed a serious restriction at D0, making it imperative to correct the situation. In Figure 14a, we show the survey data of the LBQ before the shutdown (as-found) and after (as-set). It may be that this single ¼ inch correction did the most to open up the Tevatron aperture for this run. Craig Moore led the effort for this work.

**Figure 14a:** A ¼ inch horizontal correction was carried out at D0 on the upstream side of Q4. Initial (as-found) positions are shown compared to the corrected (as-set) positions.

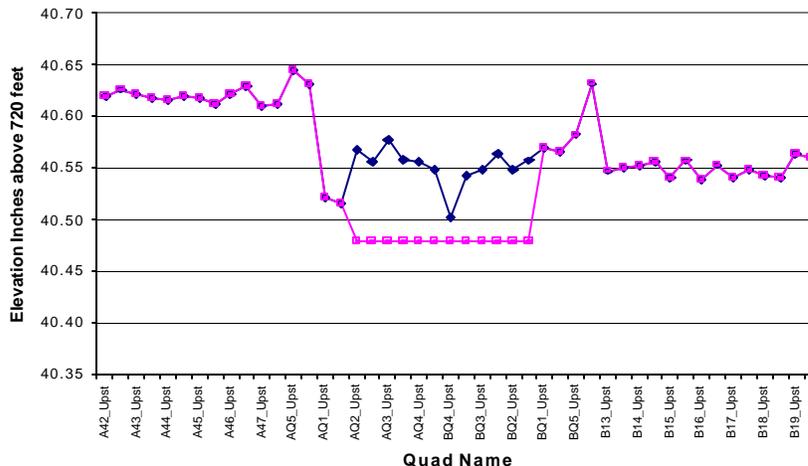
The month of December had many machine down days. We took the opportunity to adjust the vertical position of the IR at B0. The IR was about 6mm high at CDF, nearly falling off the edge of the detector acceptance. The solution was developed by a team lead by Vladimir Shiltsev, including Mike Syphers, Valery Lebedev, Norm Gelfand and Mike Martens. The correction involved moving the LBQ down by about 50 mils, which satisfied CDF requirements. The alignment changes are shown in Figure 14b.

**Figure 14b:** Vertical changes carried out at B0 to shift the IR down by about 5 mm, and back within the CDF acceptance.

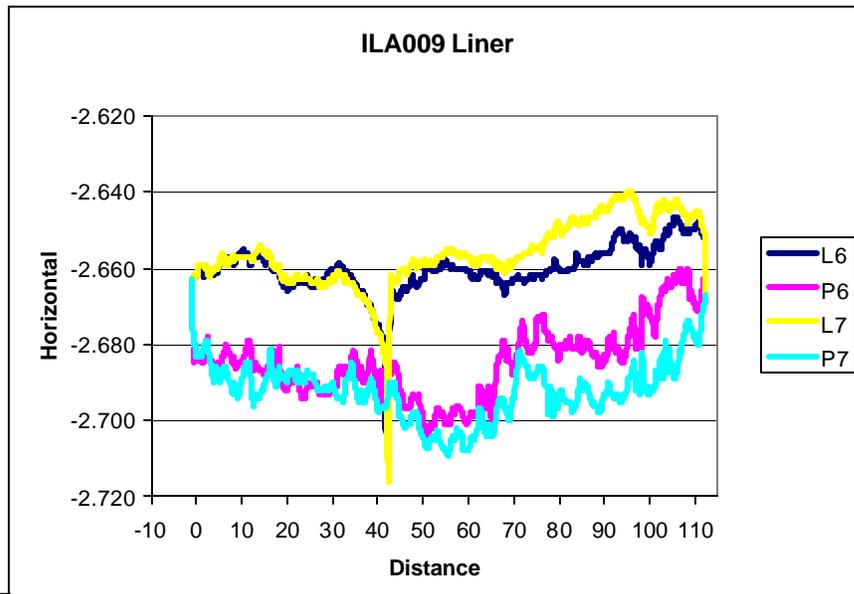
**Figure 15: Survey data taken by the AMG of the liner position within one of the Lambertson magnets. P are the before liner measurements and L are measurements with with the liner. The number represents the sixth and seventh attempts on this magnet.**

After completing the liner insertion, the two central Lambertsons were replaced on the movable stands and optically surveyed back to the as-found position. In addition to new liner insertions, improvements were made to the vacuum and instrumentation on both the upstream and downstream ends of the magnets. Improved stands and mountings were installed for the BPMs and strip line detectors. Differential pumping was added to improve the vacuum in this region of the Tevatron. In the process of reassembly a mismatch or misalignment of about 6mm (0.25 inch) was discovered between the Tevatron and Main Injector. Given the size of the beam pipe, the aperture of the magnets and that the history of successful beam transport in this part of the Tevatron, no attempt was made to correct this misalignment during the summer shutdown.

More work will be needed to understand the source of the misalignment, further beam studies will be done, with the goal of correcting this problem at the next opportunity.

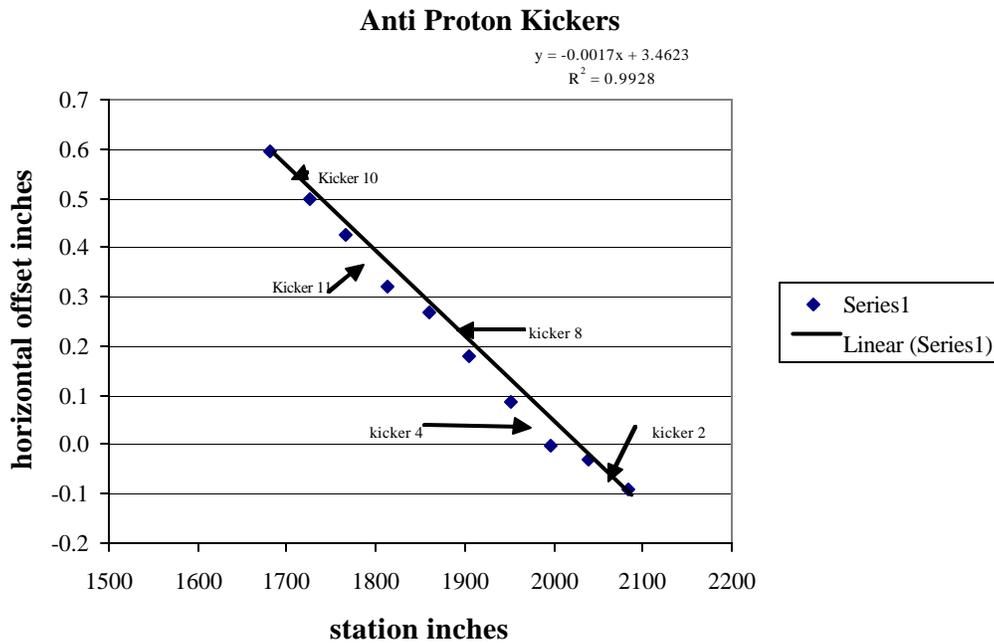
During the first part of Run II, aperture scans near A0 showed a restriction in the vicinity of the anti proton kickers. An optical survey revealed that the anti proton kickers were misaligned in the horizontal plane at the upstream end by 15 mm (0.6 inches). Figure 16 shows the deviation of the kicker alignment form an ideal horizontal line.

A study of survey data taken in 2000 and 2001 did not reveal this large discrepancy. All five kickers are mounted on a bedplate that was designed to move during the change from 800 GeV fixed target operations to colliding beam operations. Adjacent and to the radial inside were the bedplates for the fixed target extraction Lambertson magnets. Both systems were designed for easy movement during change over between these two running modes. It appears that sometime between March 2001 and October 2003 the bedplates for the Lambertson magnets were pushed into the bedplate for the kickers causing the offset.

**Figure 16: Deviation of A0 kickers relative to an ideal horizontal line.**

The bed plates for the Lambertson magnets were jacked up and placed on cribbing to immobilize them. The kicker girder was pushed back into the proper alignment and optical survey was used to realign each kicker on the correct position. Aperture scans in A0 indicate that the restriction has been successfully removed.
