Pre-injector Upgrade Updates (28 Mar 2012 – 11 Apr 2012)

C.Y. Tan
11 Apr 2012

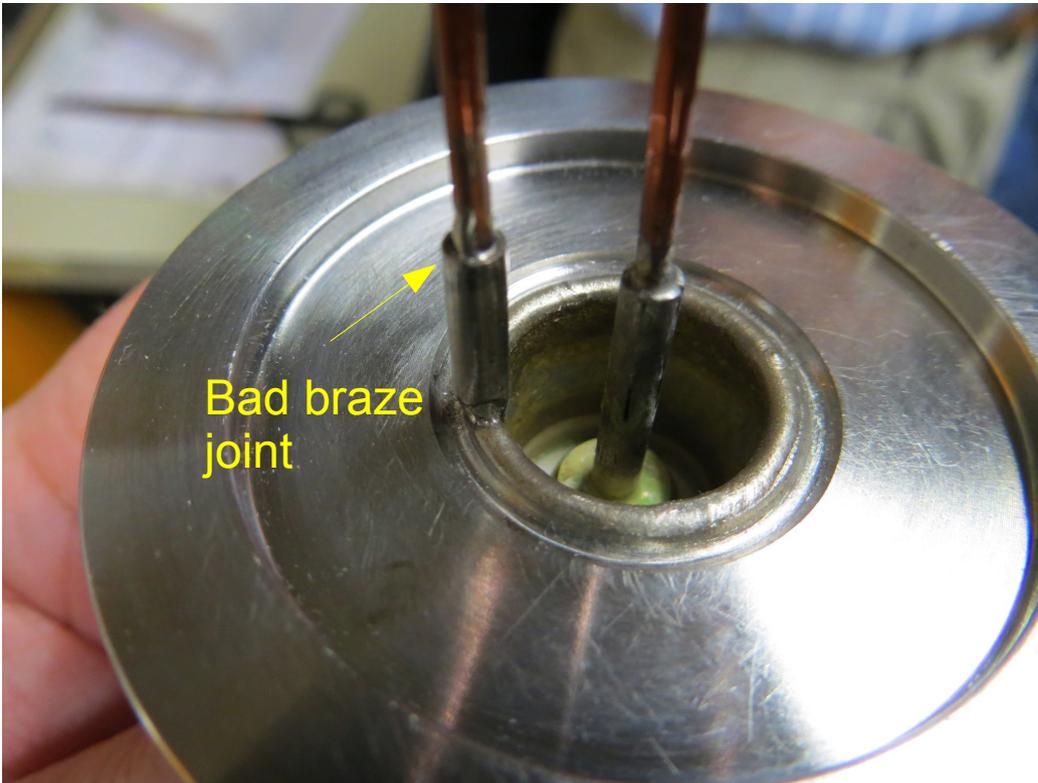
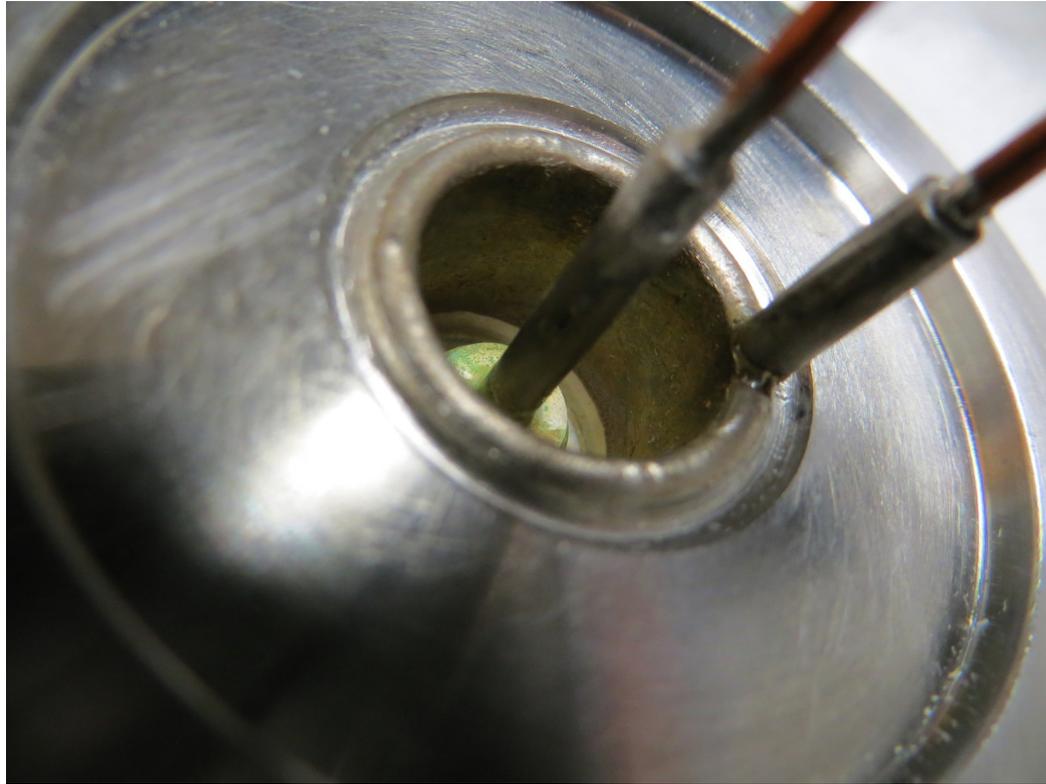
Green gunk and bad brazing

There is green gunk that is probably flux.
Copper wire is insulated.
Ding thinks that the flux produces an ion cloud that may cause sparking.

There is a bad braze joint between antenna and feedthru.

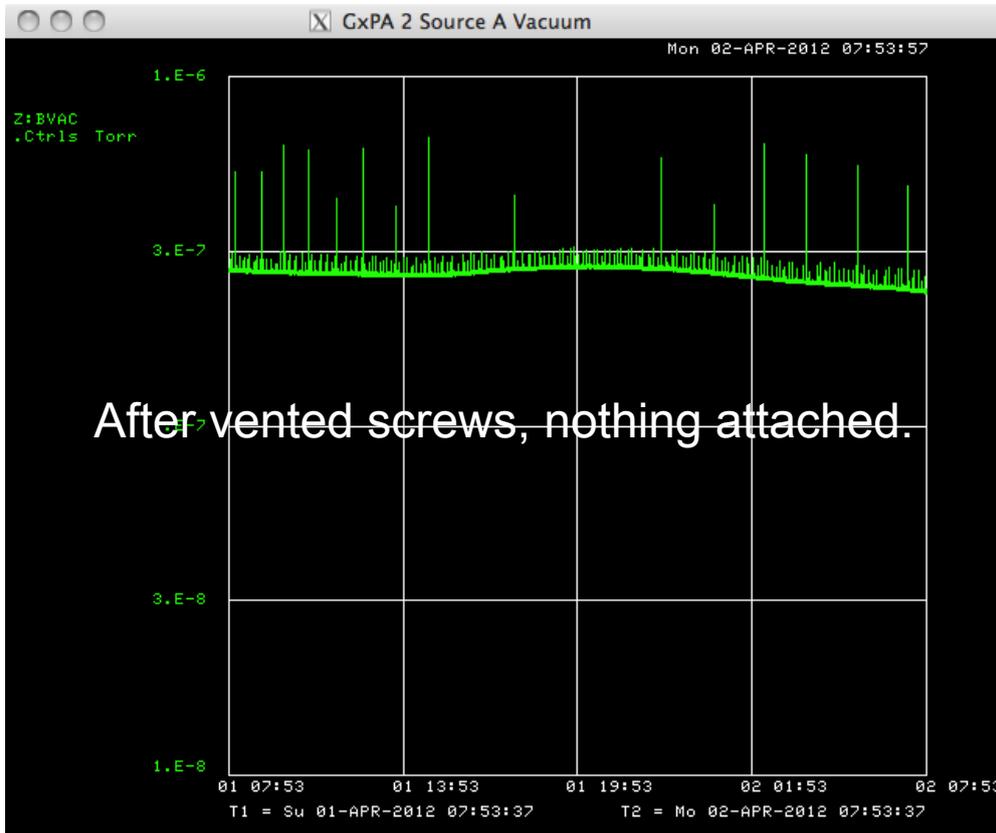
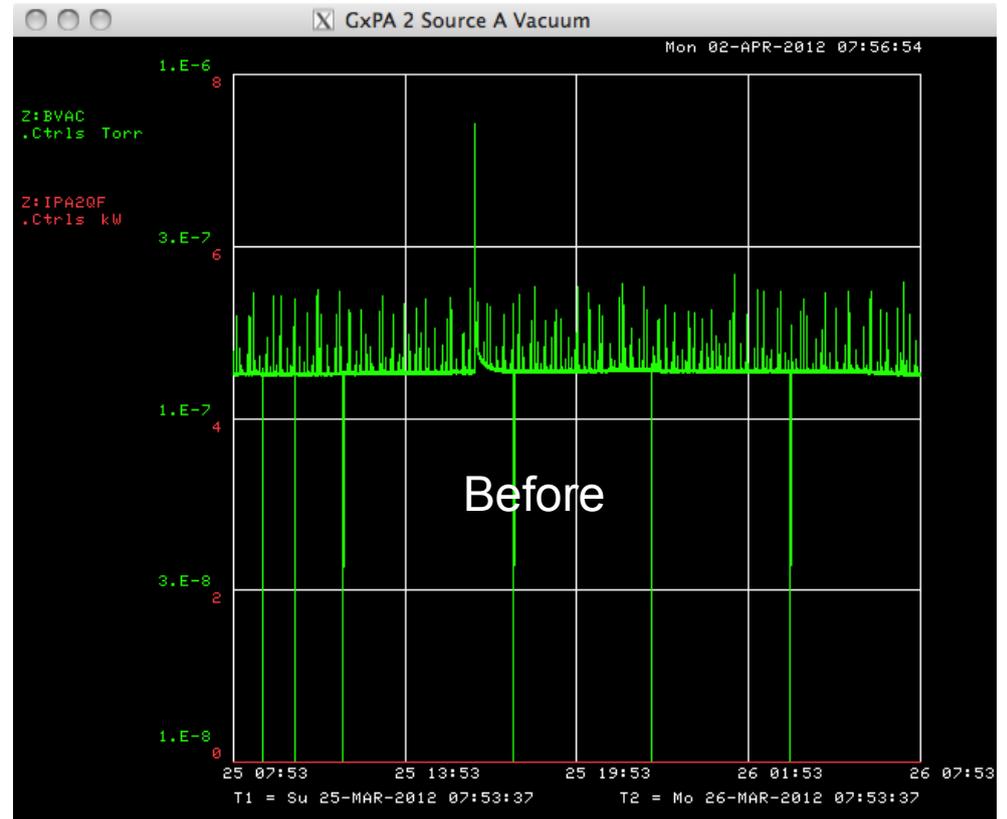
Buncher vacuum

Everything is blanked off, vented screws for tuning plates after 2.5 days of pumping with ion pump. Spikes 1 every 2 hours. Vacuum is still coming down.

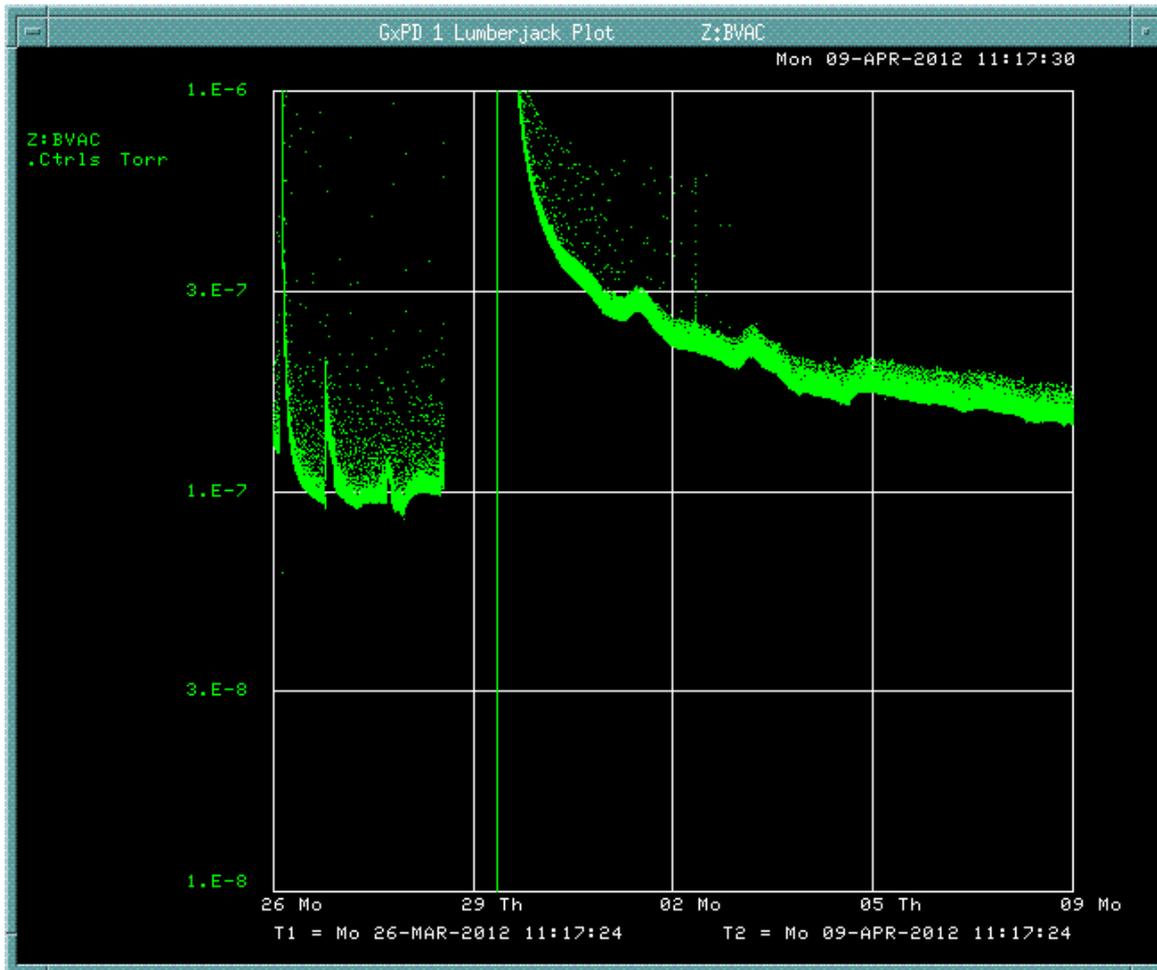
After 1 week of pumping

No more sudden spikes.

Really looks like virtual leak.

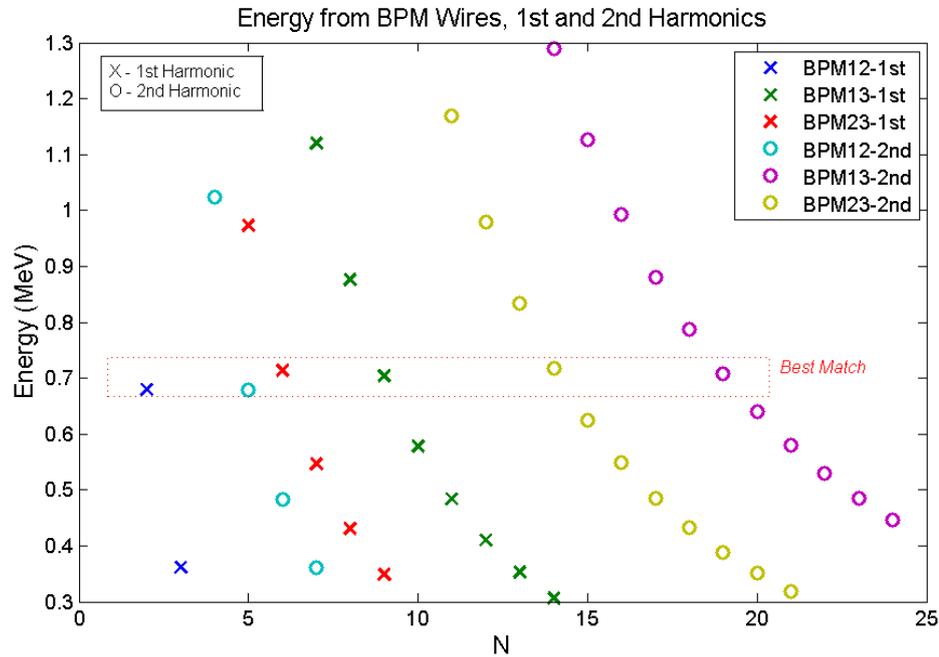
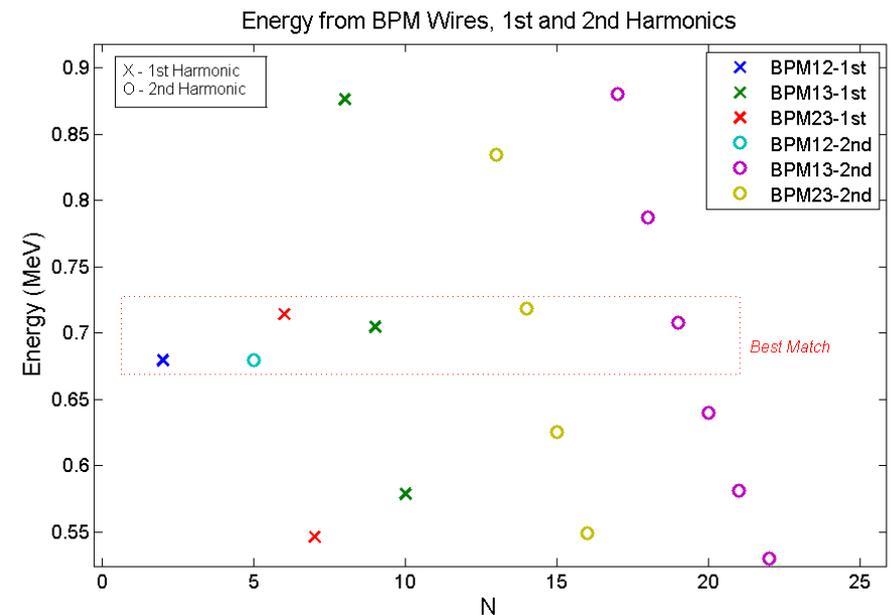
RFQ Energy Measurement with BPM wires

Device	Status	Comments
PLL work	Testing started	
RFQ	Energy measured with BPM wires	Same low energy of ~700 keV

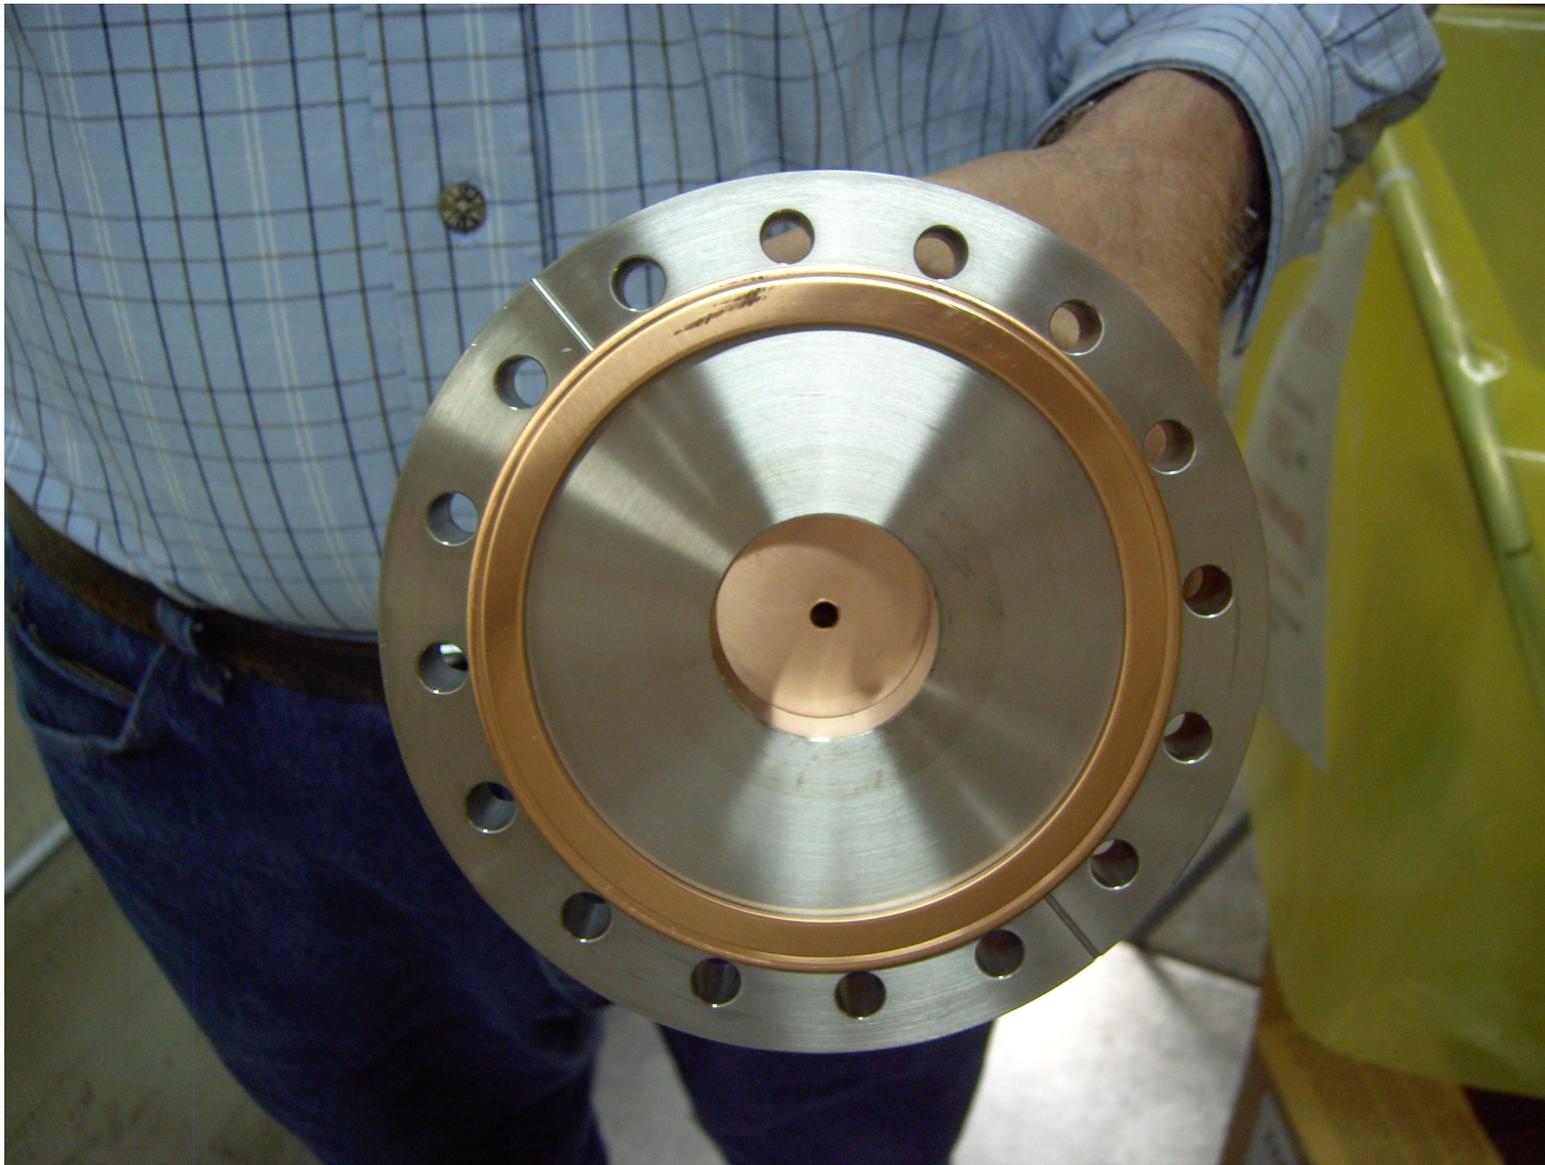
Slow Faraday Cup Aperture

6 mm hole

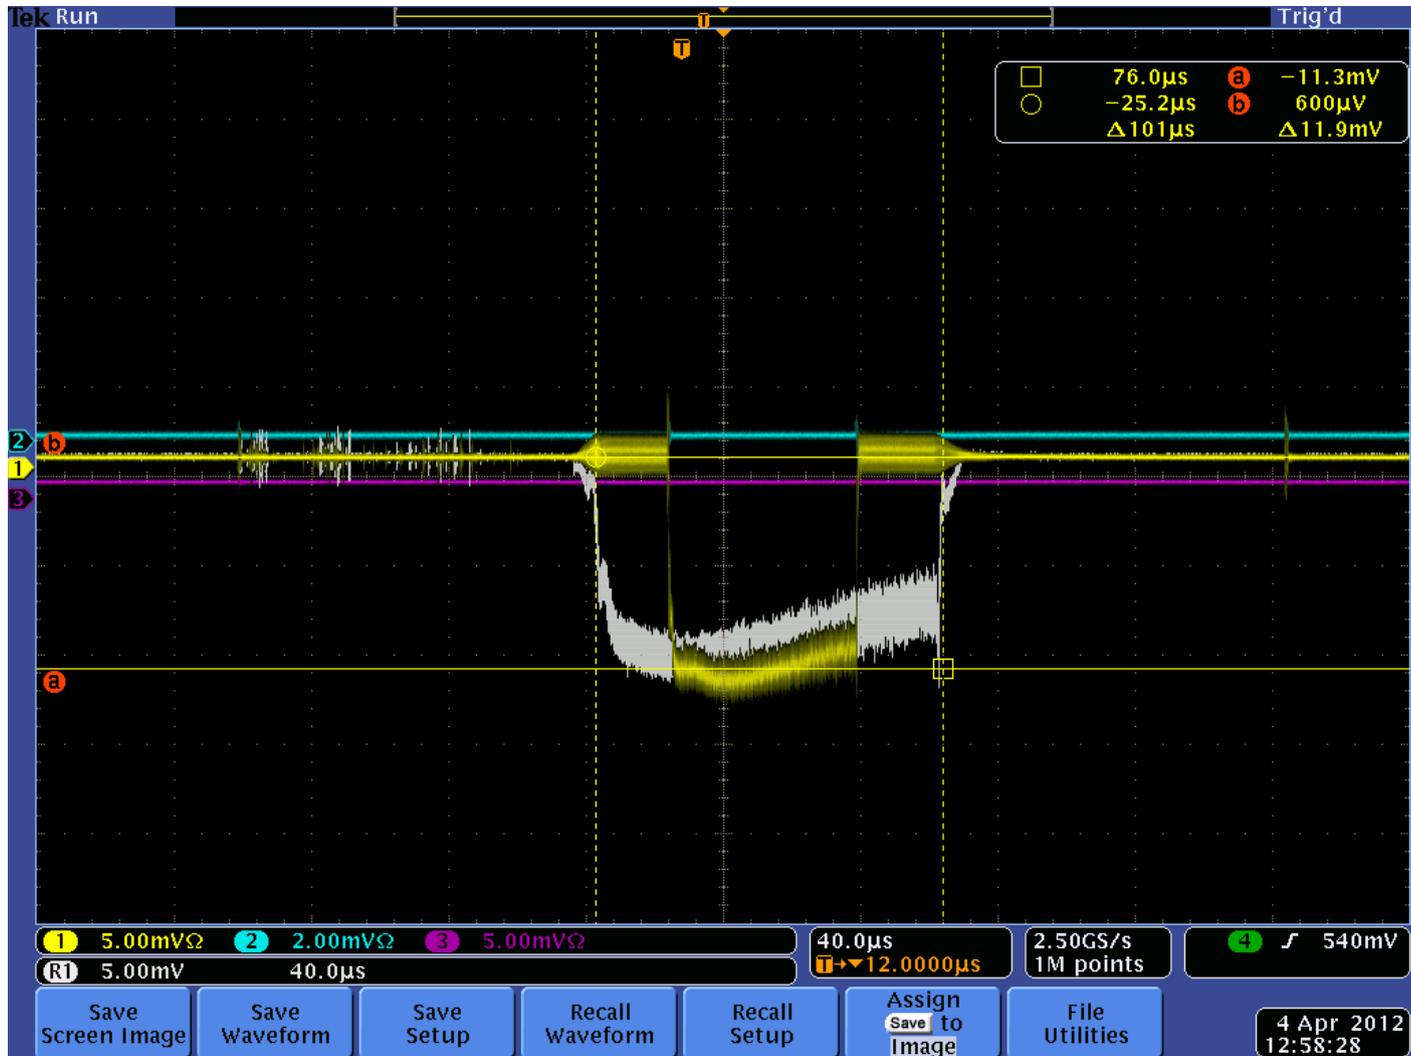
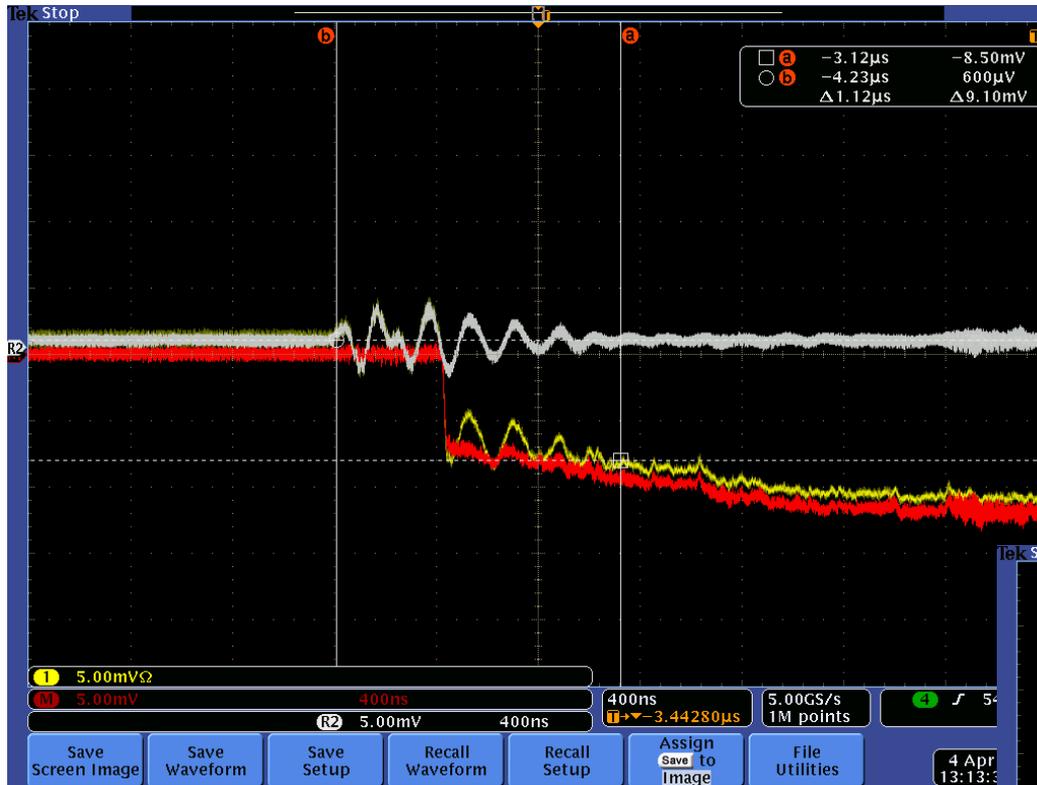
Rise time 17.5 ns!???

Probably aperture ... 6 mm hole in Faraday cup

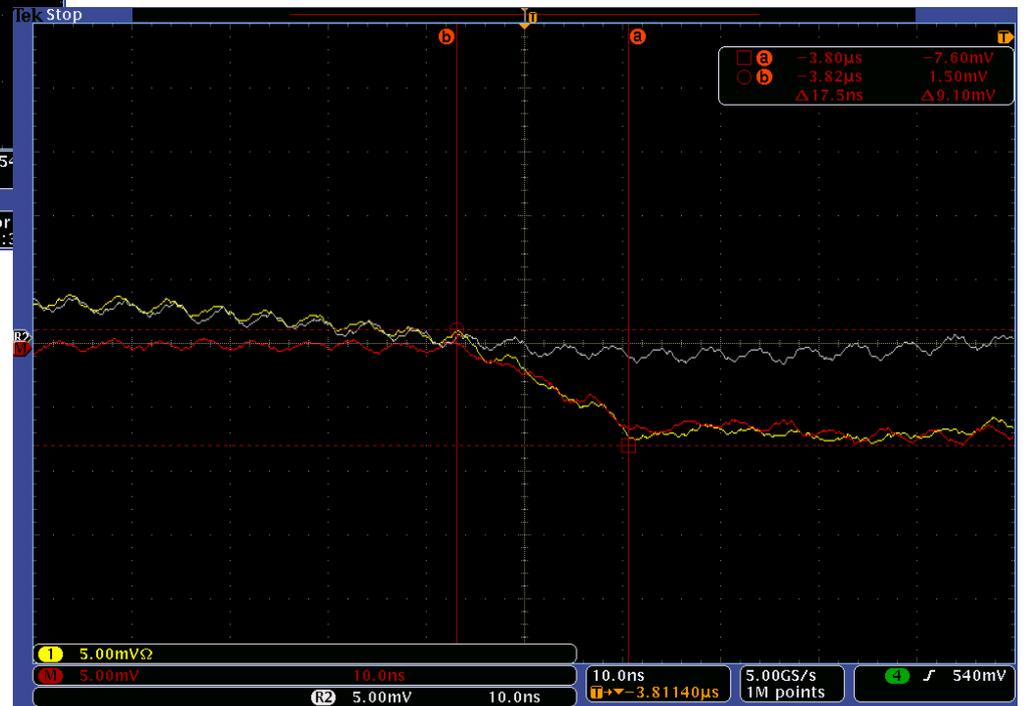
Falling edge 17.8 ns !!!!

Note: after pulse
