Compensation of Beam Roll Due to HP3US Regulation Errors in Switchyard

¹Fermilab, Accelerator Division, External Beamlines

ABSTRACT

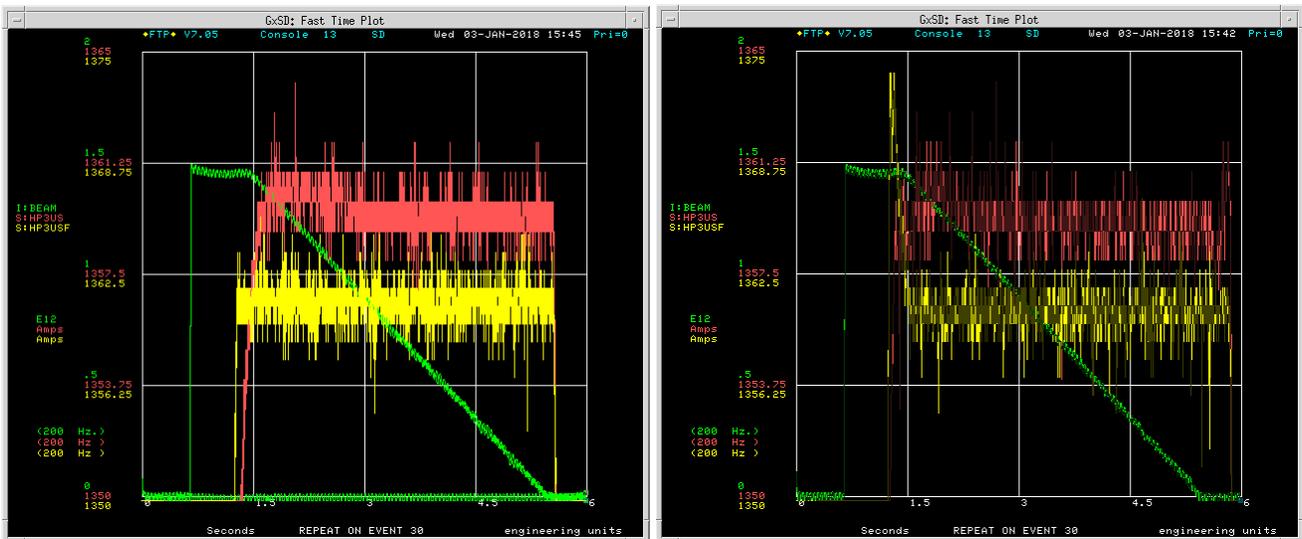
Figure 3. HP3US power supply current reference (yellow) and output current (red) as-found (left) and with the intentional over-shoot reference (right).³

Figure 3 shows the original HP3US reference signal (yellow) and output current (red) on the left, and the same signals after creating a reference over-shoot on the right. **Figure 4** shows the resulting improvement in the horizontal beam roll as measured by BPMs downstream of the magnet string. The improvement is significant, though there may be more room for improvement given dedicated tuning time to further adjust the reference over-shoot.

The largest alleviation of the beam roll has been achieved by building a custom ramp that over-shoots the current reference so the actual power supply output current is much closer to nominal by the time beam begins to spill. This alleviates the more than 10mm spike in horizontal position in the first half-second of the spill. It remains to be seen how consistent this behavior will be when the seasons and line voltage change.

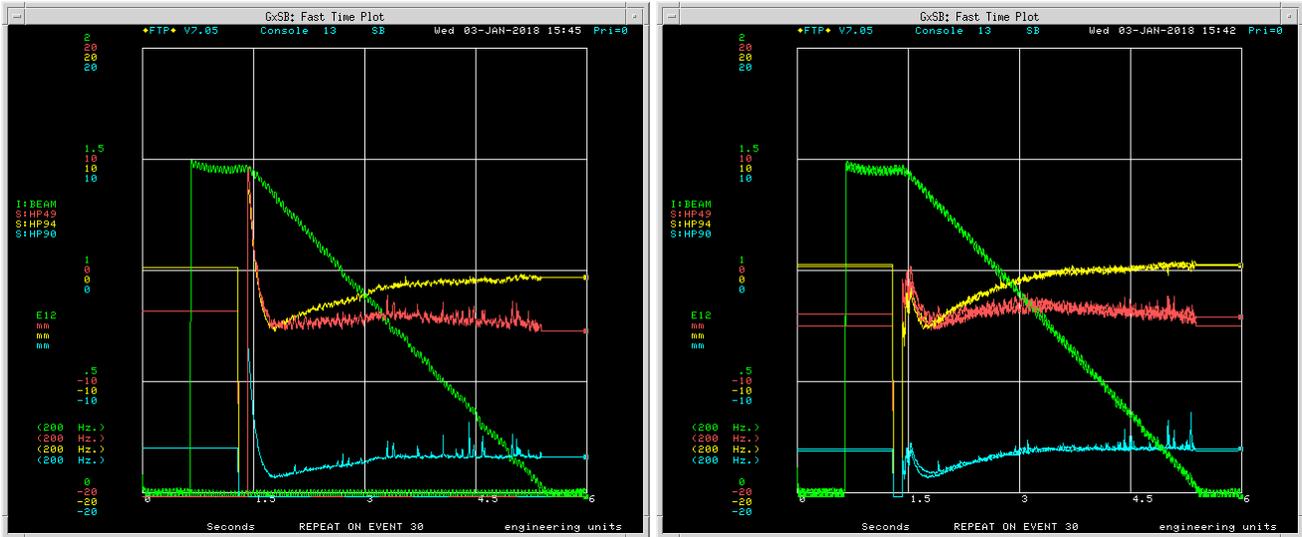
Figure 4. Horizontal BPM readings during the spill without any change to HP3US (left), and with the over-shoot reference ramp (right).³

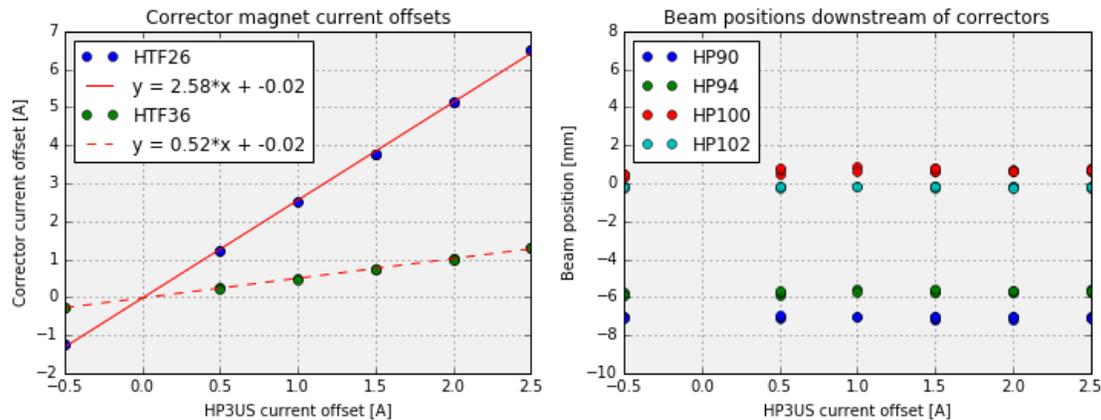
current, then compensating with the bump until downstream beam position monitors return to nominal values. The results of the beam study are shown in **Figure 8**, and show successful proof-of-principle operation of the HTF26 and HTF36 corrector magnets to correct for small deviations in HP3US output current.

Figure 8. Corrector current changes (left) to compensate for small HP3US output current offsets. Beam positions remain unchanged when correctors are used to compensate (right).
