Doc Number: Beams-doc-1382

## Residual Radiation Hints for Aperture and Alignment Issues in the Main Injector

Bruce C. Brown

30 December 2004

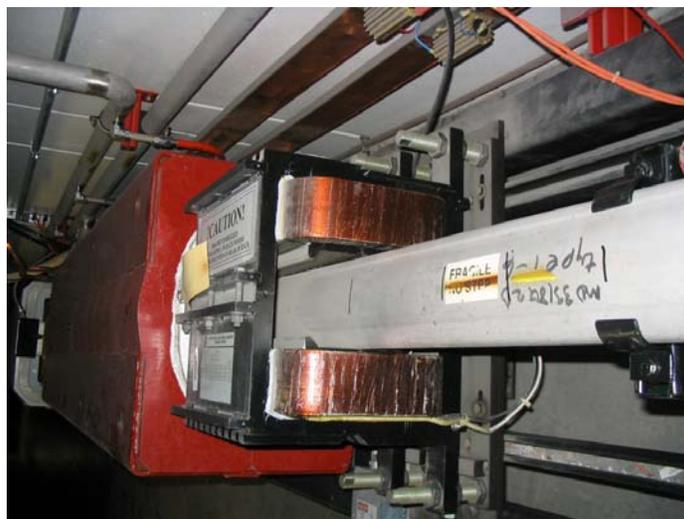
Figure 19: Image of upstream minitube at Q113 showing radiation damage to tape.

and these tags provide a visual representation of the beam loss. The are usually discolored where the radiation is high, not discolored where it is low and the image reveals a band indicating the limited horizontal extent of the beam. At Q321, the offset due to the requirement that the beam reach the off-centered field free region of the Lambertson is quite apparent (in the tunnel if not in the picture). Figures 19,20, 21 and 22 were photos taken in Summer 2004.

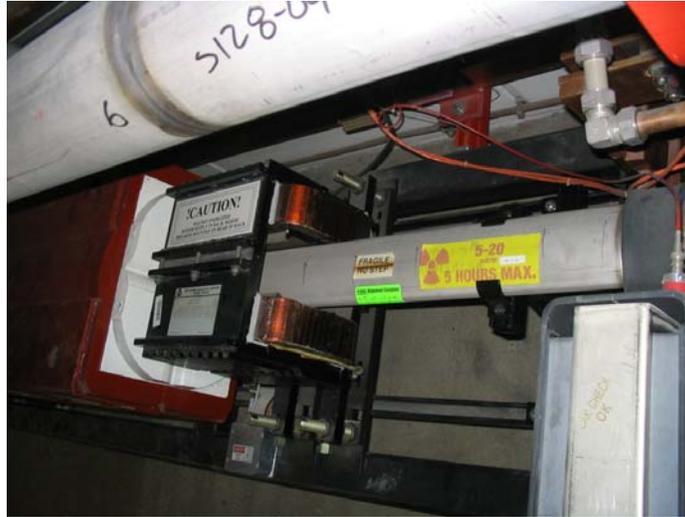
Figure 20: Image of upstream minitube at Q129 showing radiation damage to tape.

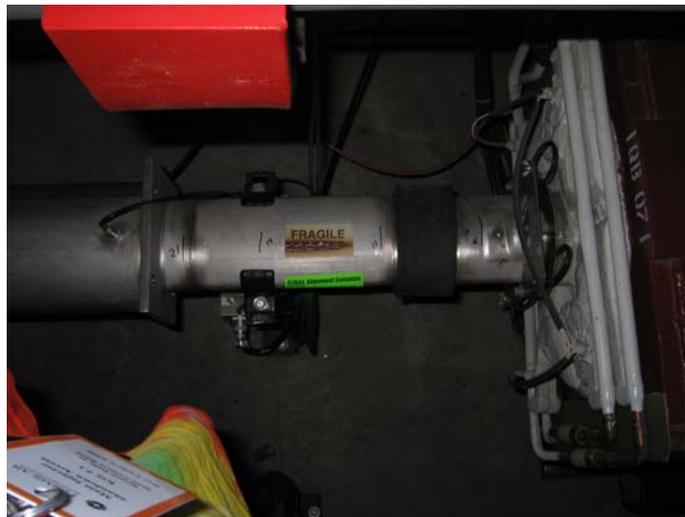
Figure 21: Image of upstream minitube at Q321 showing radiation damage to tape.

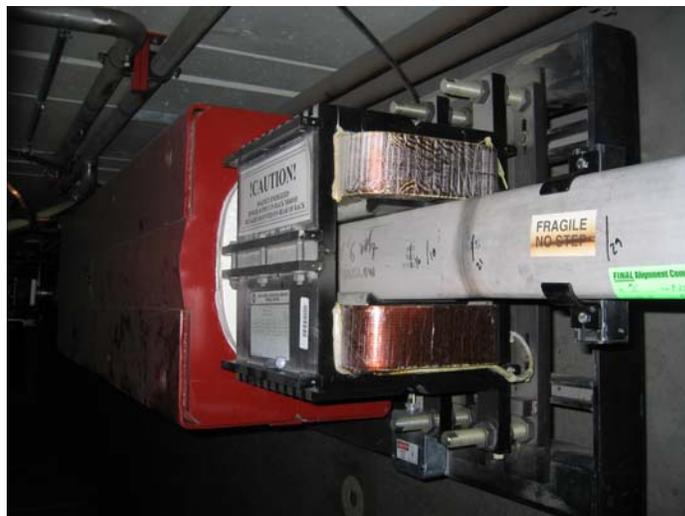
Figure 22: Image of upstream minitube at Q401 showing radiation damage to tape.
