Beams-doc-1385  
Version: 1  
Document type: Note

**Pictures of a Good and a Failed Main Injector Bellows**

Bruce C. Brown  
Fermi National Accelerator Laboratory\*  
P.O. Box 500  
Batavia, Illinois 60510

5/23/2003

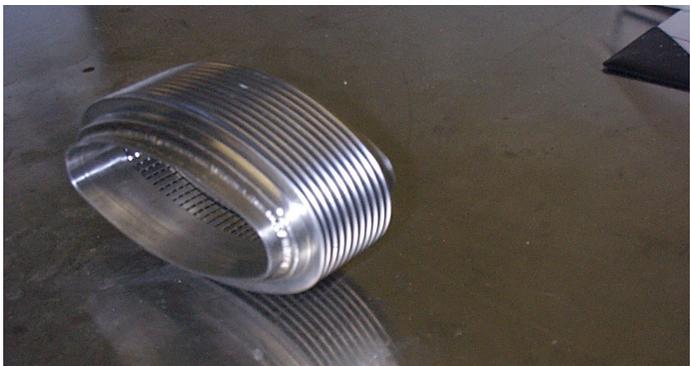
<p>Main Injector Bellows Assembly</p>

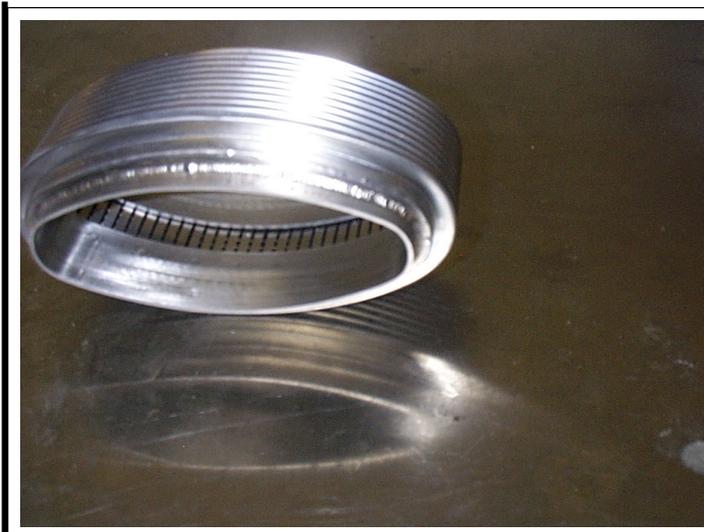
Main Injector Bellows Assembly

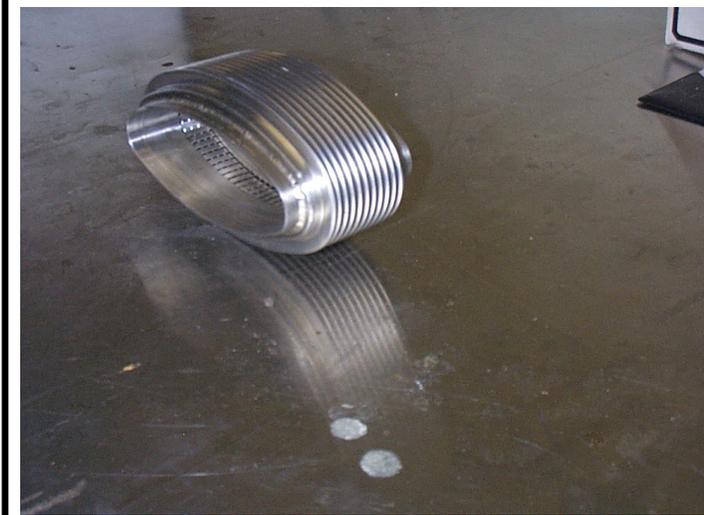
Main Injector Bellows Assembly

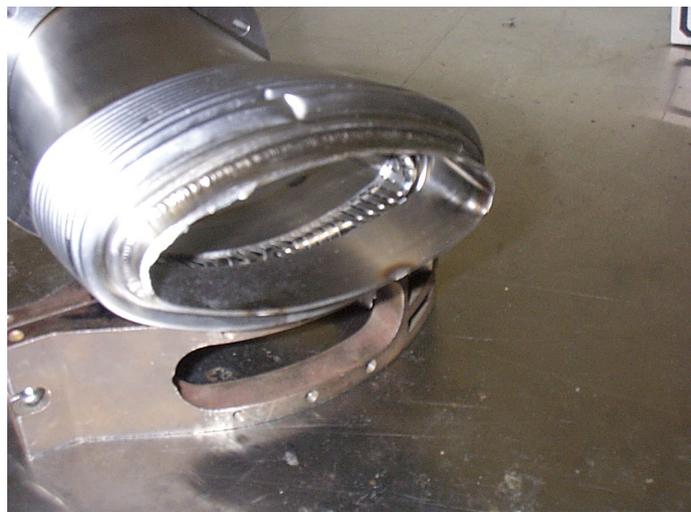
Kieth Dillow provided the author with an unused bellows assembly for examination. He also had an assembly which had been damaged by an incident which caused a large torque to release all of the upper fingers. After a portion of beam pipe had been clamped to the assembly, a failure occurred.

Picture	Comments
	<p>Main Injector Bellows Assembly</p>
	<p>Main Injector Bellows Assembly</p>

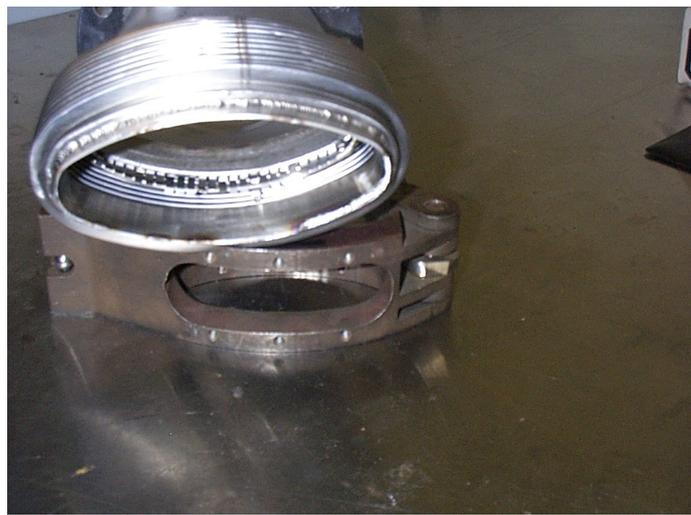
Main Injector Bellows Assembly
