LHC Status

2 July 2009

Jim Strait

Edited version of the talk
given at CERN today
by Steve Myers

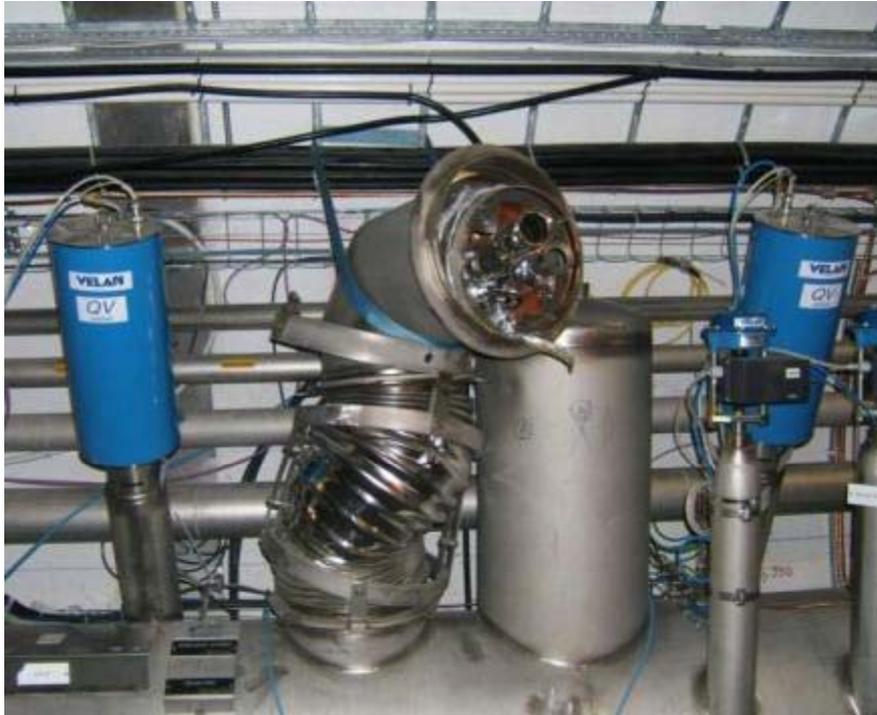
Repair of QRL service module in S3-4

Before repair

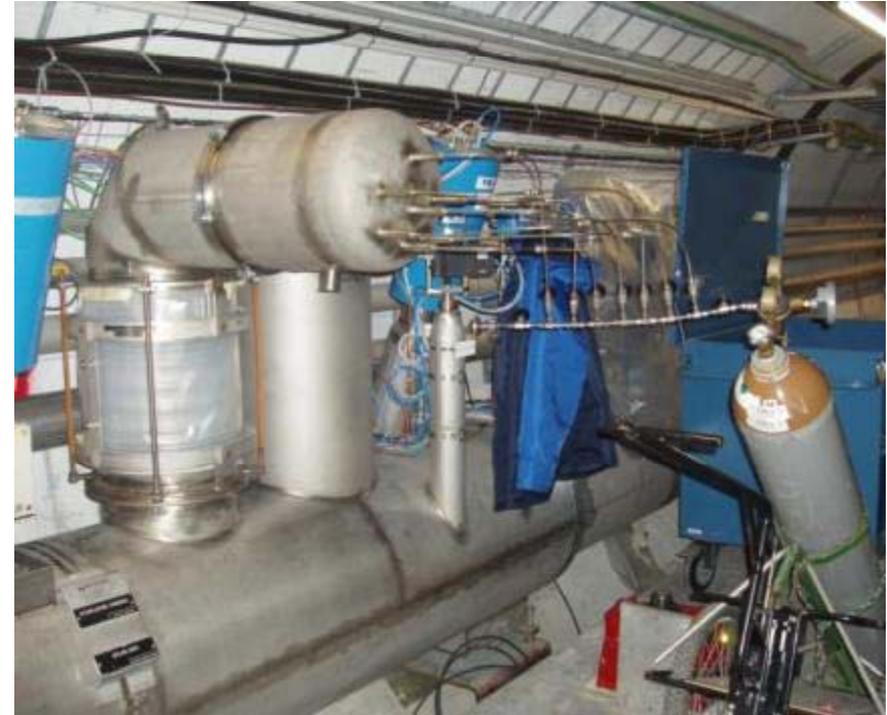
Q27

After repair

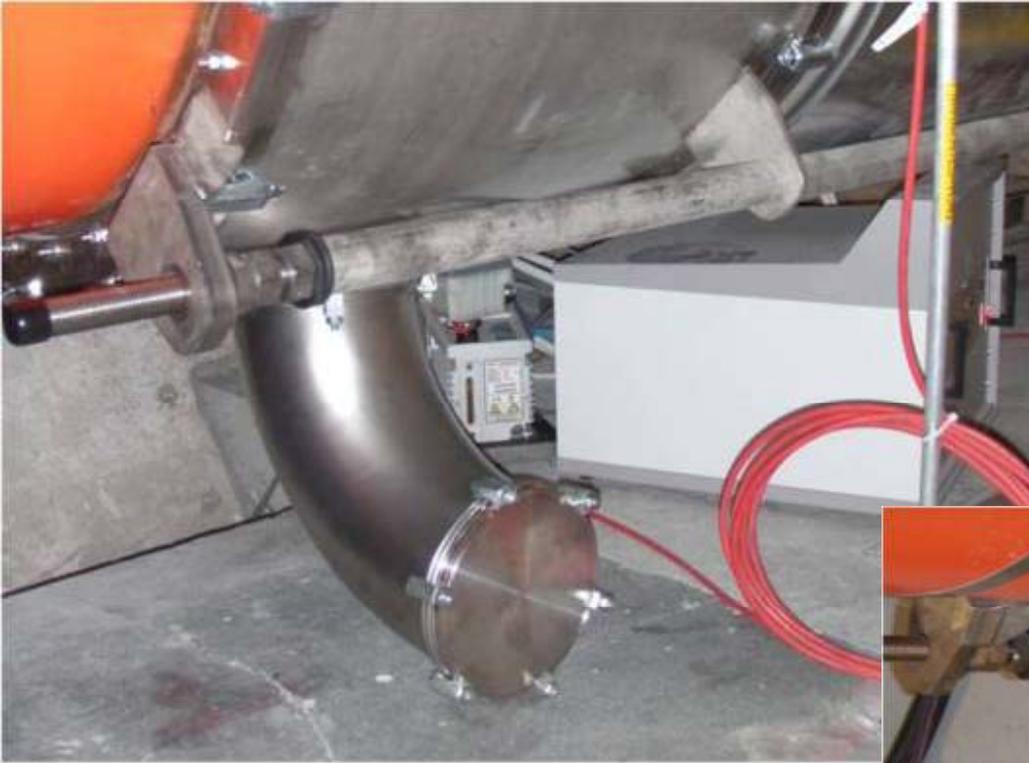
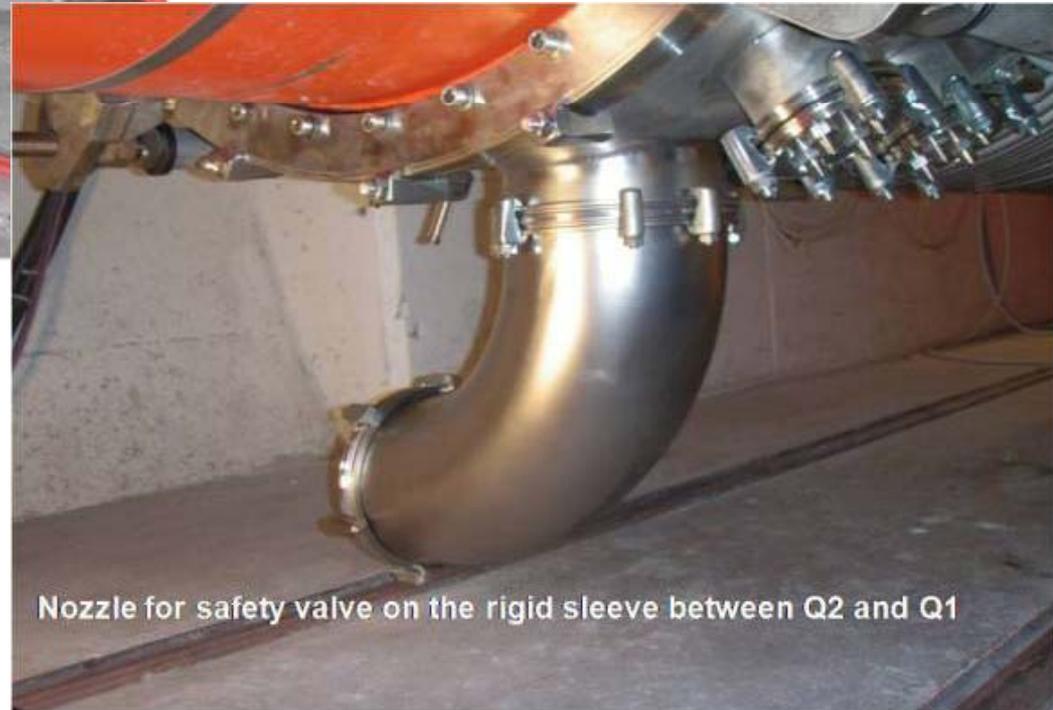
Inner Triplet DN200

Nozzle for safety valve on the rigid sleeve between Q2 and Q1

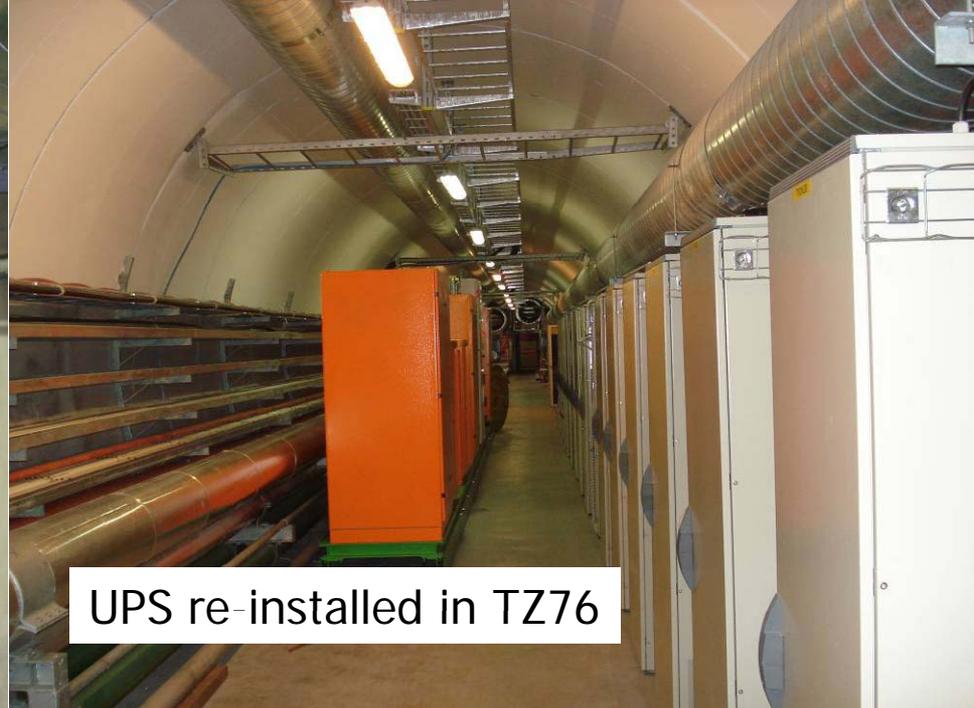
UPS re-installed in TZ76

- Re-locate now to low radiation area the most critical equipment (ex UPS)
- Prepare relocation (space, cabling, cooling, network, etc.) of other equipment for next LHC shut-down (ex Power Converters)
- Shield with iron blocs whatever cannot be relocated (ex Safe room)

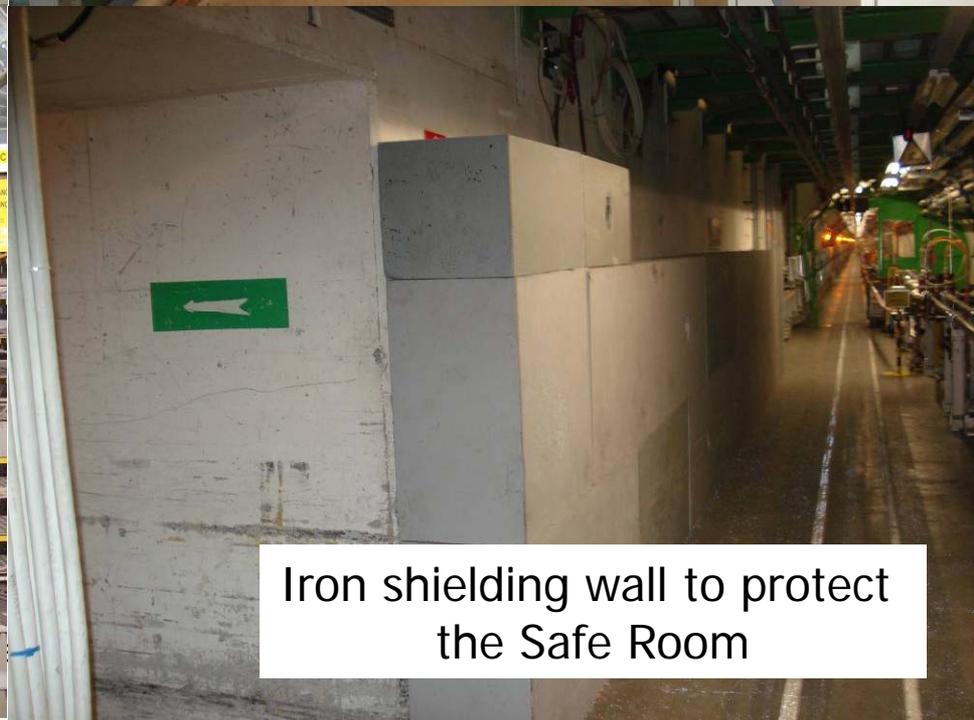
Iron shielding wall to protect the Safe Room
