# Fermi National Accelerator Laboratory

Proton Source Workshop  
Linac Momentum Dump

# Linac Momentum Dump

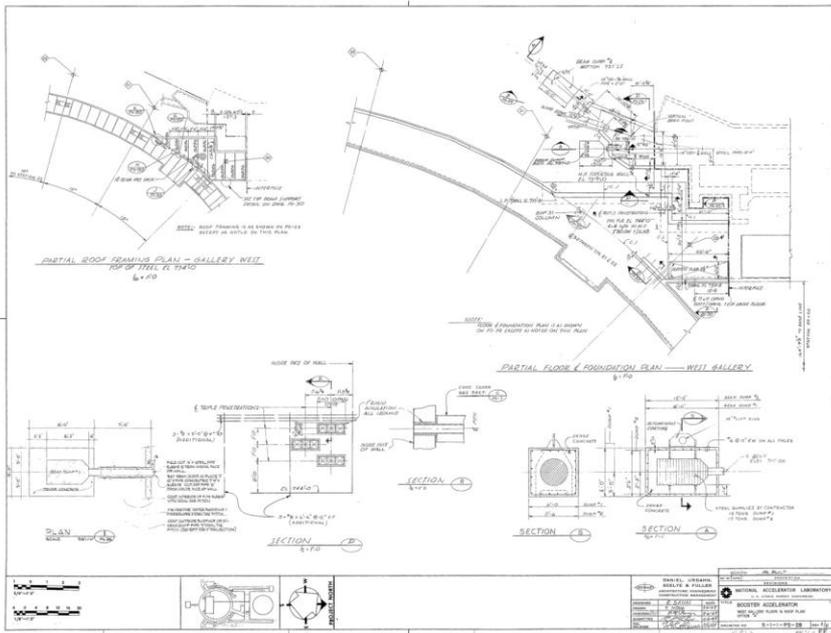
# FESS/DUSAF Drawing

- Designed by Sahai/Noda 2/6/69, NAL release by Collins
- No photo records of the dump either before or during installation could be found.
- No purchase records of the dump could be found.
- May have been part of the responsibility of the construction contractor

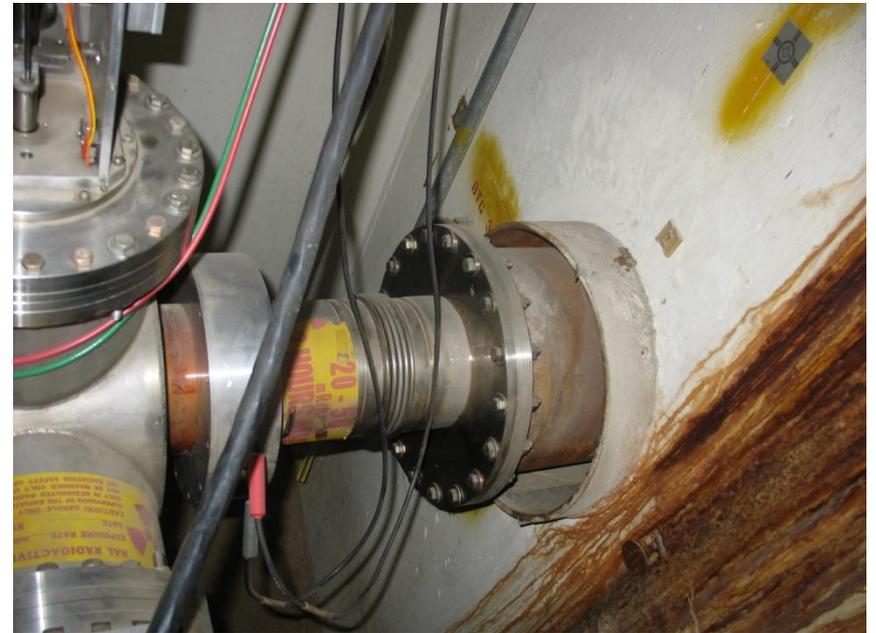
# Vacuum Degradation

- Vacuum becoming poor  
12/6/07
- High radiation in vicinity
- Plan to install titanium vacuum window

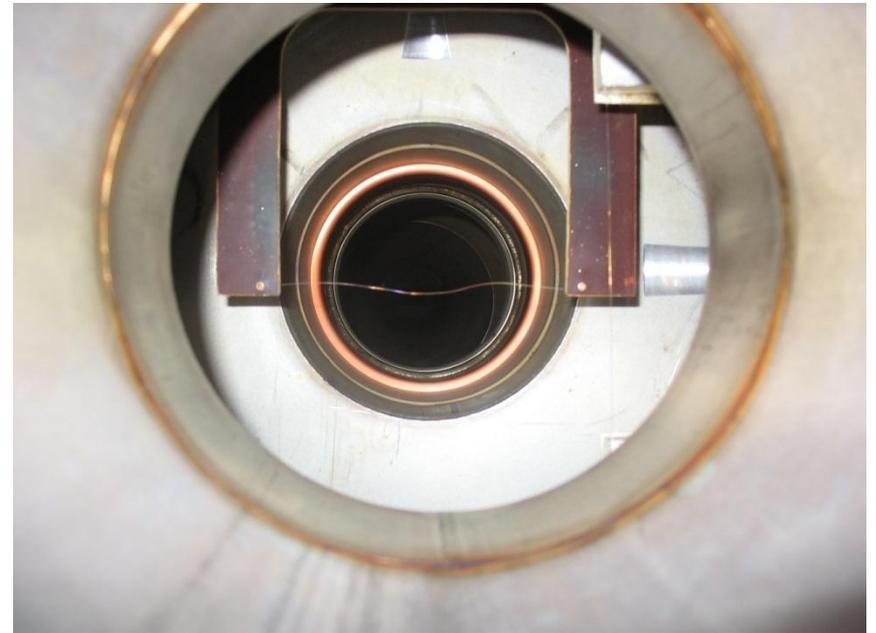
# Wire in Beam Line

- Vacuum let up, beam tube opened 12/6/07
- Wire in beam line
- Relaxed, no tension
- Changed vacuum seals

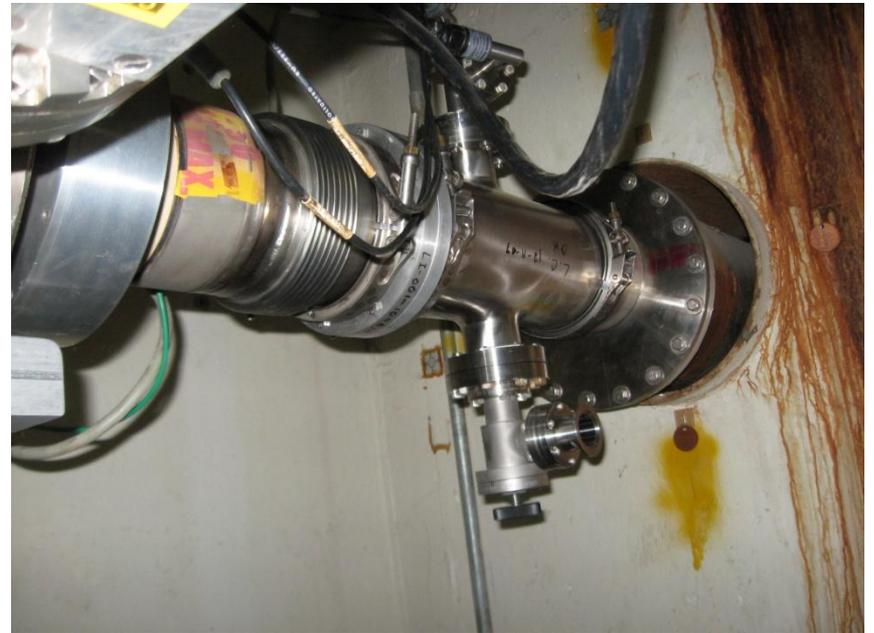
# Window Installation

- Vacuum still poor
- Opened 12/12/07
- Installed .003" thk. titanium window upstream of dump
- Installed pumpout port and ion gauge
- Separate vacuum from Linac

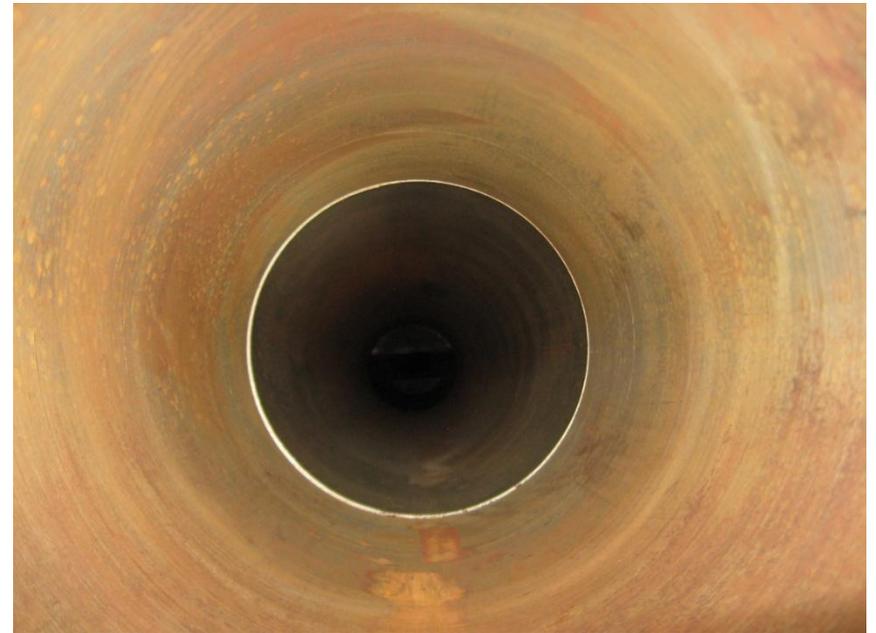
# What's in the Beam Dump?

- Photo taken 12/12/07
- Compare with AD dwg ME-2303
- Shield blocks A,B,C,D on dwg 2303 are not in dump
- Otherwise appears to conform to dwg 2303
- Steel casting with sand cored half-round wedge shaped internal cavity, tube welded on upstream end

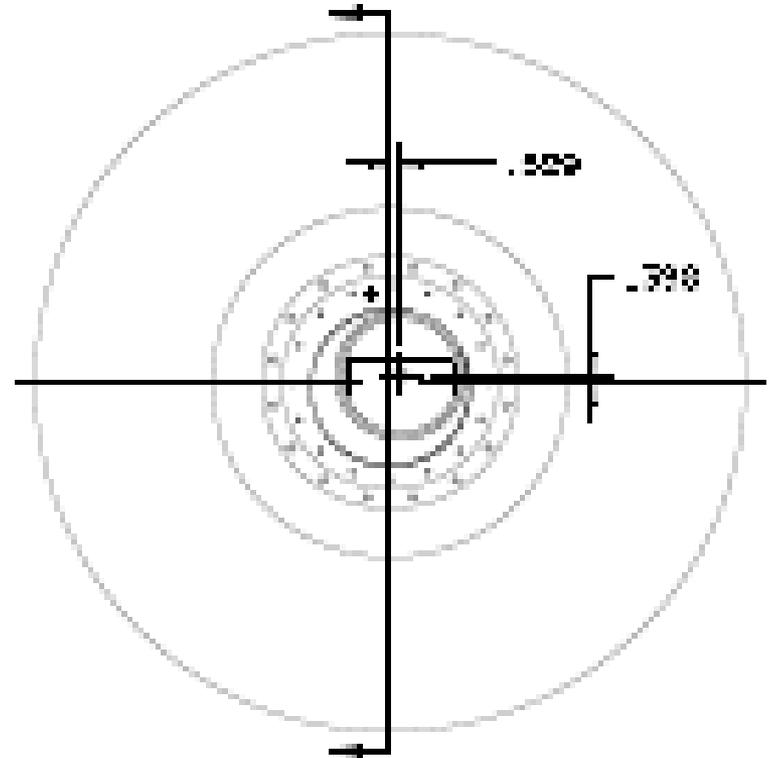
# Additional Complication

- Dump is offset from beam line
- Don't know how well we can trust old drawings
- Possible defects inside such as casting lumps

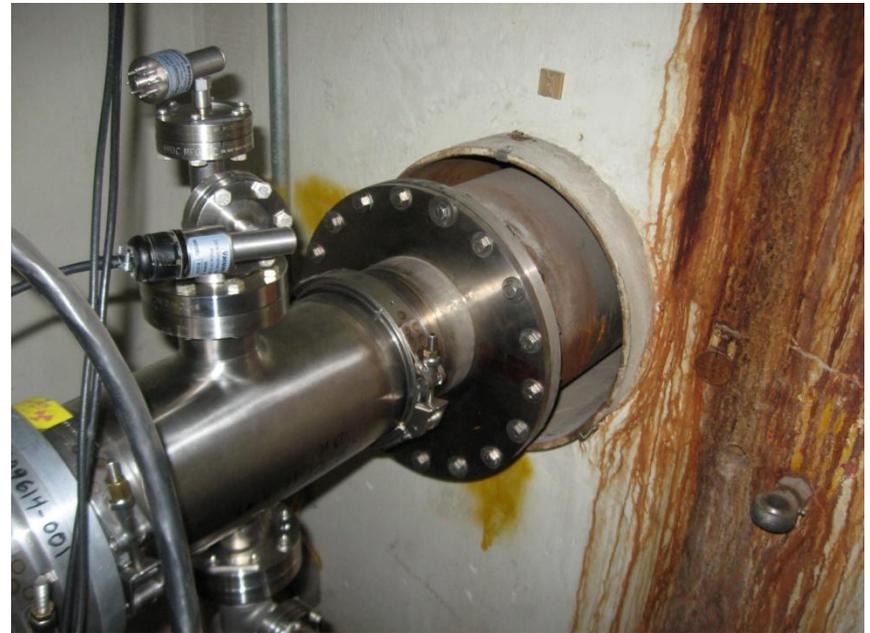
# Borescope Camera Tour

- Opened pumpout port  
1/26/10
- Fed in borescope on long  
cable
- Video record saved 469Mb
- Y:\public\AUGUSTINE\LINAC  
Dump video 1-26-2010
- Confirms that we believe  
ME-2303 reasonably close  
to accurate
- Some casting lumps  
observed in cavity

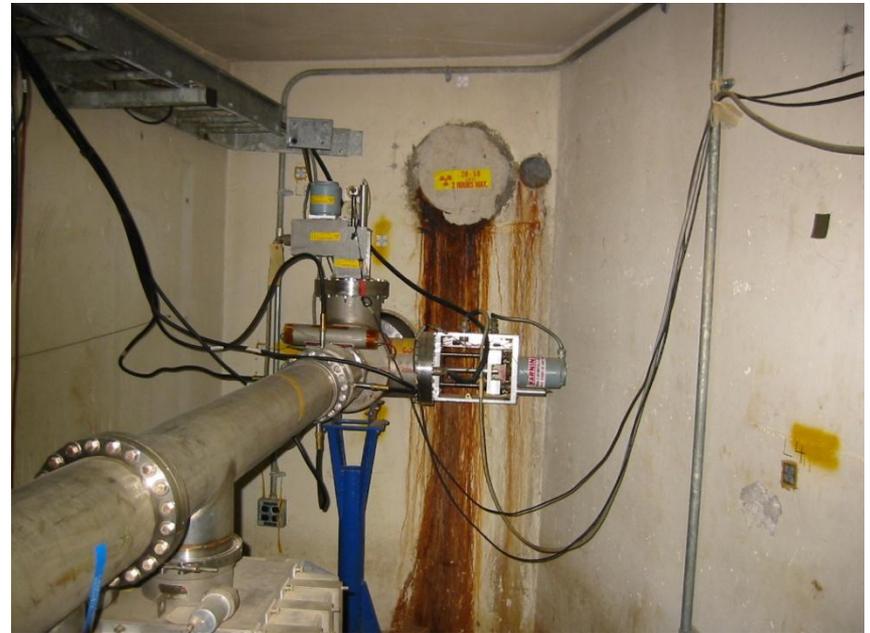
# Evaluation of the Problem

- Believe tube rusting from outside, ground water contaminating vacuum
- Vacuum pump on chamber isolated by window can maintain adequate vacuum for the short term

- Dig up dump and perform in-place repairs
- Inject sealant from berm or tunnel wall
- Dig up and replace dump
- Make a new dump in different place
- Backfill with helium
- Insert vacuum sleeve inside dump cavity
- Vacuum sleeve looks like the best solution to pursue
