Booster measurements

C.Y. Tan, K. Seiya & C. Bhat
14 Jun 2017

Tune scan with high intensity

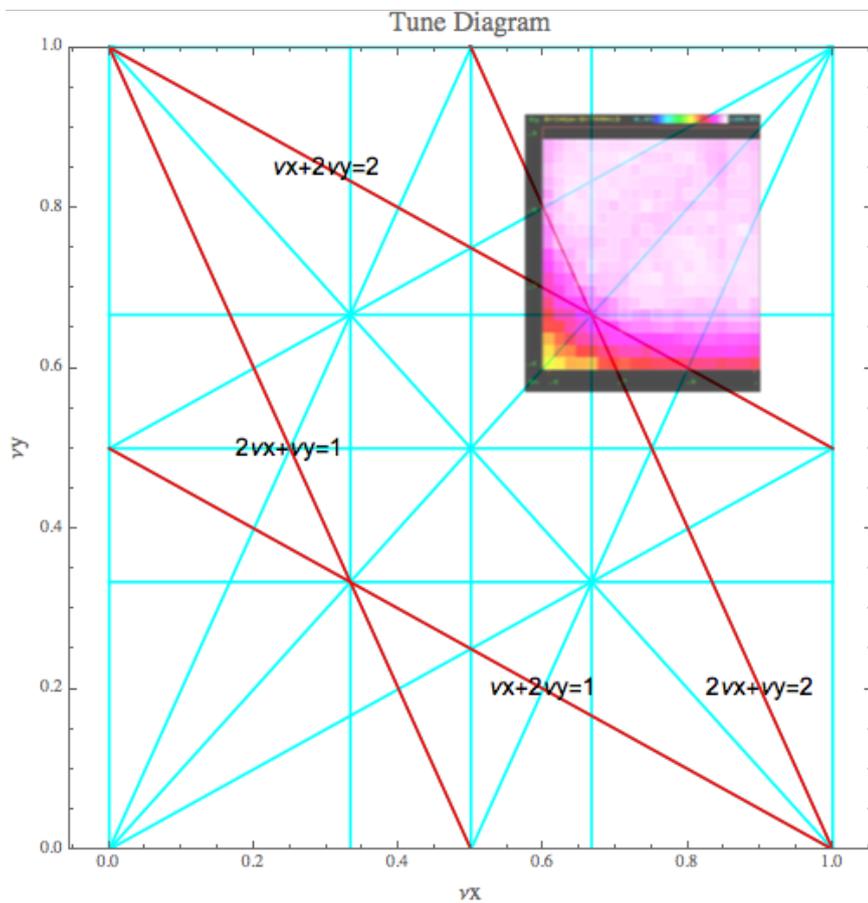
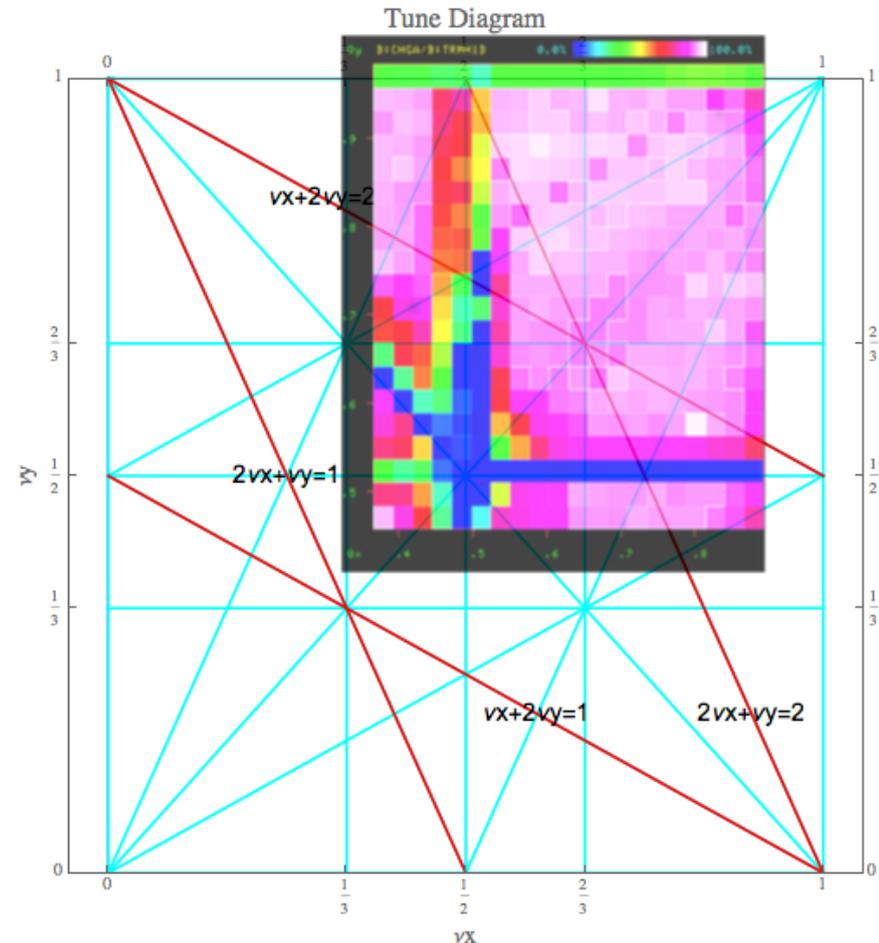
Are the losses (left pic) from 3rd order resonance or from 1/2 integer resonances because they became thicker? Yellow region may be intersection of 1/2 integer lines.

Intensity: $4.6e12$, pseudo-flat lattice 2. Skew quad current is zero for first 5 ms.

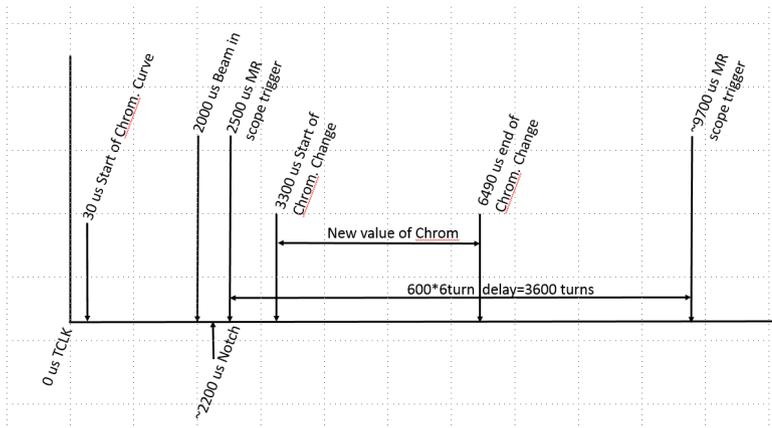
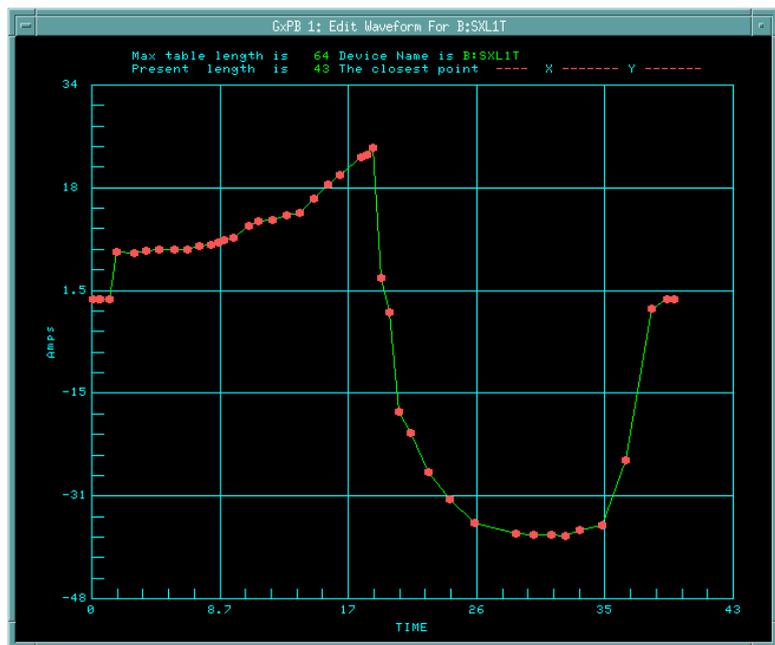
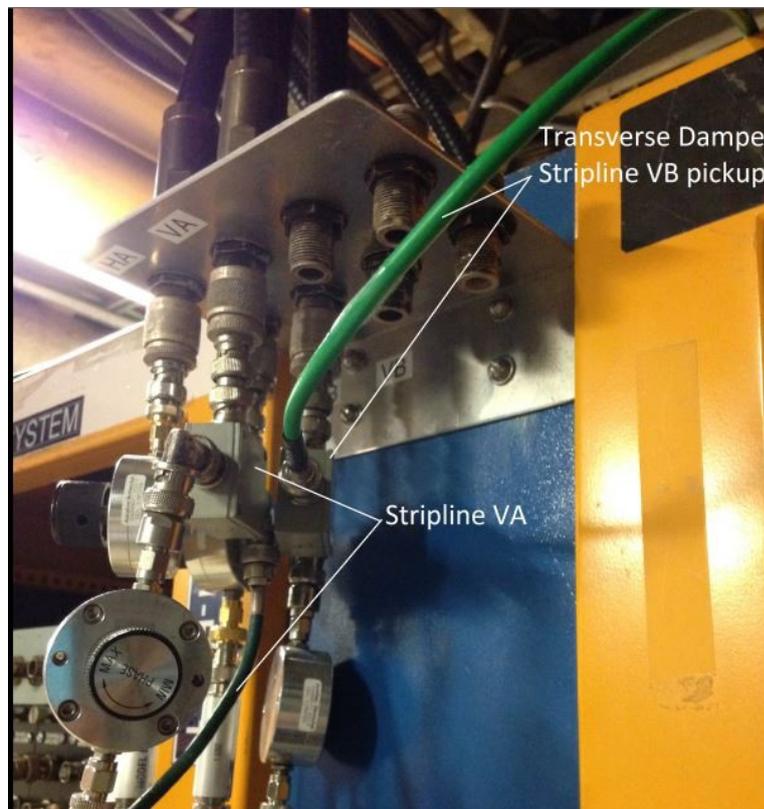
SXL=0 at injection

Vertical damper pickup used for measurements.

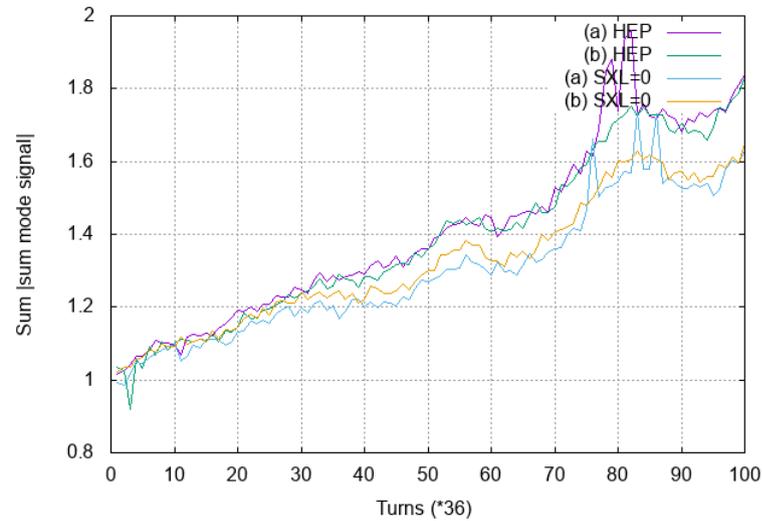
Comparison between HEP and SXL=0

Sum increases because of shoulders in the |signal| at higher turn number.

Since beam loss is there with transverse dampers on, this means that instability is outside the bw of the dampers. Head-tail?

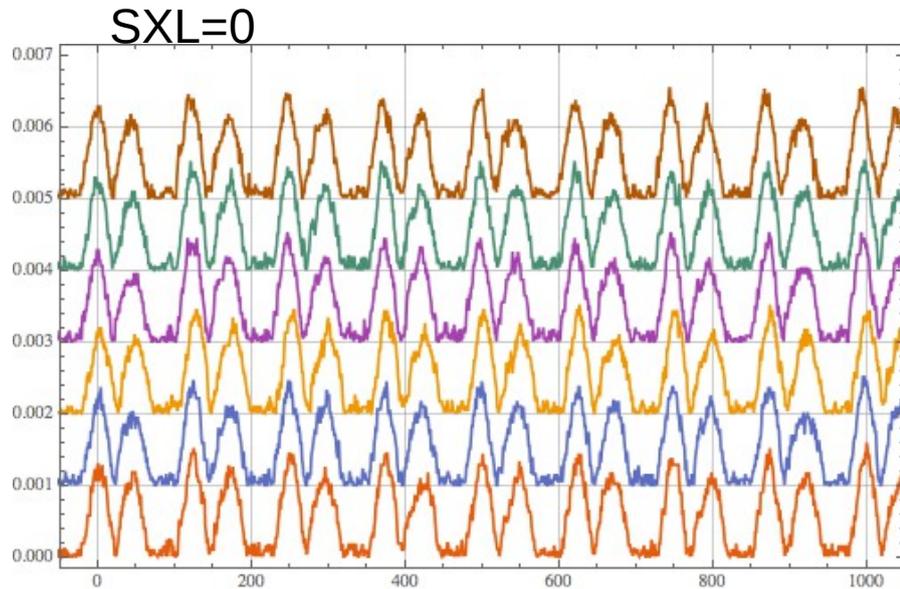
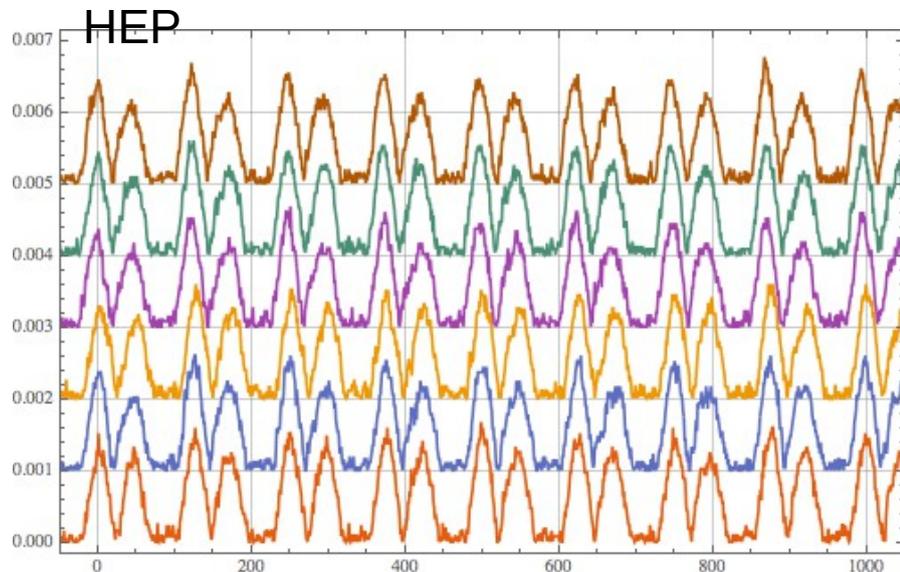
SXL=0, dampers on (cont'd)

Did a scan of the entire vertical data set.
Cannot see any head-tail.
Comparison between HEP and SXL=0
shows no difference in signal!

Every line is 6 turns which is approximately
1/4 to 1/3 of a synchrotron period.
(assuming 25 kHz synchrotron tune)

Only solution is that the problem is in the
horizontal.
