Progress this week on the Plume

External Beamlines Department

NOvA Test Beam Halo Meeting

3/11/2020

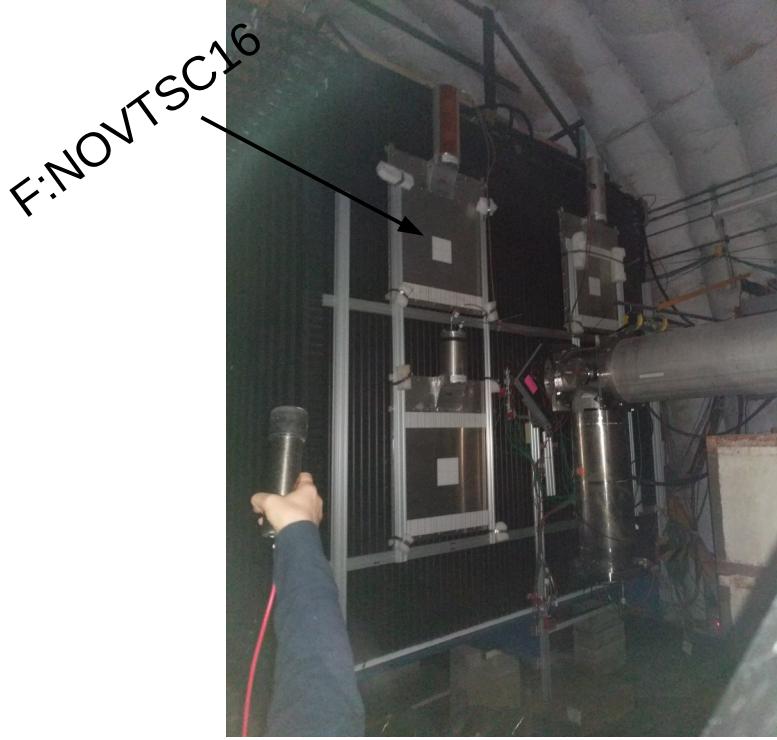
- Plot of upper-west quadrant scintillator counts (F:NOVTSC16) at peak of plume suggests 8mm MC6CV collimator opening is better balance between secondary rate on target (F:NOVTSC01) and plume intensity.
- Not a solution, but a potential bandaid while we figure out the plume.
- Ran this way overnight; NOvA folks, was this helpful in any way?

- Collimator scan at 1E9 ppp using scintillators on NOvA detector to show that halo dissipates continuously, may have found more optimal gap setting.
- Verified that halo appears gone with MC6D in negative polarity, all other magnets off.
- Ran at negative polarity 64 GeV/c secondary mode, tuned up on target. Halo appeared gone, but secondary rates too low to be useful, even with MC6CV collimator wide open. Shutoff?
- Mike and Andrew slide MWPC in MC7 upstream end up and down to see if they could identify the plume; they could not.
- Carol and Adam accessed MC6 and MC7 to do a radiation survey and better understand the geometry of the shielding and line-of-sight to the plume. No obvious holes in shielding identified.

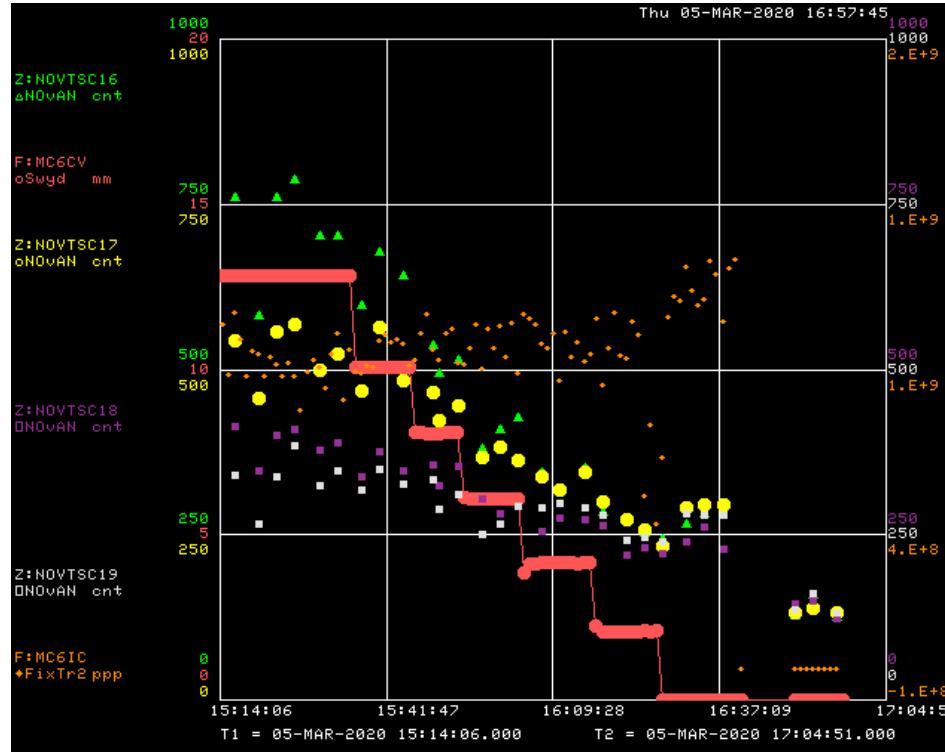
- Plot of upper-west quadrant scintillator counts (F:NOVTSC16) at peak of plume suggests 8mm MC6CV collimator opening is better balance between secondary rate on target (F:NOVTSC01) and plume intensity.
- Not a solution, but a potential bandaid while we figure out the plume.
- Ran this way overnight; NOvA folks, was this helpful in any way?

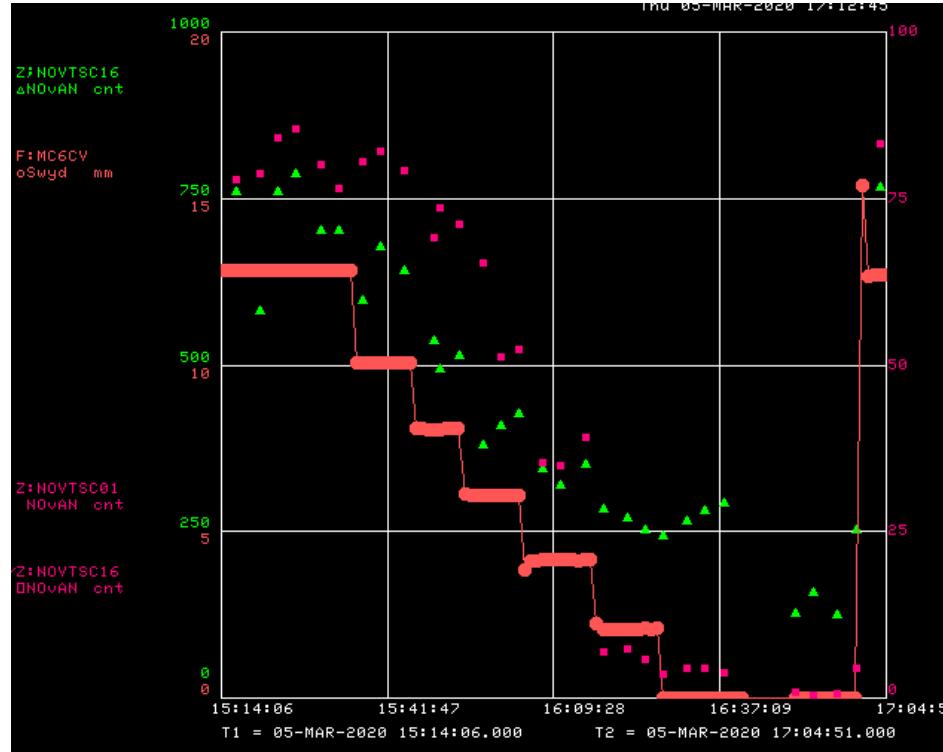
- Plot of upper-west quadrant scintillator counts (F:NOVTSC16) at peak of plume suggests 8mm MC6CV collimator opening is better balance between secondary rate on target (F:NOVTSC01) and plume intensity.
- Not a solution, but a potential bandaid while we figure out the plume.
- Ran this way overnight; NOvA folks, was this helpful in any way?

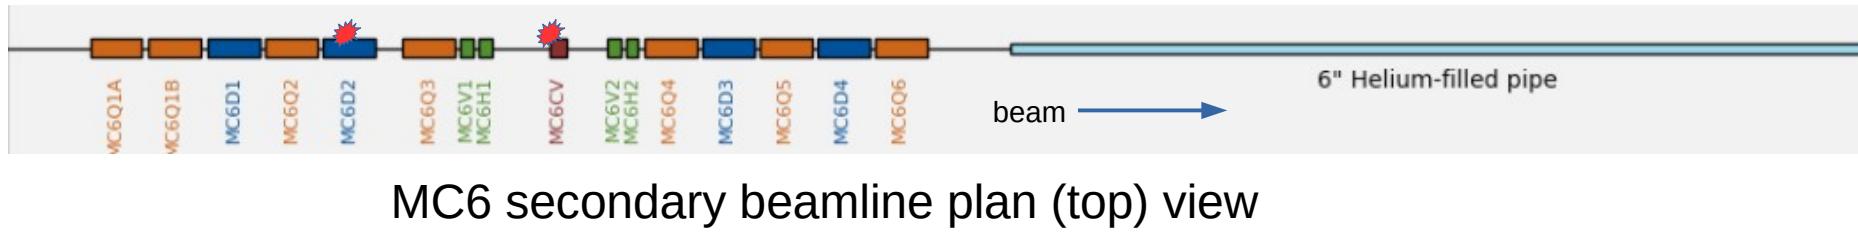
Hot spots in MC6 secondary beamline

- Asymmetric hot spots verified on West side, upstream $\frac{1}{4}$ of MC6D2, as well as West and $\sim 1\text{cm}$ high on MC6CV upstream face.
- Same spots were identified before target position/angle scan, appear unchanged.
- May suggest horizontal alignment issue, consistent with target angle scan results.
- Will work with alignment stationing data to draw line-of-sight from plume upstream.

- Moving scintillator array to trace back origin point of plume (Mike/Andrew/Evan in progress).
- MC2 pinhole collimator in beam, can check for obvious alignment issues, see if impacts plume.
- Scrutinize alignment data to determine possible errors and line-of-sight between beamline loss points and plume. *In particular, are the scrapers in MC6 aligned?*
- Remove MC6 primary target, keep secondary beamline tuned to 64 GeV/C, see if plume remains.

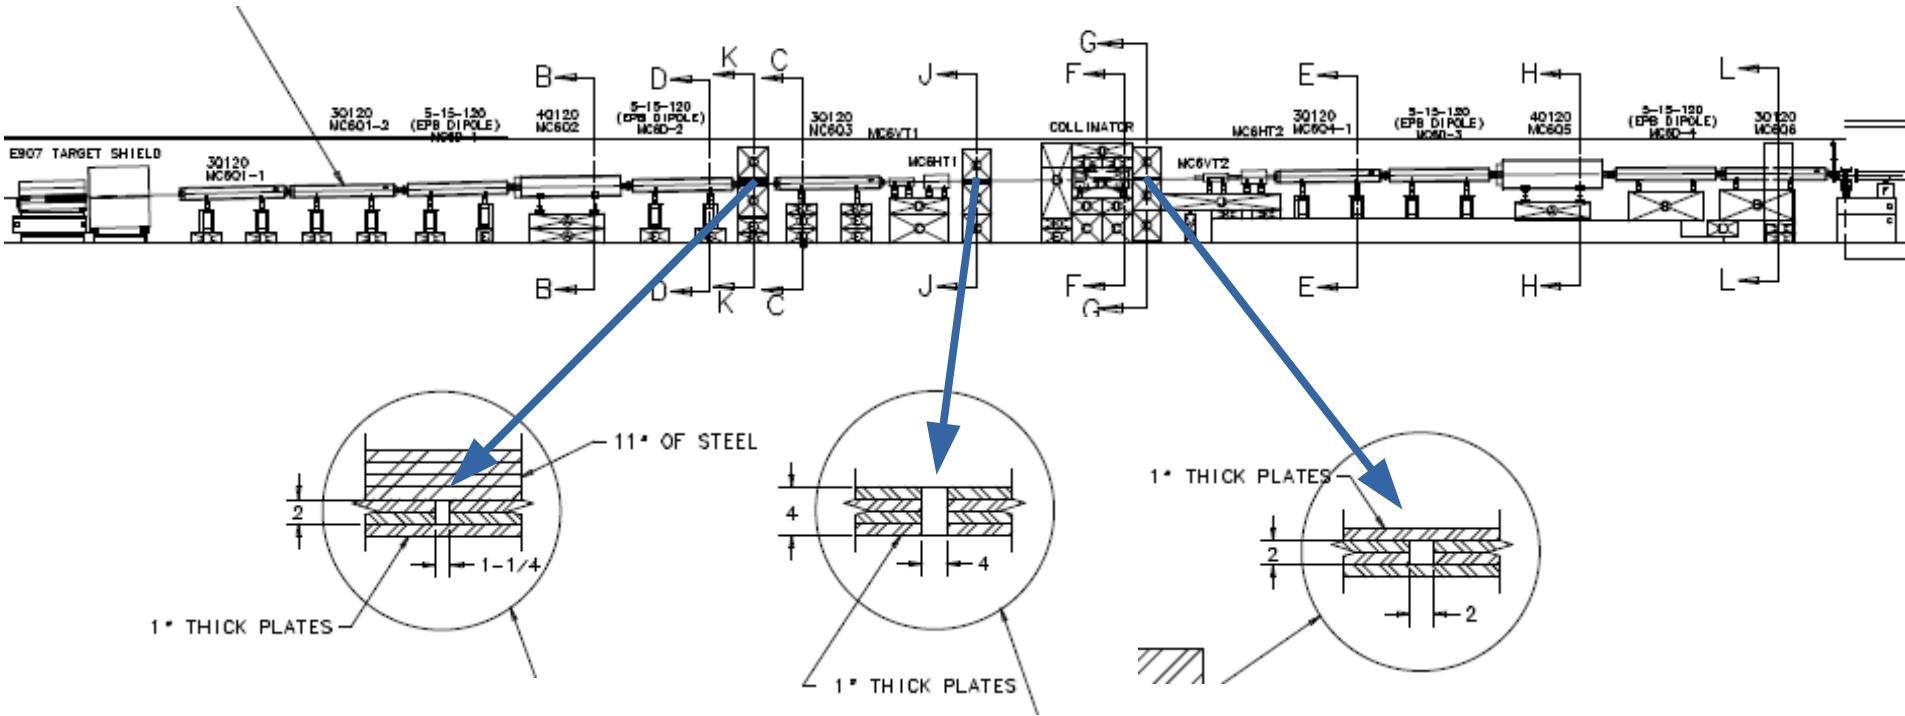
MC6 secondary beamline apertures

- Optics model suggests we're likely dumping remaining primary beam at the upper aperture of the "K" scraper (120 GeV beam height is 1.8" from center line).
- Radiation survey couldn't determine asymmetry in radiation pattern at K scraper, but plenty of radiation was apparent.
