Fermilab

Doc Number: Beams-doc-1382
Version: 2.0
Category: Note

Residual Radiation Hints for Aperture and Alignment Issues in the Main Injector

18 January 2005

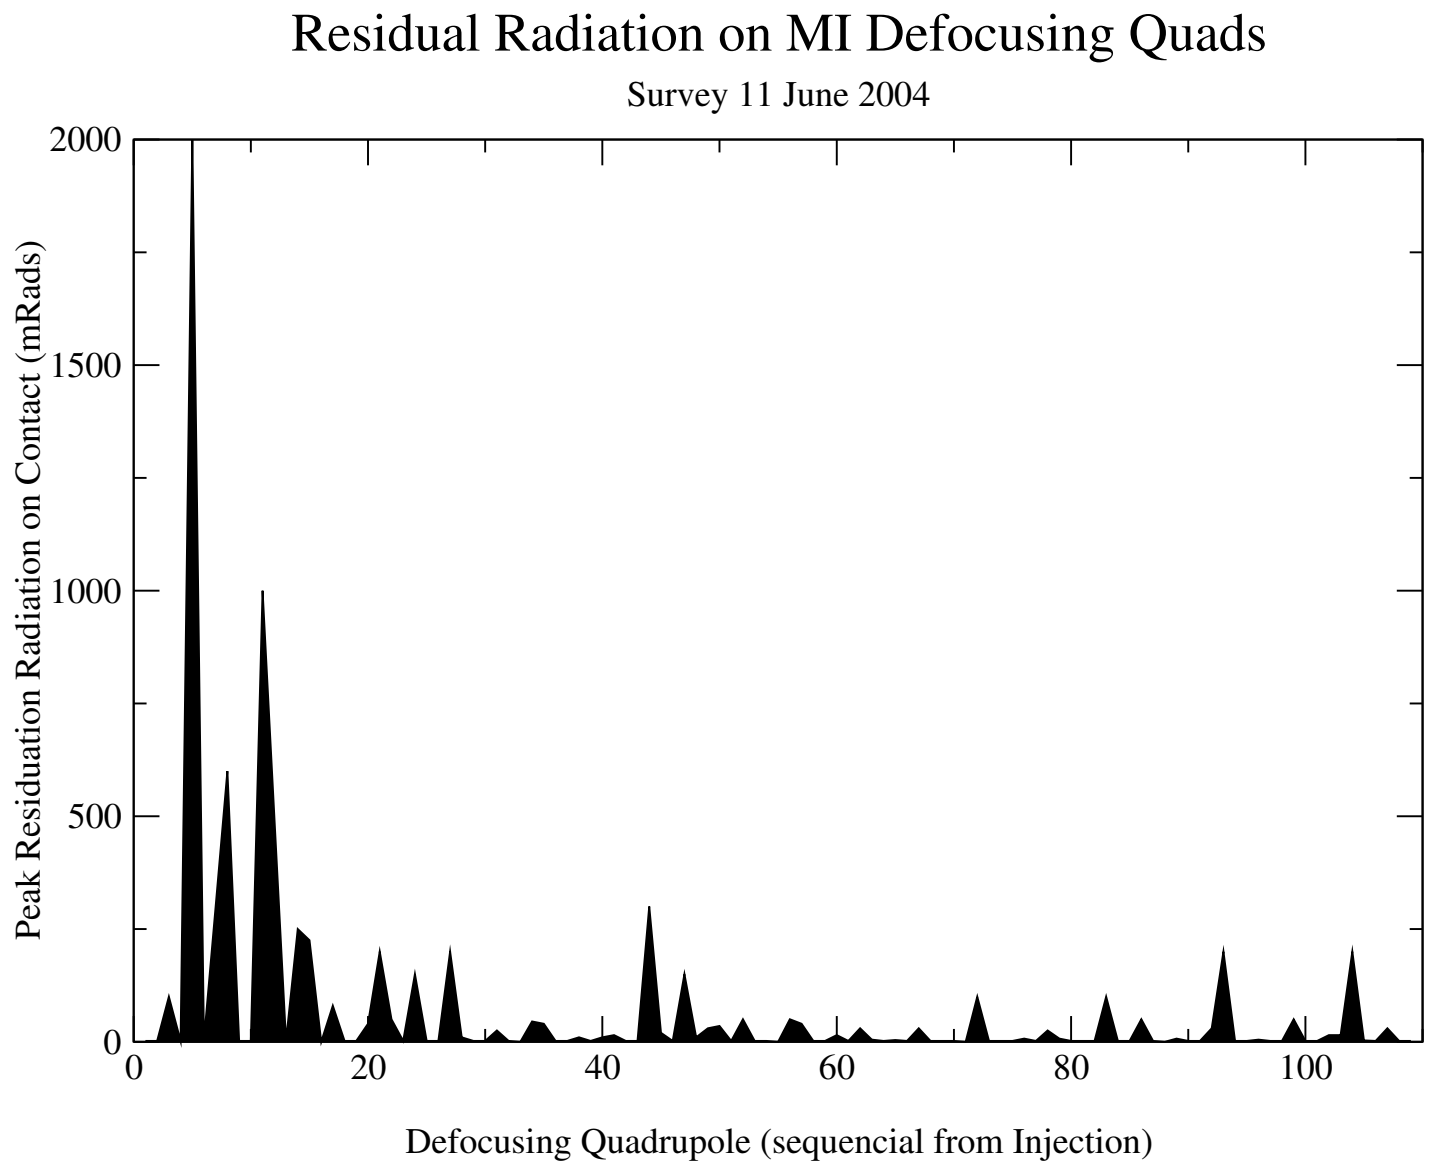
Figure 1: Residual Radiation on Contact at minitube on upstream of Main Injector Defocusing Quadrupoles after few hours cooldown.

On June 11 the radiation survey was continued with an awareness of this pattern which appeared at D Quad (odd half cell) locations. The pattern was detailed at three locations by recording at one inch intervals the residual radiation measured on contact at the top of the beam pipe. This data is plotted in Figures 2, 3 and 4. It is sharply defined and local to the bare beam pipe.

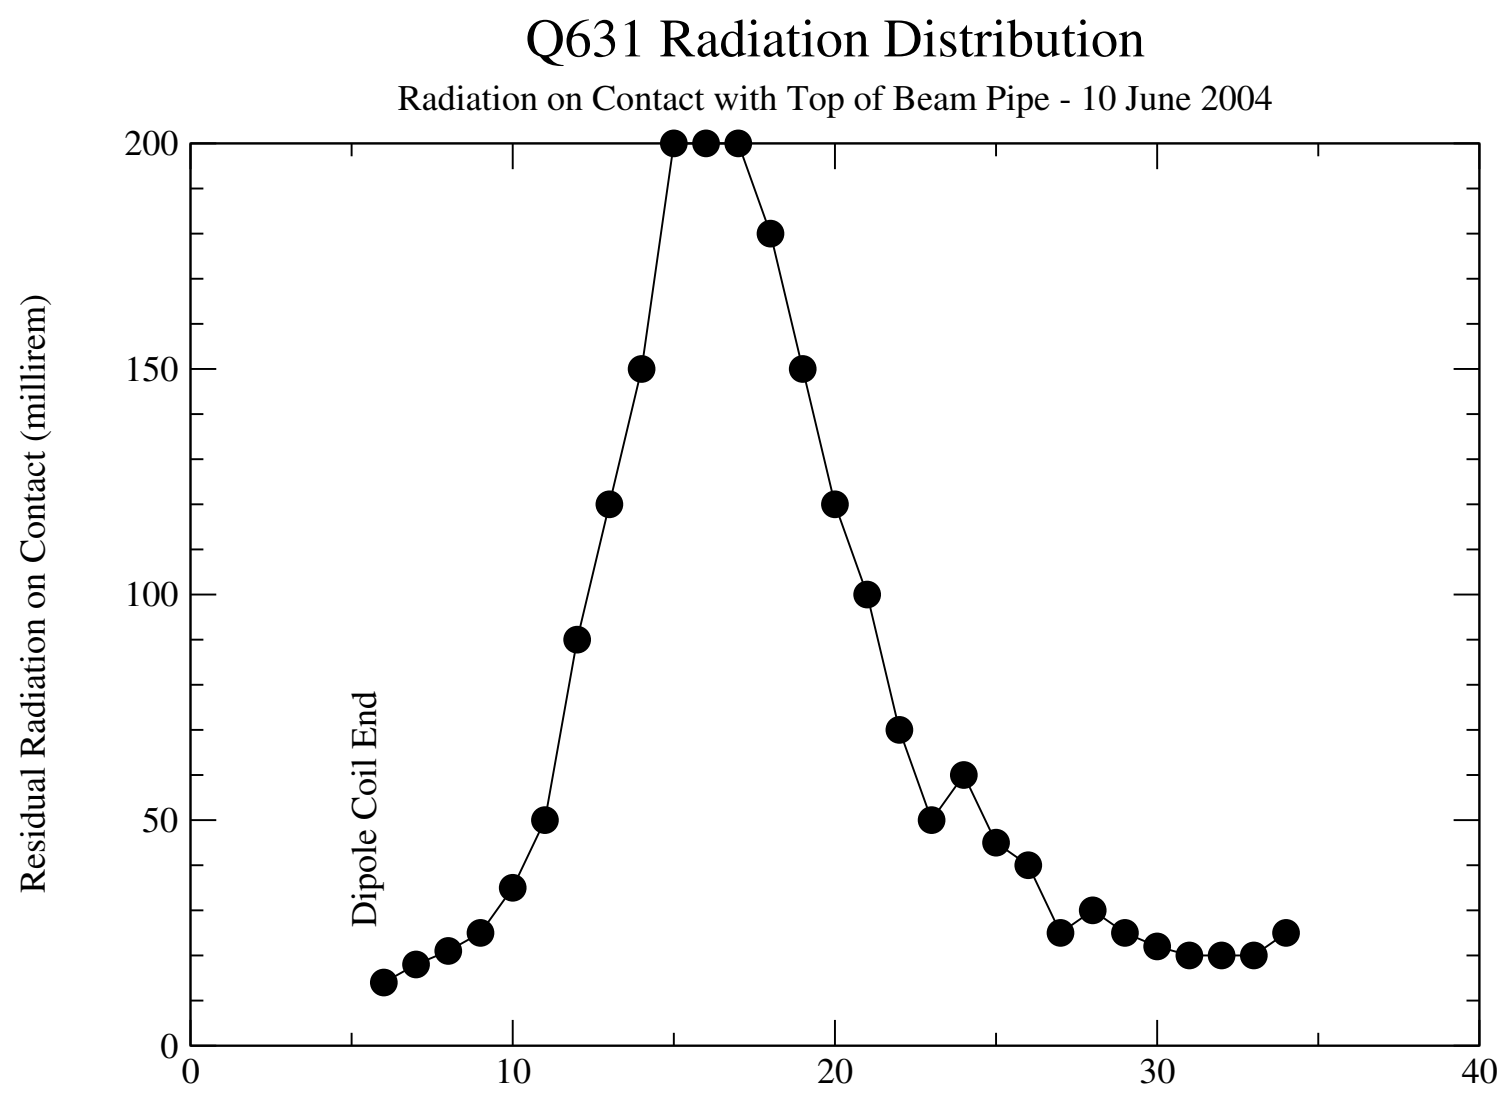
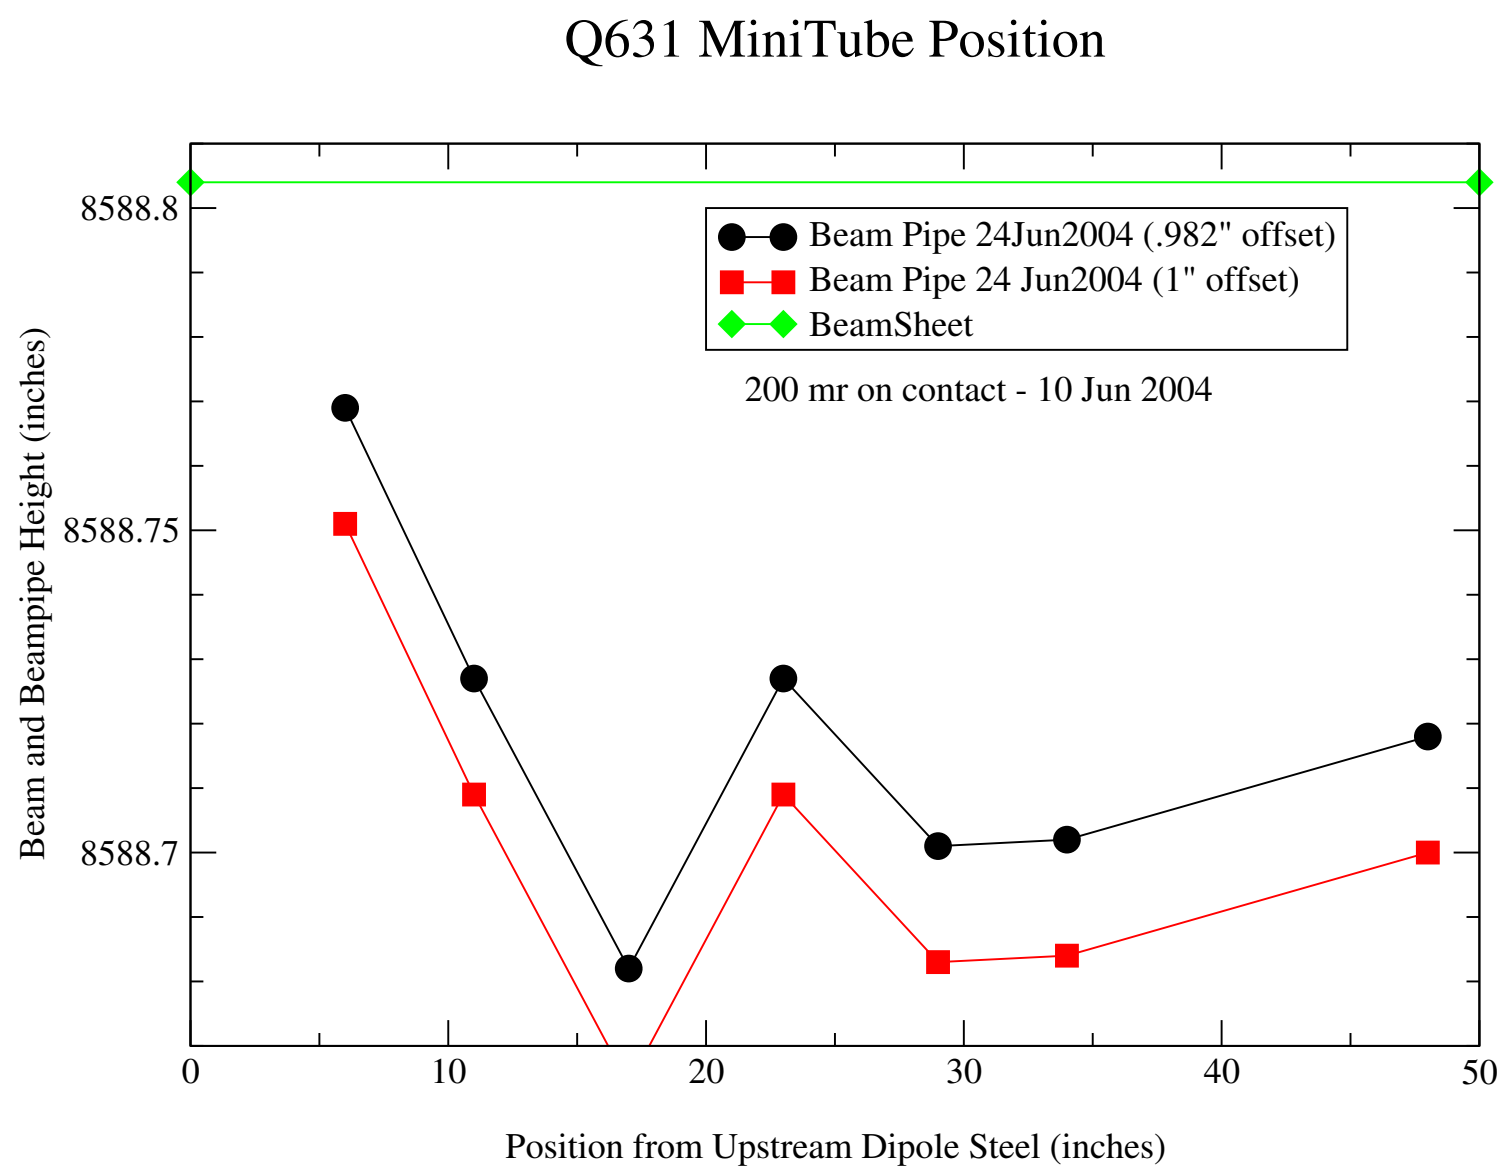
Figure 2: Upper Figure shows residual radiation pattern at Q631 as measured on contact with the top of the beam pipe. Lower Figure shows the elevations as surveyed at the top of the beam pipe but expressed as location of beam pipe center assuming a constant 1 inch or 0.982 inch offset from center to top of beampipe.

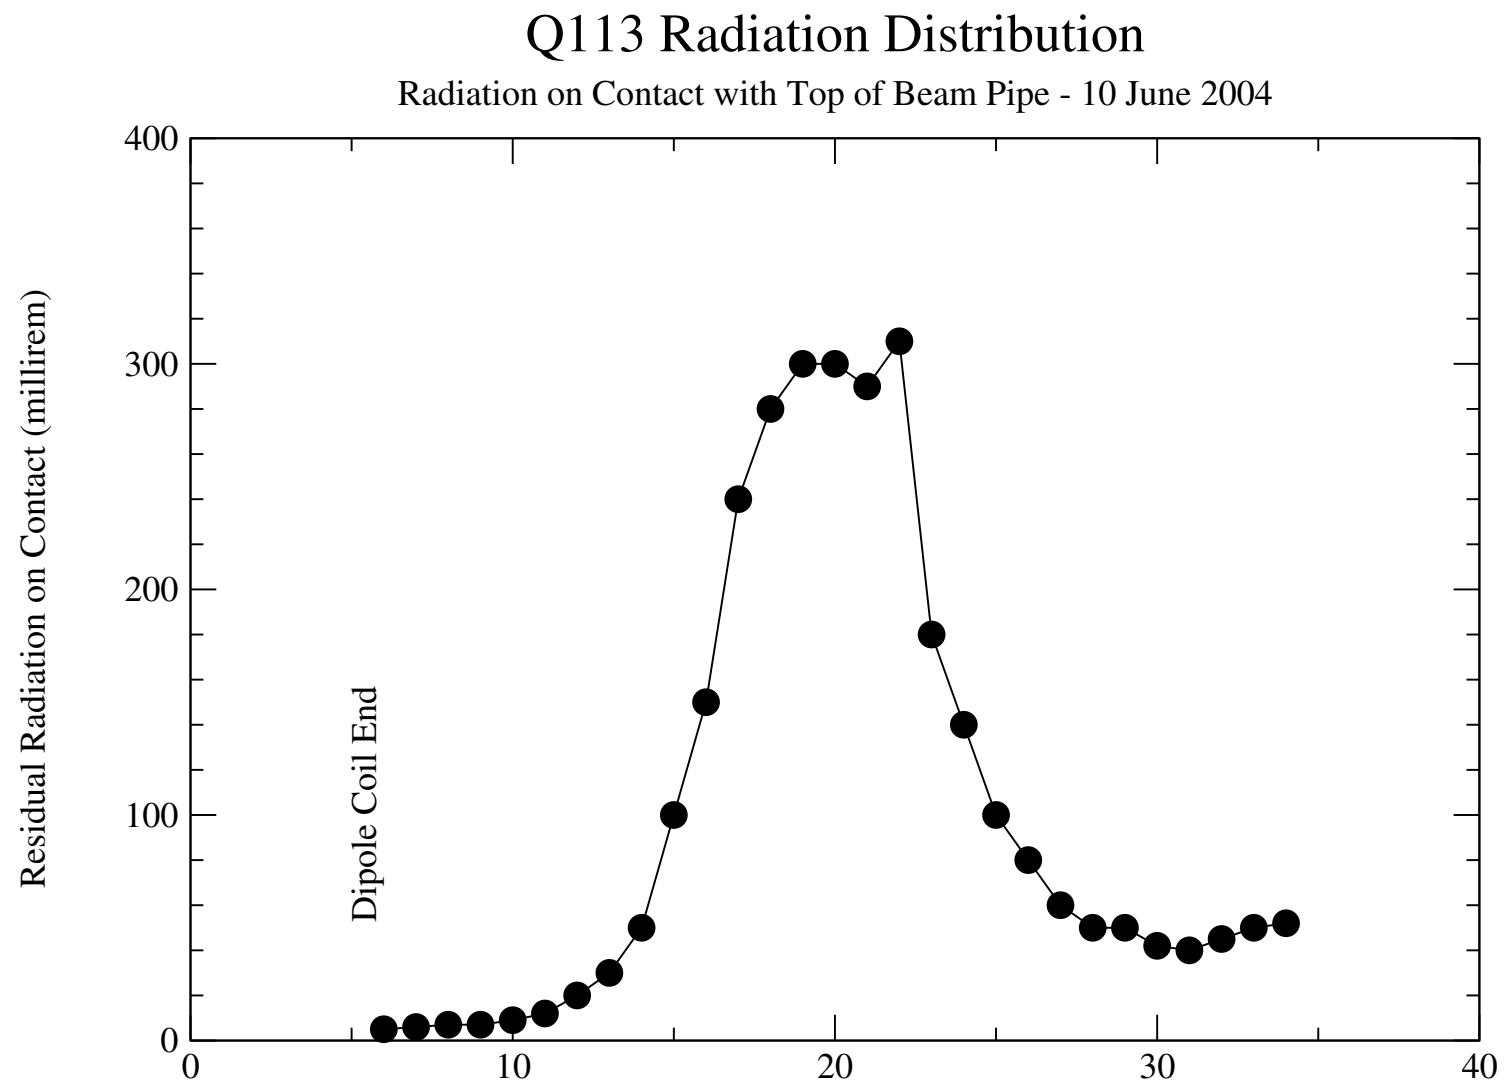
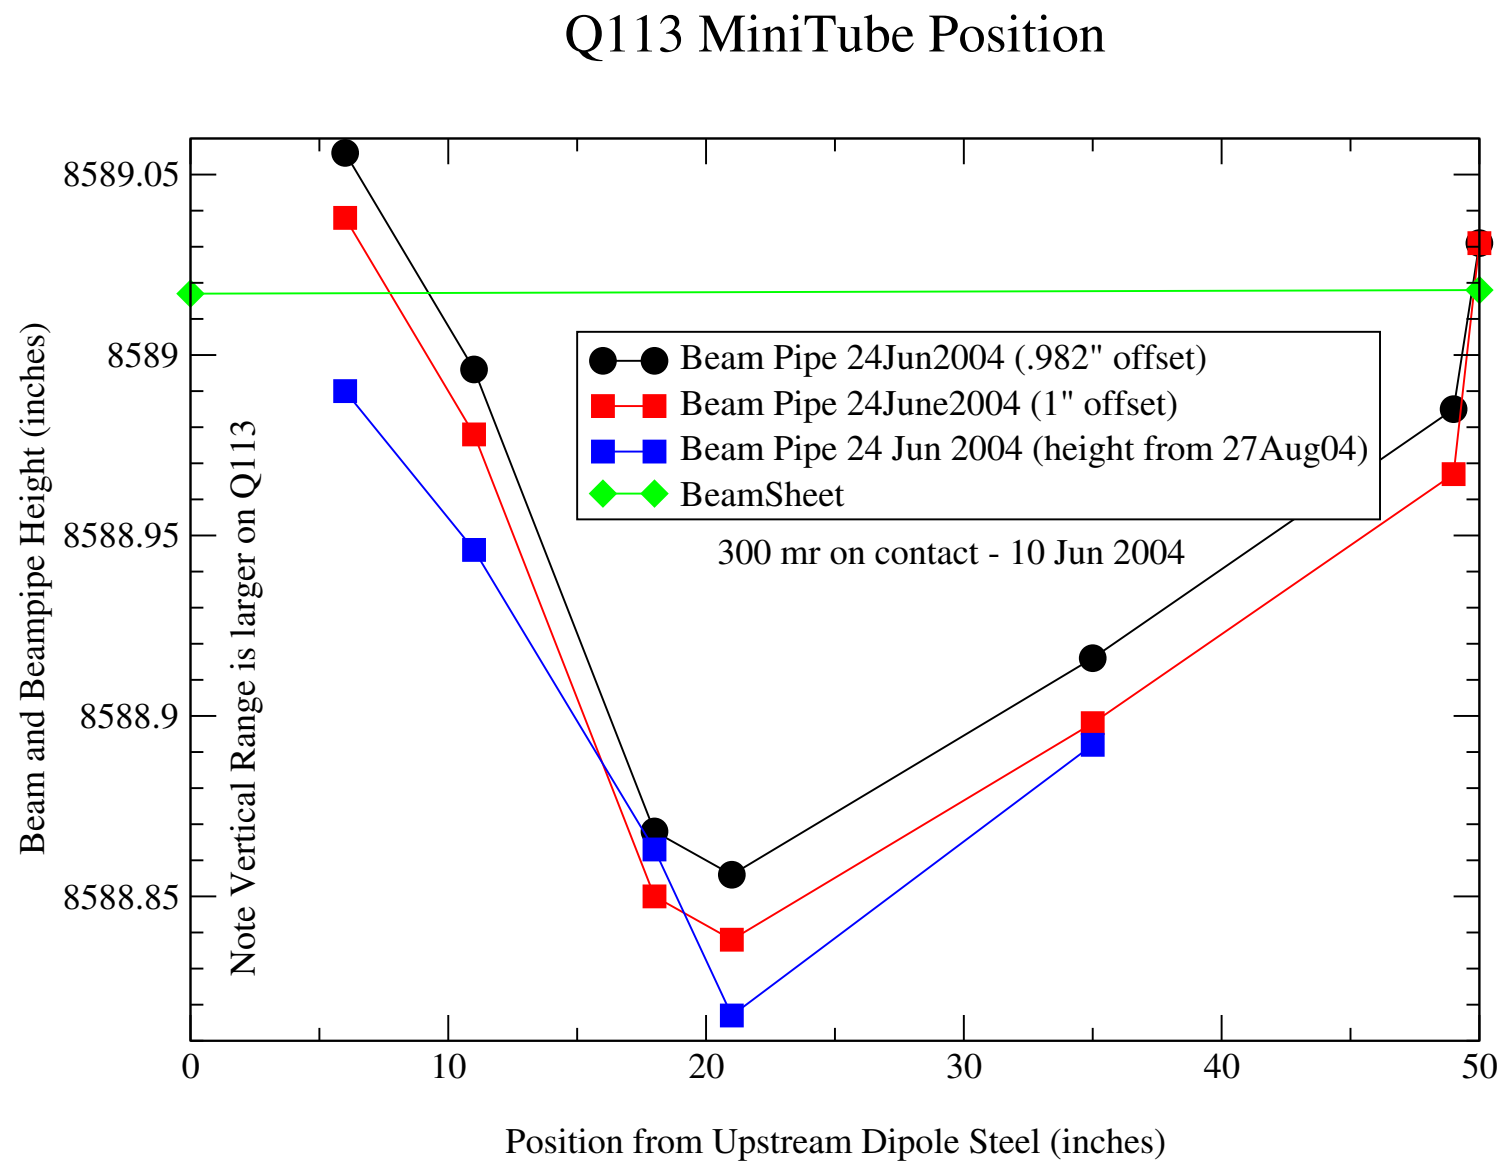
Figure 3: Upper Figure shows residual radiation pattern at Q113 as measured on contact with the top of the beam pipe. Lower Figure shows the elevations as surveyed at the top of the beam pipe but expressed as location of beam pipe center assuming a constant 1 inch (red squares), 0.982 inch offset (black circles) or as measured offset (blue squares) from center to top of beampipe.

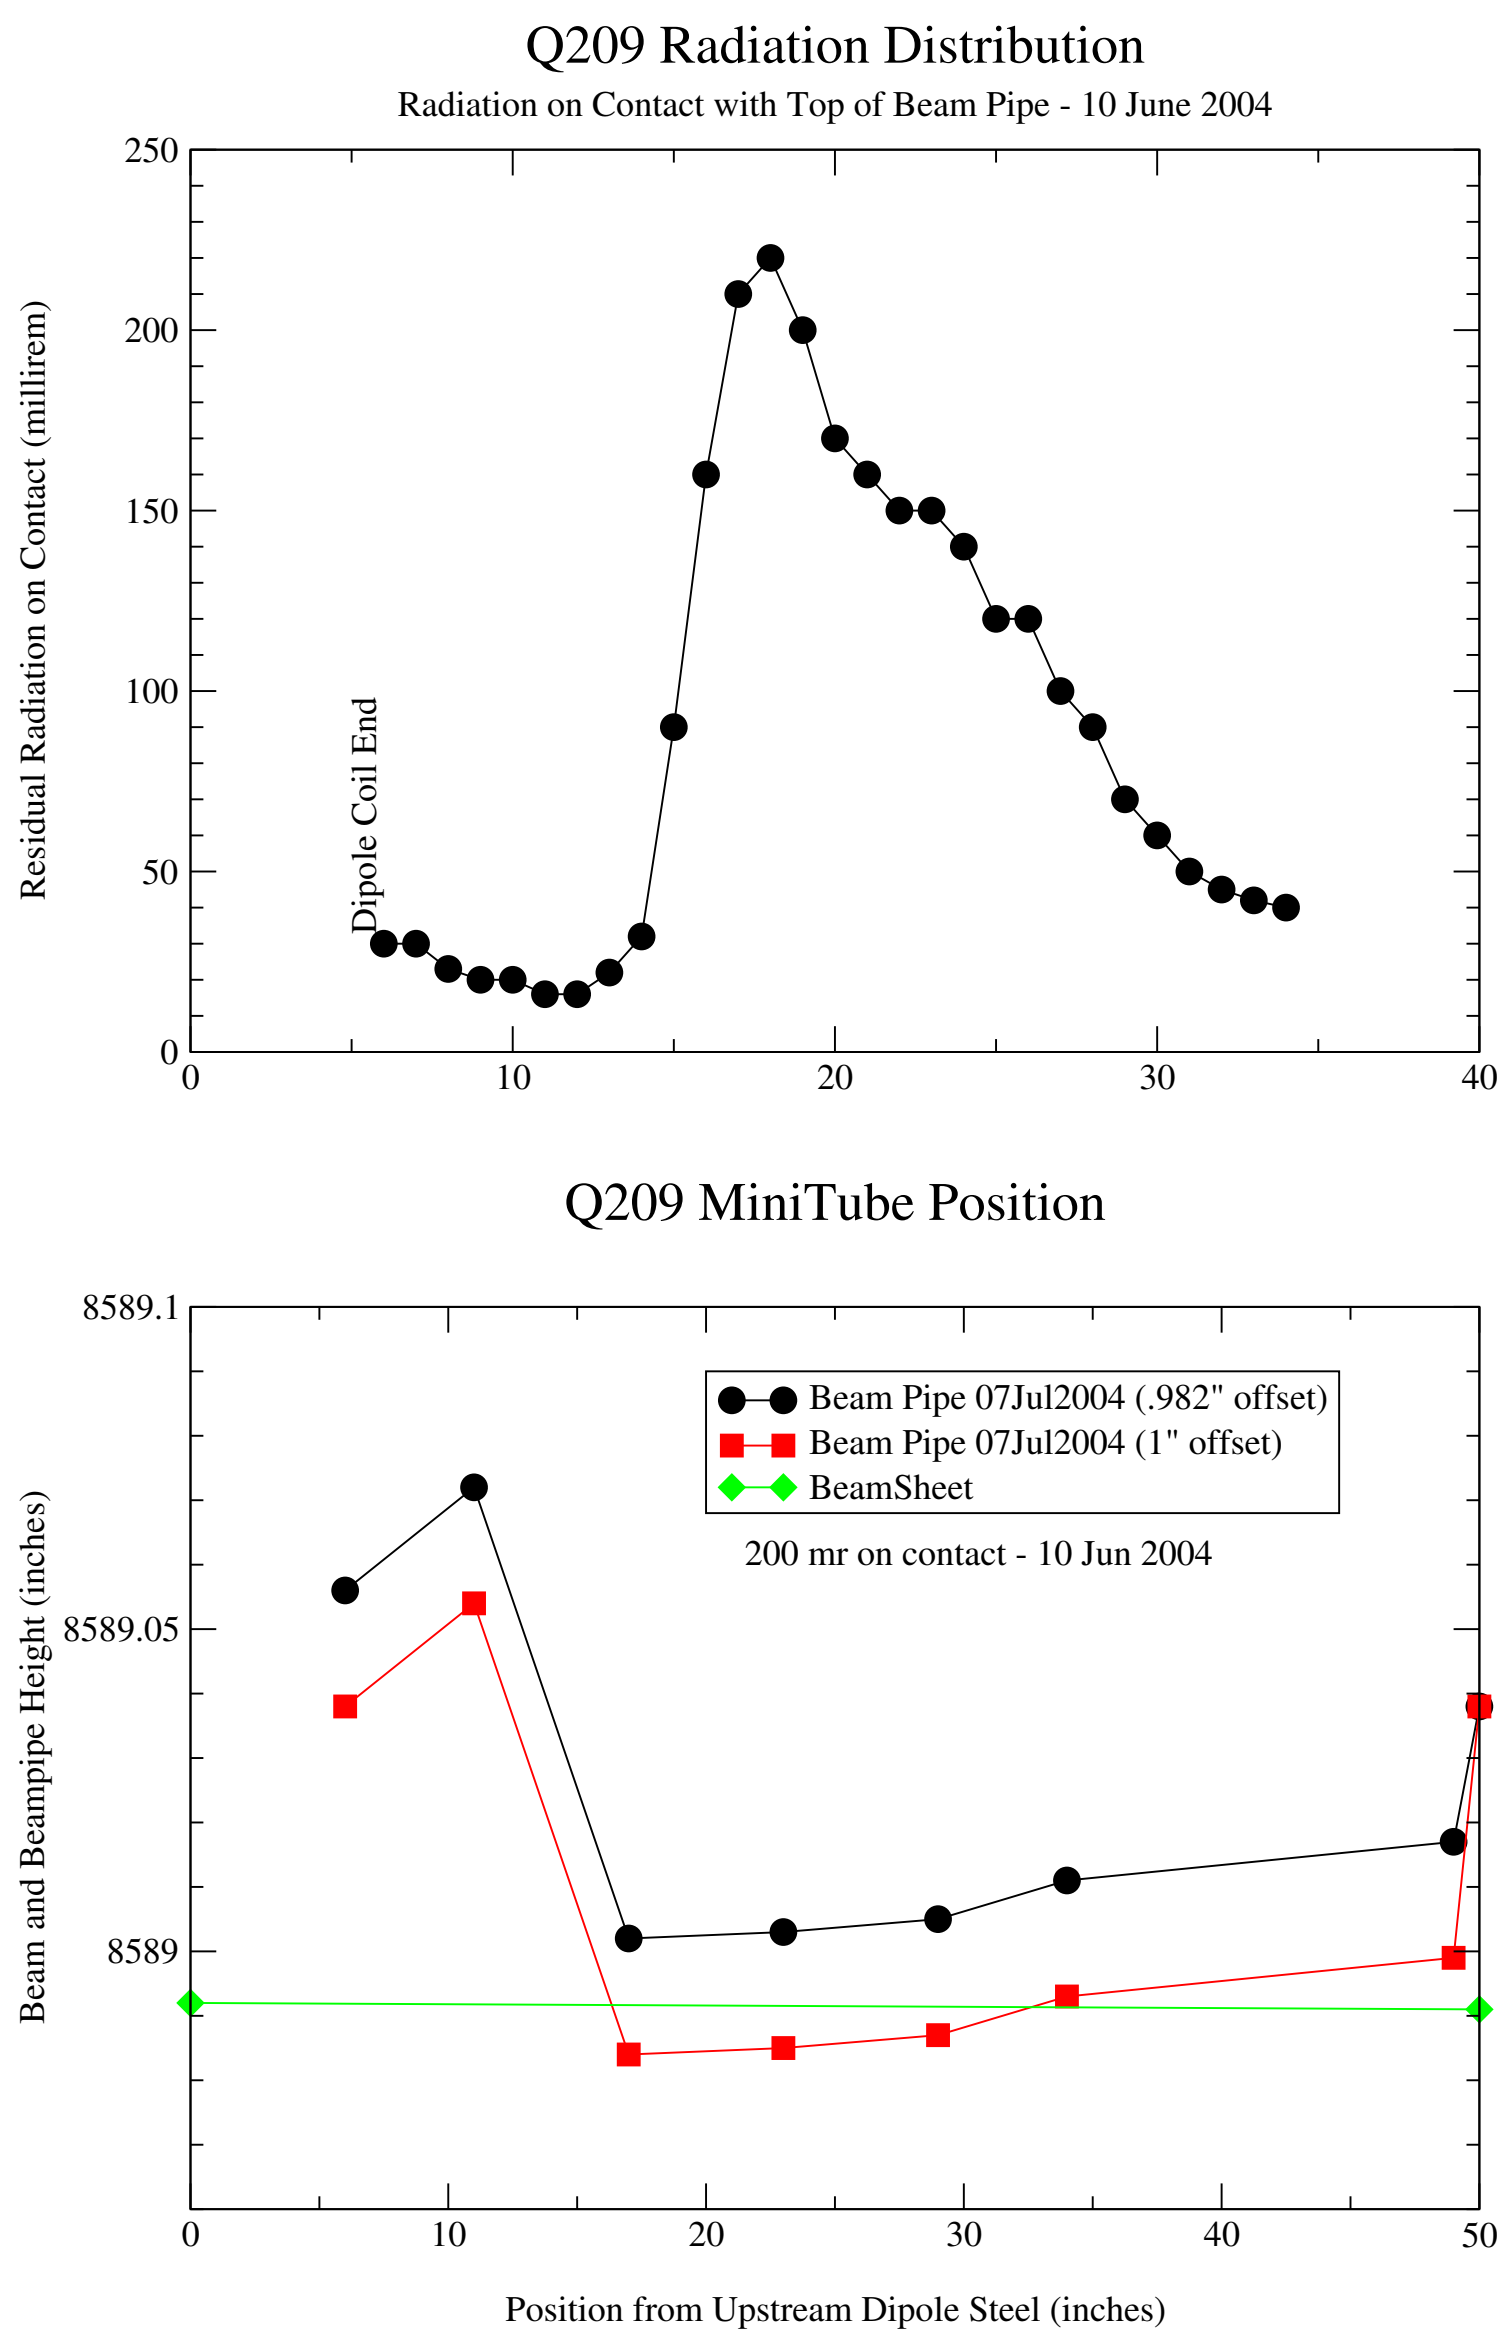
Figure 4: Upper Figure shows residual radiation pattern at Q209 as measured on contact with the top of the beam pipe. Lower Figure shows the elevations as surveyed at the top of the beam pipe but expressed as location of beam pipe center assuming a constant 1 inch or 0.982 inch offset from center to top of beampipe.

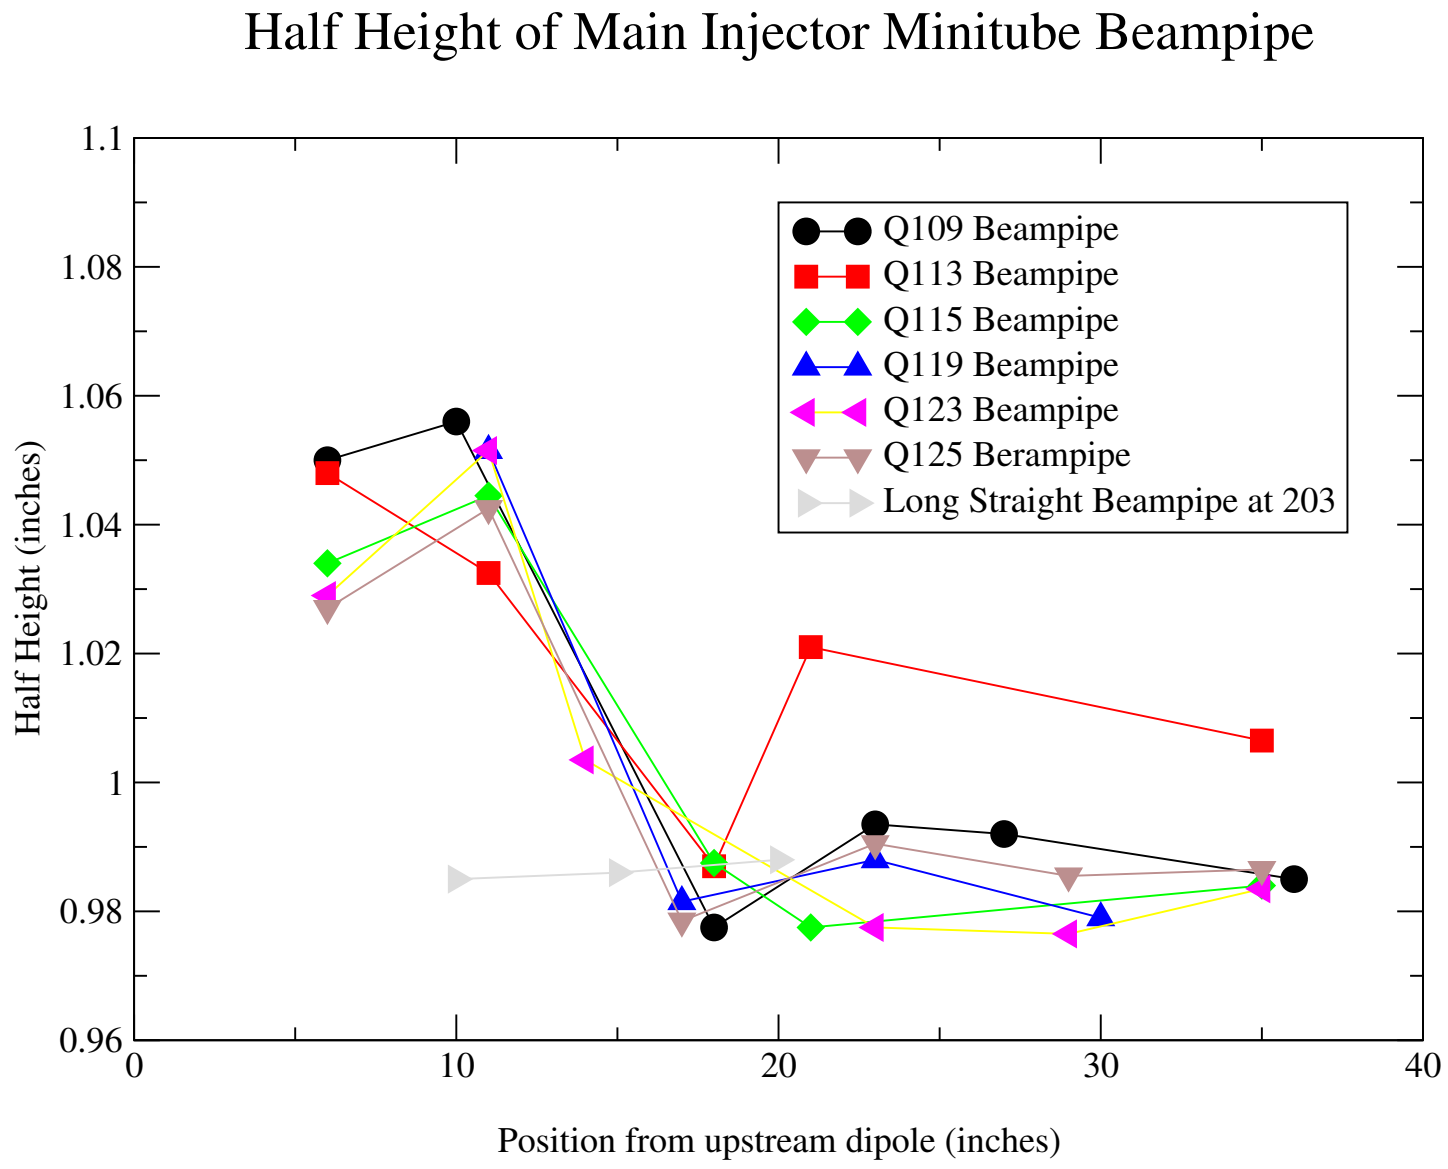
Figure 5: Minitube half heights (external) upstream of defocusing quadrupoles.

On August 27th, a digital caliper was employed to record the beam tube height at a number of the locations of interest[1]. In Figure 5 the data are plotted. We see that the initial assumption that the pipe would exhibit the two inch dipole gap was to simple. The beam pipe is more than 2.1″ high in the region where the ion pump is attached (a port pointing to the aisle side) and maintains this height as it attaches to the bellows assembly which also has beam pipe about 2.1″ high. Lengths of pipe unsupported and under vacuum are about 0.986″ high (see right-pointing triangles in figure). The transition from the bellows support size to the size unsupported under vacuum occurs in about 6 inches and changes the beam pipe half height by about 0.05 - 0.07″ (1.5 mm). Plots showing the survey analysis with the measured beam pipe height are shown in Appendix A.

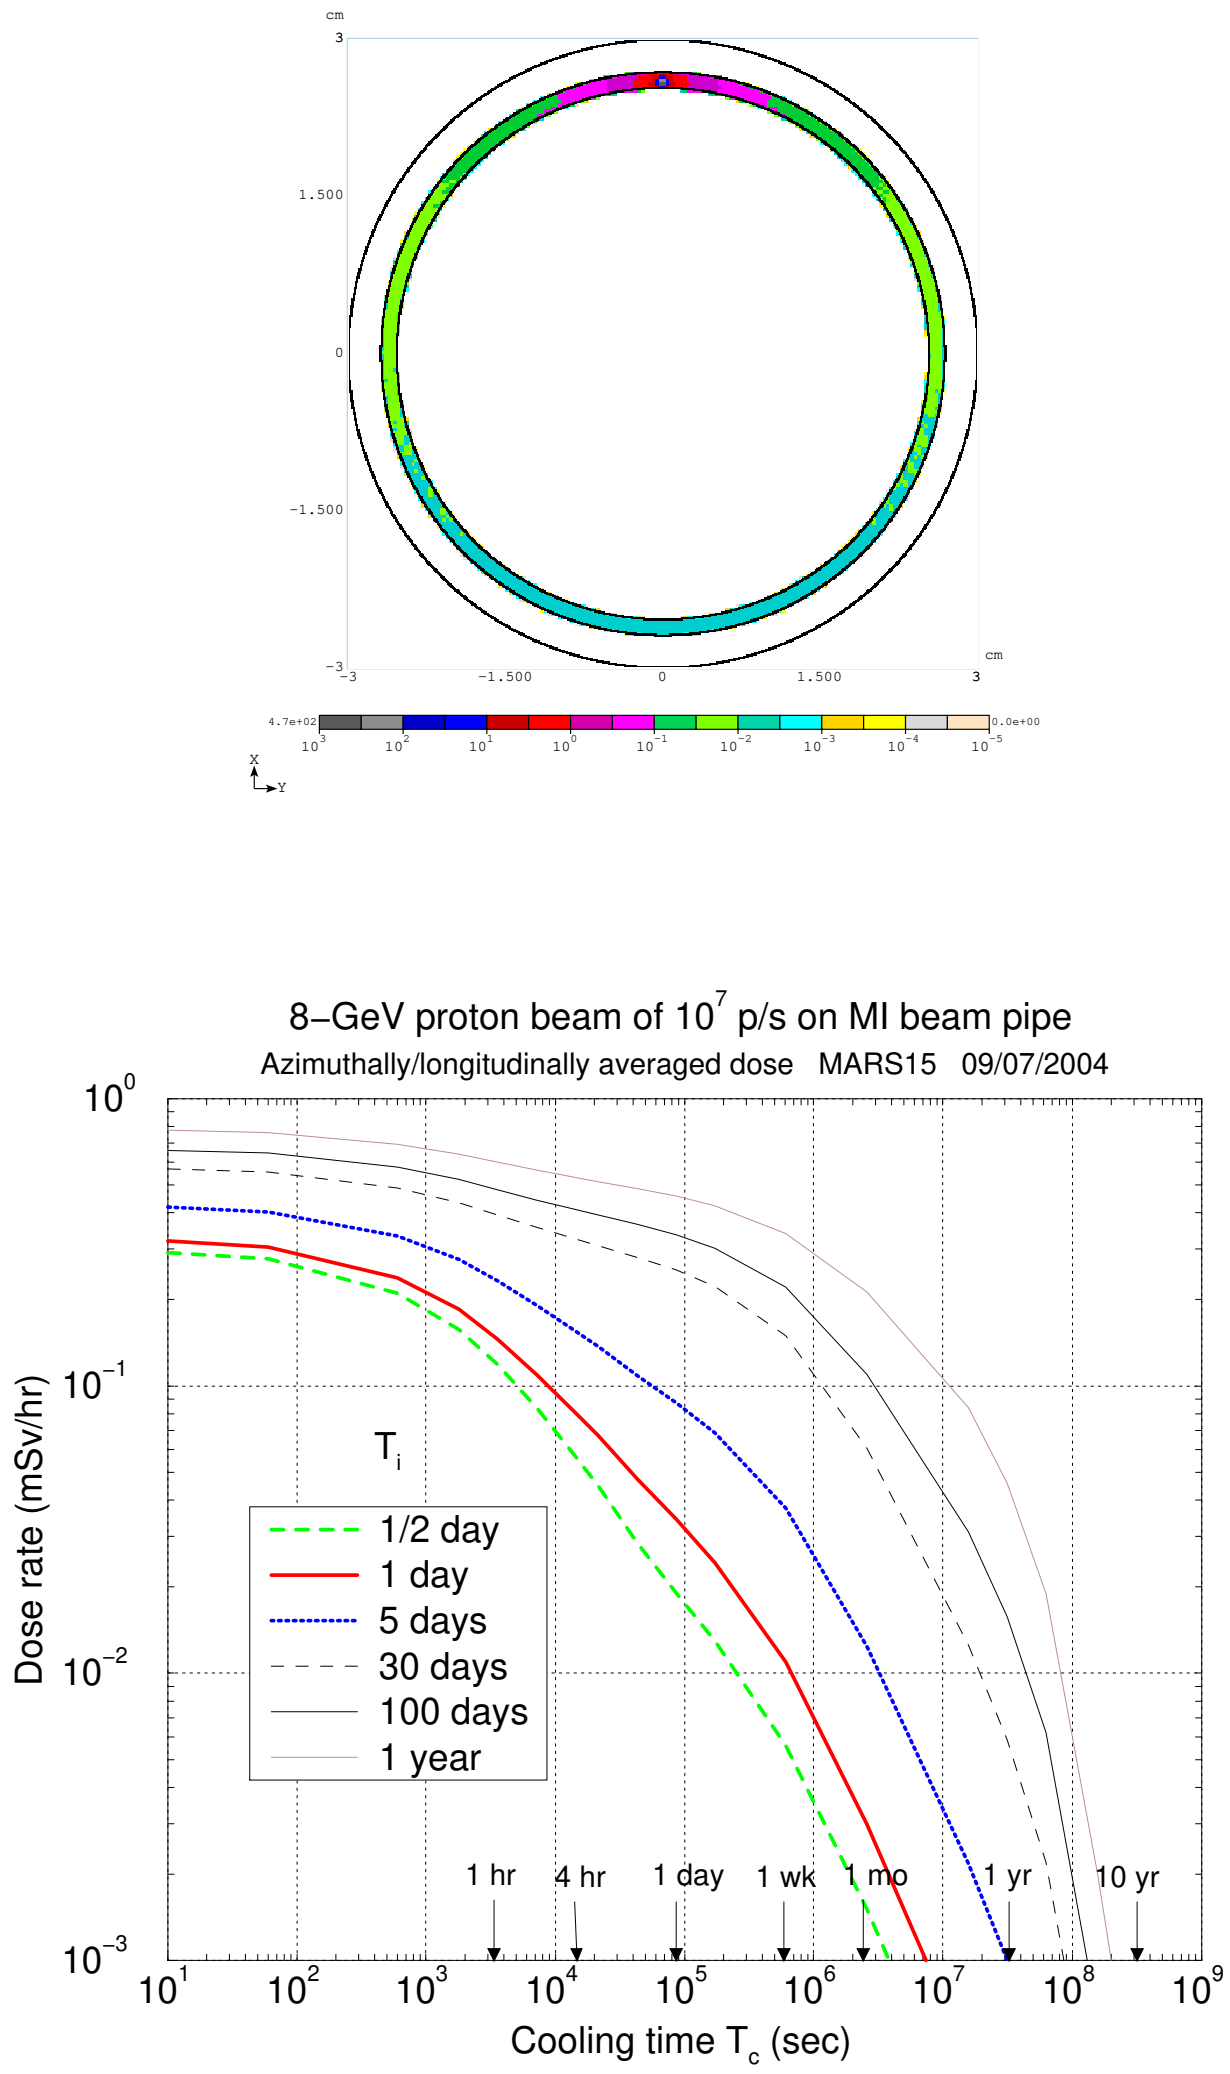
In order to find what level of localized beam loss would result in the observed residual radiation levels, a MARS calculation was performed[2] The beam pipe vertical profile reported above (approximate) was applied to a 2″ diameter, 1.5 mm thick circular pipe. An 8 GeV beam was assumed to be pointlike (zero transverse size), impinging on the top of the pipe where the pipe was lowest. A geometry correction (residual dose reduction) factor of 3 for a 1.5-mm thick SS pipe which was determined in a previous calculation was applied. Results are shown in Figure 6. The dose longitudinal profile shows the same features reported above. The calculation predicted that for a rate of 3×10^7 protons/sec for thirty days of exposure and 1 day of cooldown, the residual radiation would measure 300 millirem on contact.

Figure 6: Upper Figure shows residual radiation pattern from MARS calculation of beam interacting at top of a beam pipe. Lower Figure shows the variation of residual radiation for various exposure and cooldown times

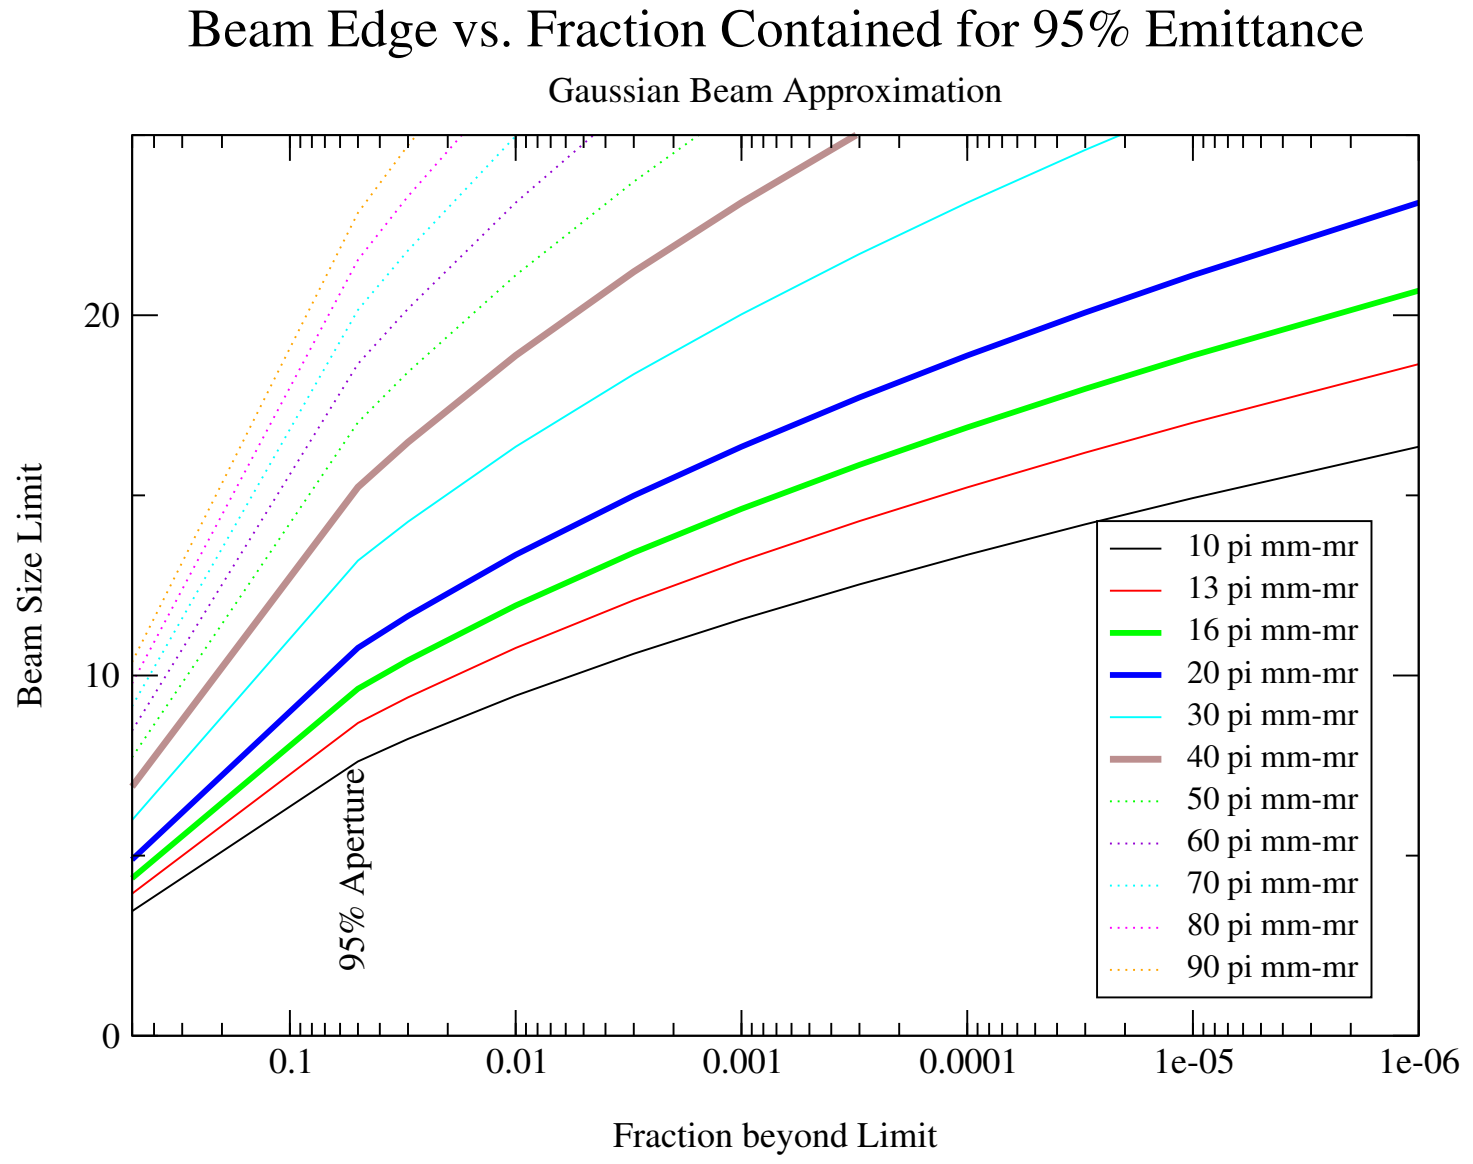
Figure 7: For specified emittance this plot shows the beam size (half height at $\beta_v = 55$ m) which will contain all but the fraction shown on the horizontal axis.

We noted above that the MARS calculation predicted an activation of 300 mr for a fractional loss rate of 3×10^{-5}. For a Gaussian beam distribution and a vertical emittance of 16π mm-mr (95%) we would expect 3×10^{-5} of the beam to be at vertical positions larger than 18 mm. The beam pipe under vacuum shows an external height of 24.8 mm at the observed minimum point (see Figure 5). Wall thickness of 1.5 mm leaves 23.3 mm. Typical beampipe misalignments of 1.5 to 2.5 mm leave us with clearance of 20.8 to 21.8 mm. We observe that a combination of closed orbit errors plus injection errors of 3 to 4 mm is sufficient to create the conditions described by the MARS calculation.

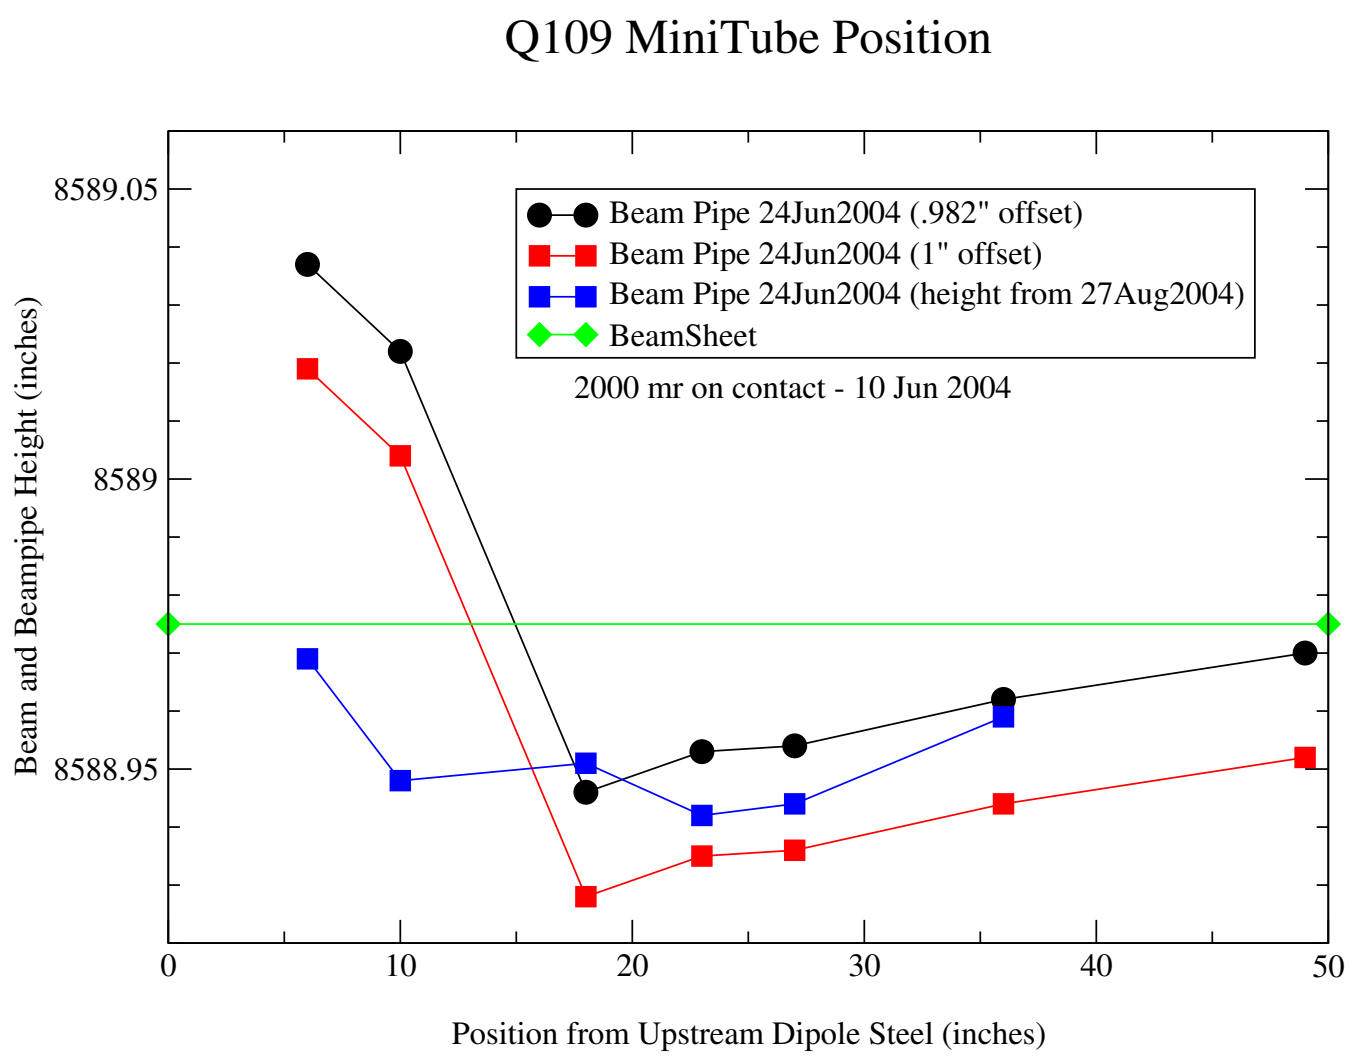
Figure 8: Alignment of Minitube upstream of Q109. Results assuming a constant pipe half height are shown in black and red. Results shown in blue use the measured beam tube half height. Expected Dipole and Quadrupole elevations from the Main Injector Beam Sheets are shown in green.

Alignment Crews checked the location of the beam pipe at the upstream minitube in eight Defocusing Quadrupole locations on June 24, 2004 and an additional six on July 7, 2004[4] The measurements were referenced to the tunnel wall elevation markers for the halfcell. Analysis used the current reference positions for these markers which were most recently updated based on surveys in 2001. The reference position for the dipoles and quadrupoles are documented in the Main Injector "BeamSheet" which shows the desired position for installation in the 1996 - 1998 era. In Figures 2 - 4 and 8 - 18 this alignment data is plotted. Locations with low residual radiation were included in the sample.

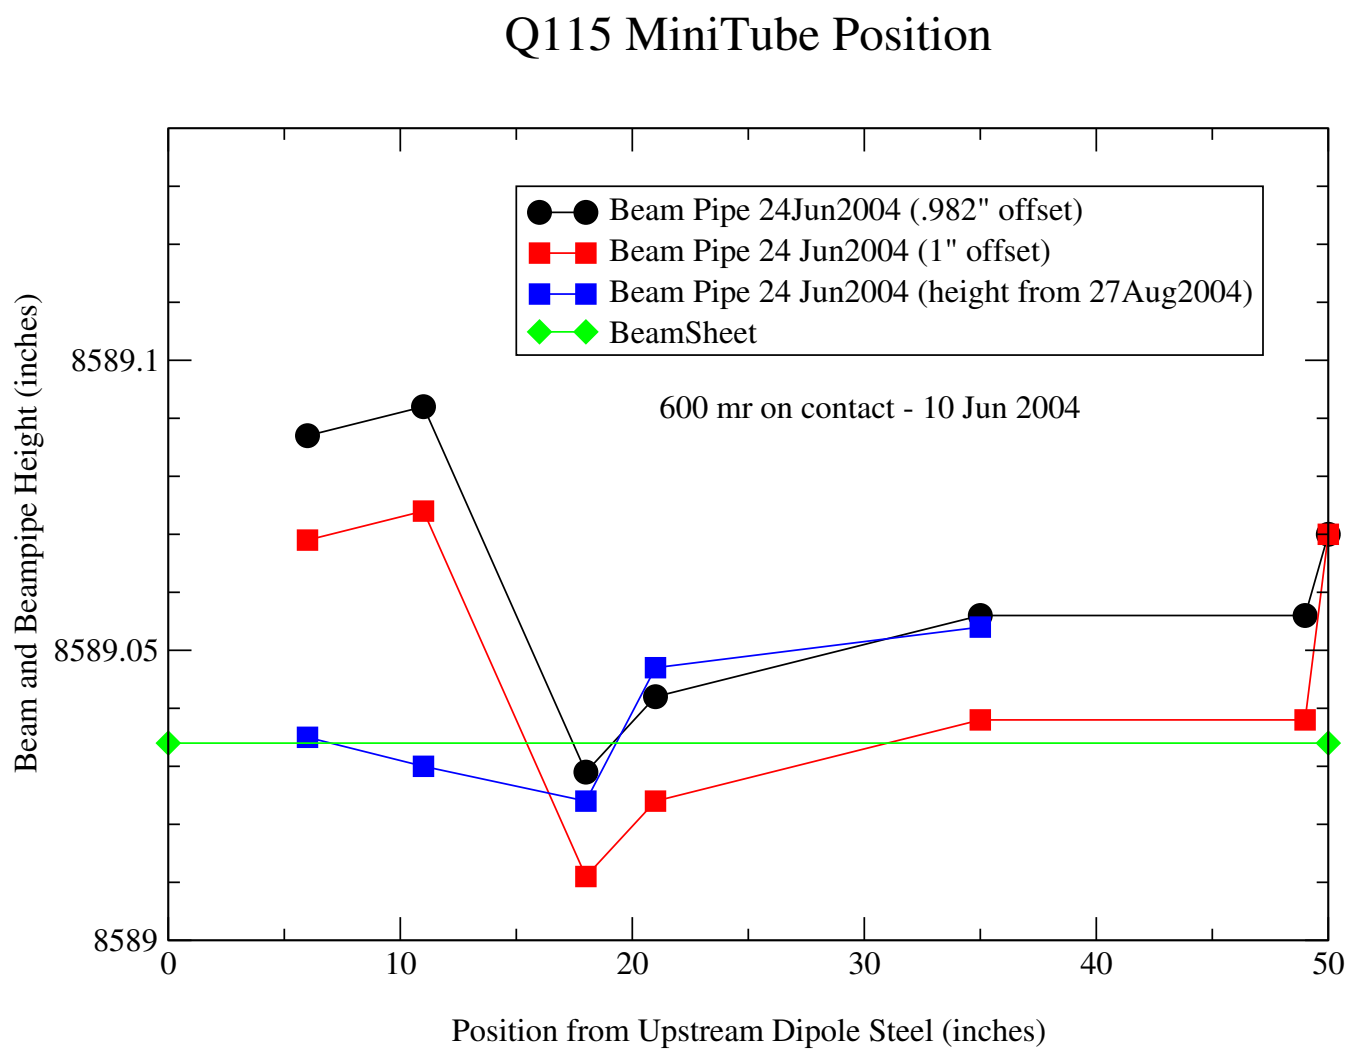
Figure 9: Alignment of Minitube upstream of Q115. Results assuming a constant pipe half height are shown in black and red. Results shown in blue use the measured beam tube half height. Expected Dipole and Quadrupole elevations from the Main Injector Beam Sheets are shown in green.
