Fermilab

Doc Number: Beams-doc-1382
Version: 2.0
Category: Note

Residual Radiation Hints for Aperture and Alignment Issues in the Main Injector

18 January 2005

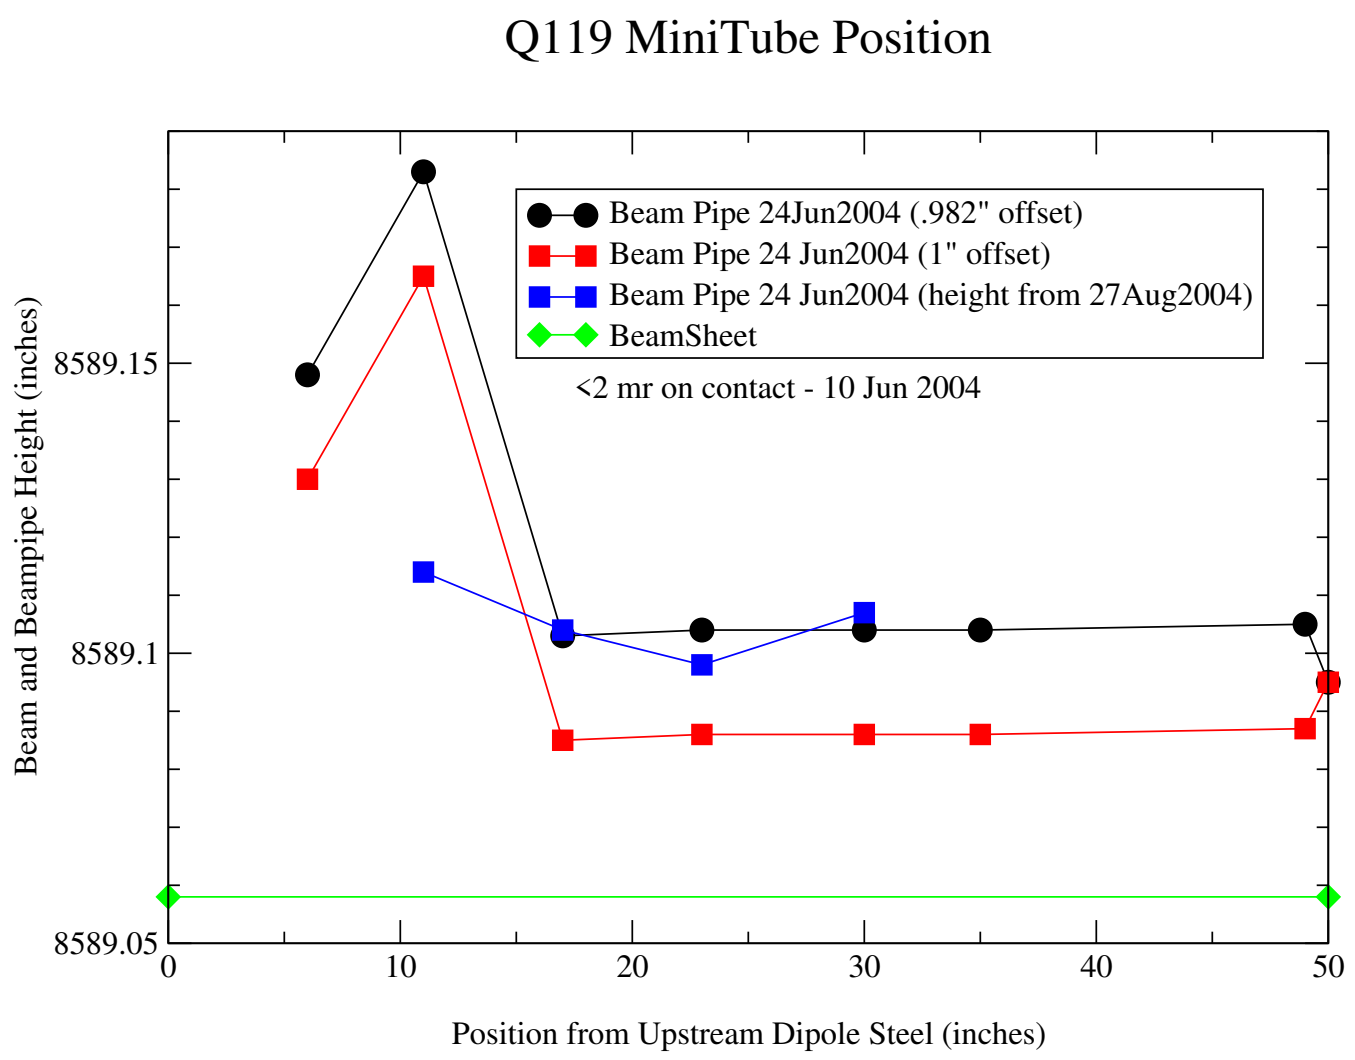
Figure 10: Alignment of Minitube upstream of Q119. Results assuming a constant pipe half height are shown in black and red. Results shown in blue use the measured beam tube half height. Expected Dipole and Quadrupole elevations from the Main Injector Beam Sheets are shown in green.

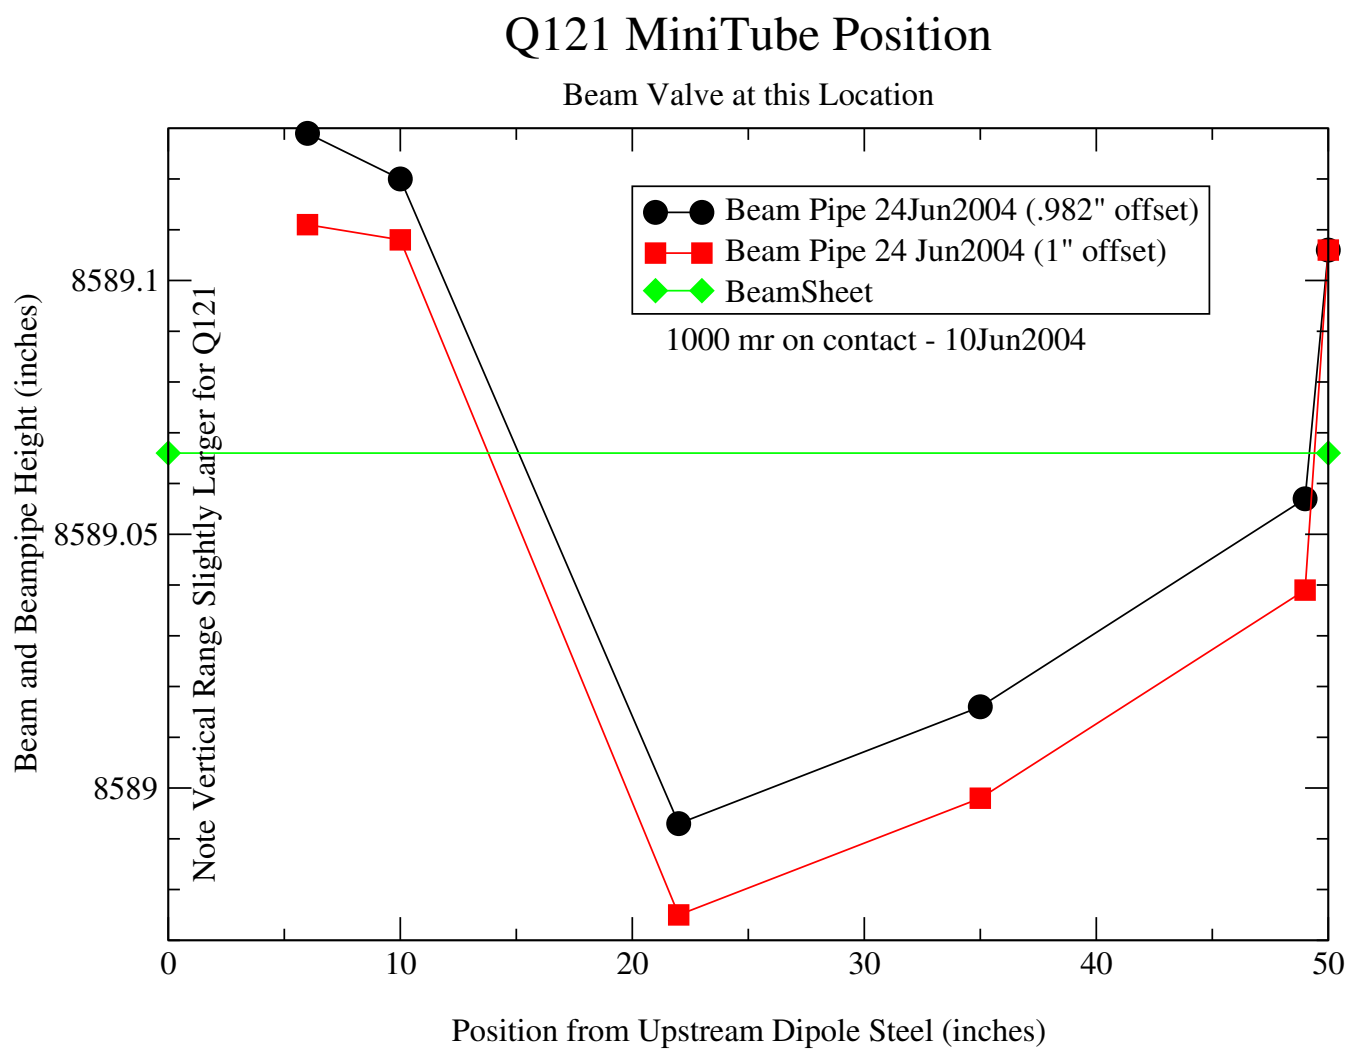
Figure 11: Alignment of Minitube upstream of Q121. Results assuming a constant pipe half height are shown in black and red. Expected Dipole and Quadrupole elevations from the Main Injector Beam Sheets are shown in green.

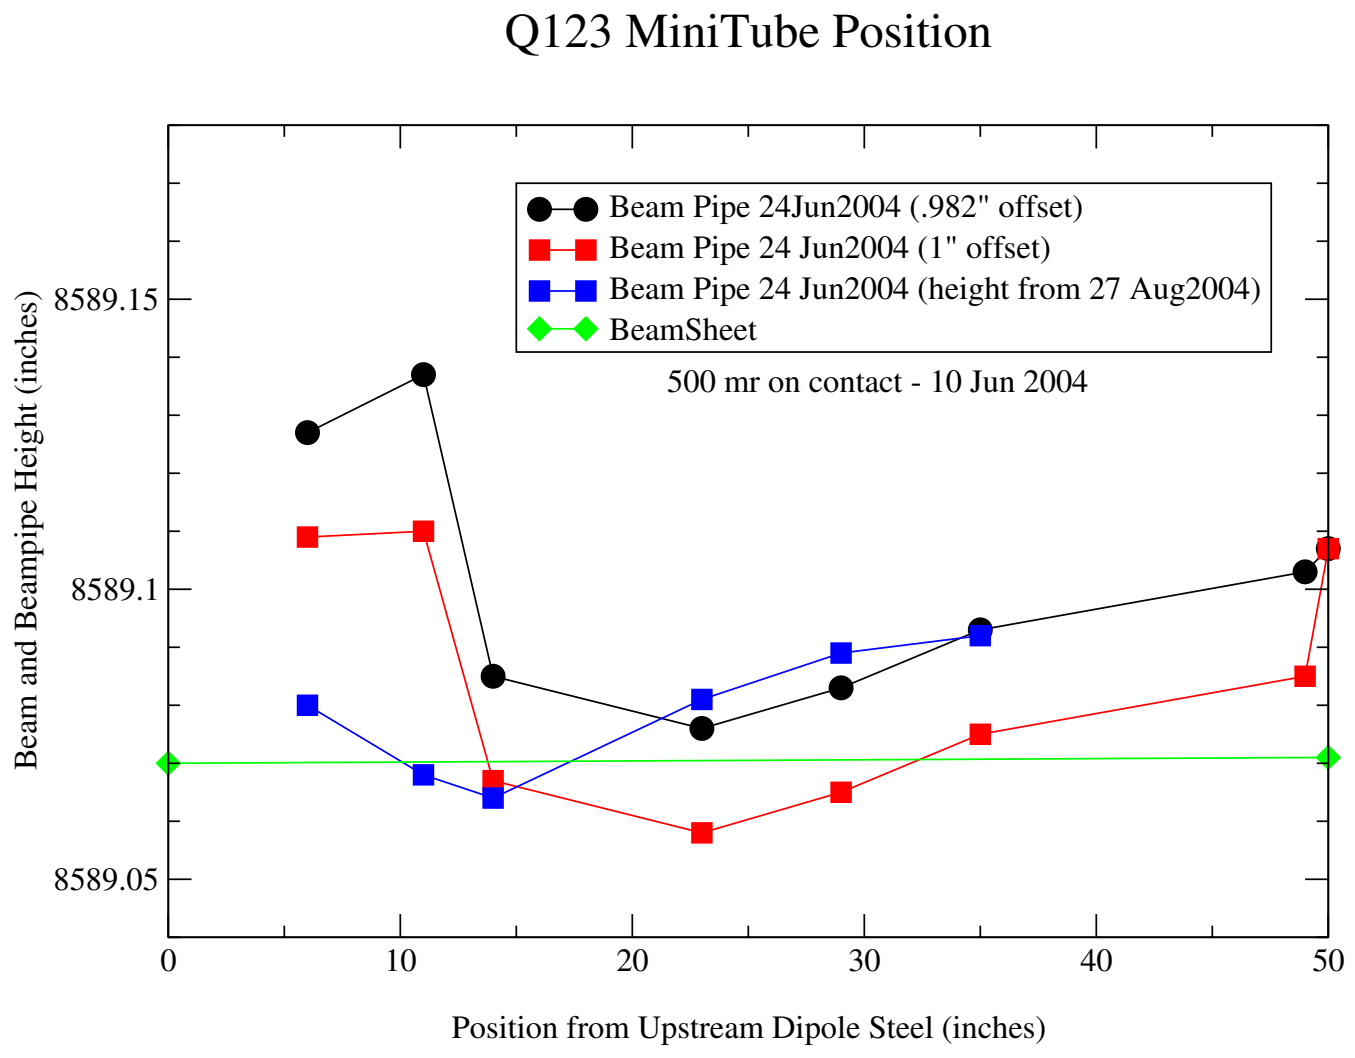
Figure 12: Alignment of Minitube upstream of Q123. Results assuming a constant pipe half height are shown in black and red. Results shown in blue use the measured beam tube half height. Expected Dipole and Quadrupole elevations from the Main Injector Beam Sheets are shown in green.

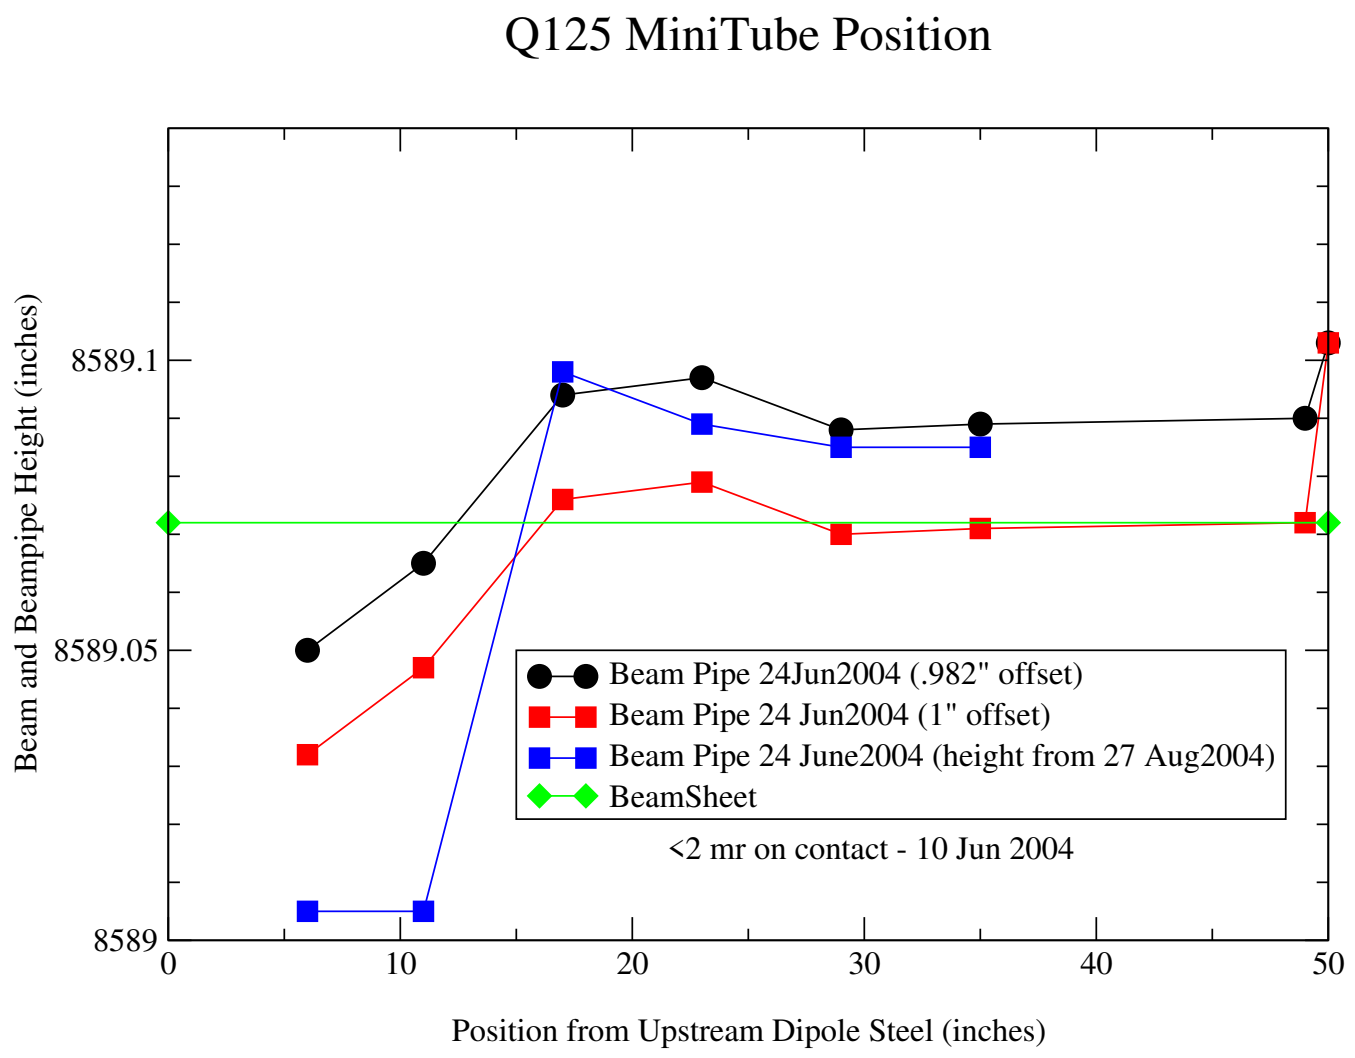
Figure 13: Alignment of Minitube upstream of Q125. Results assuming a constant pipe half height are shown in black and red. Results shown in blue use the measured beam tube half height. Expected Dipole and Quadrupole elevations from the Main Injector Beam Sheets are shown in green.

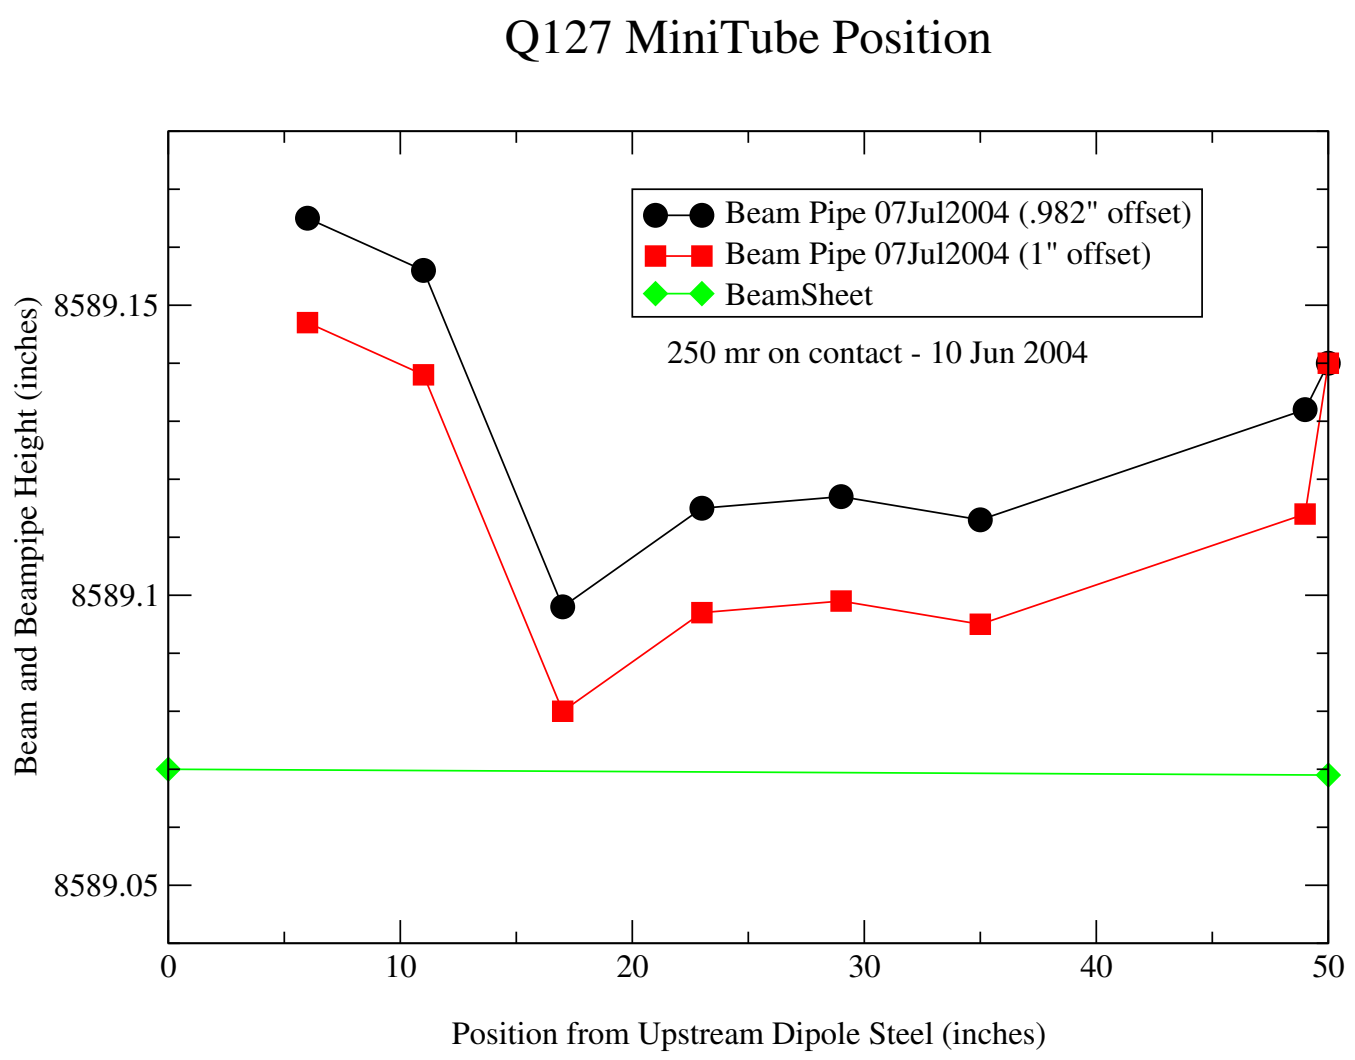
Figure 14: Alignment of Minitube upstream of Q127. Results assuming a constant pipe half height are shown in black and red. Expected Dipole and Quadrupole elevations from the Main Injector Beam Sheets are shown in green.

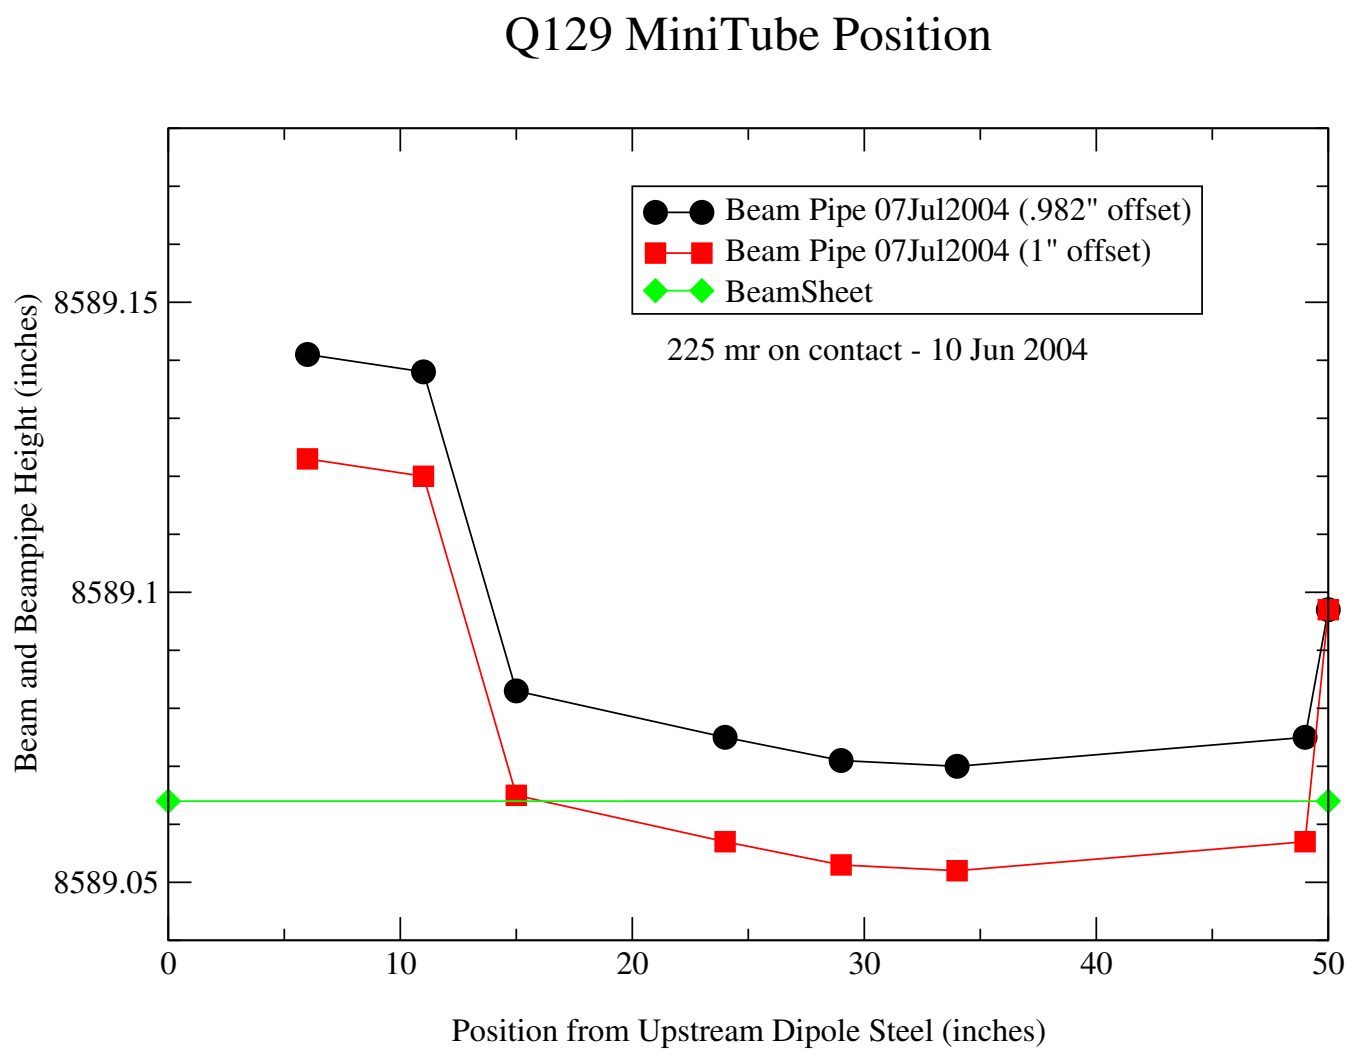
Figure 15: Alignment of Minitube upstream of Q129. Results assuming a constant pipe half height are shown in black and red. Expected Dipole and Quadrupole elevations from the Main Injector Beam Sheets are shown in green.

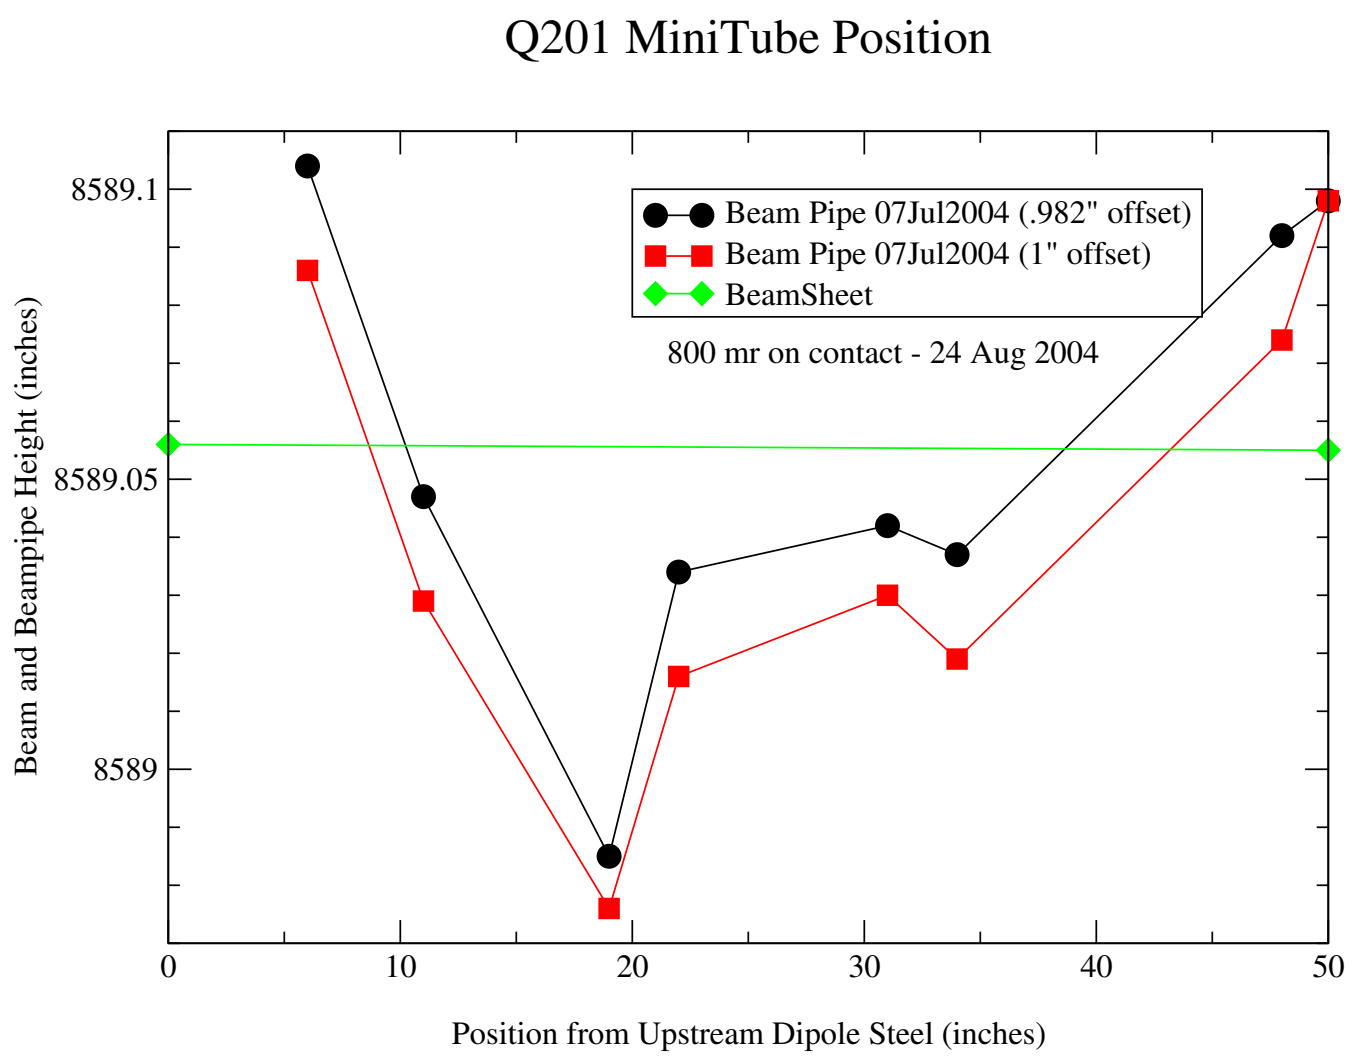
Figure 16: Alignment of Minitube upstream of Q201. Results assuming a constant pipe half height are shown in black and red. Expected Dipole and Quadrupole elevations from the Main Injector Beam Sheets are shown in green.

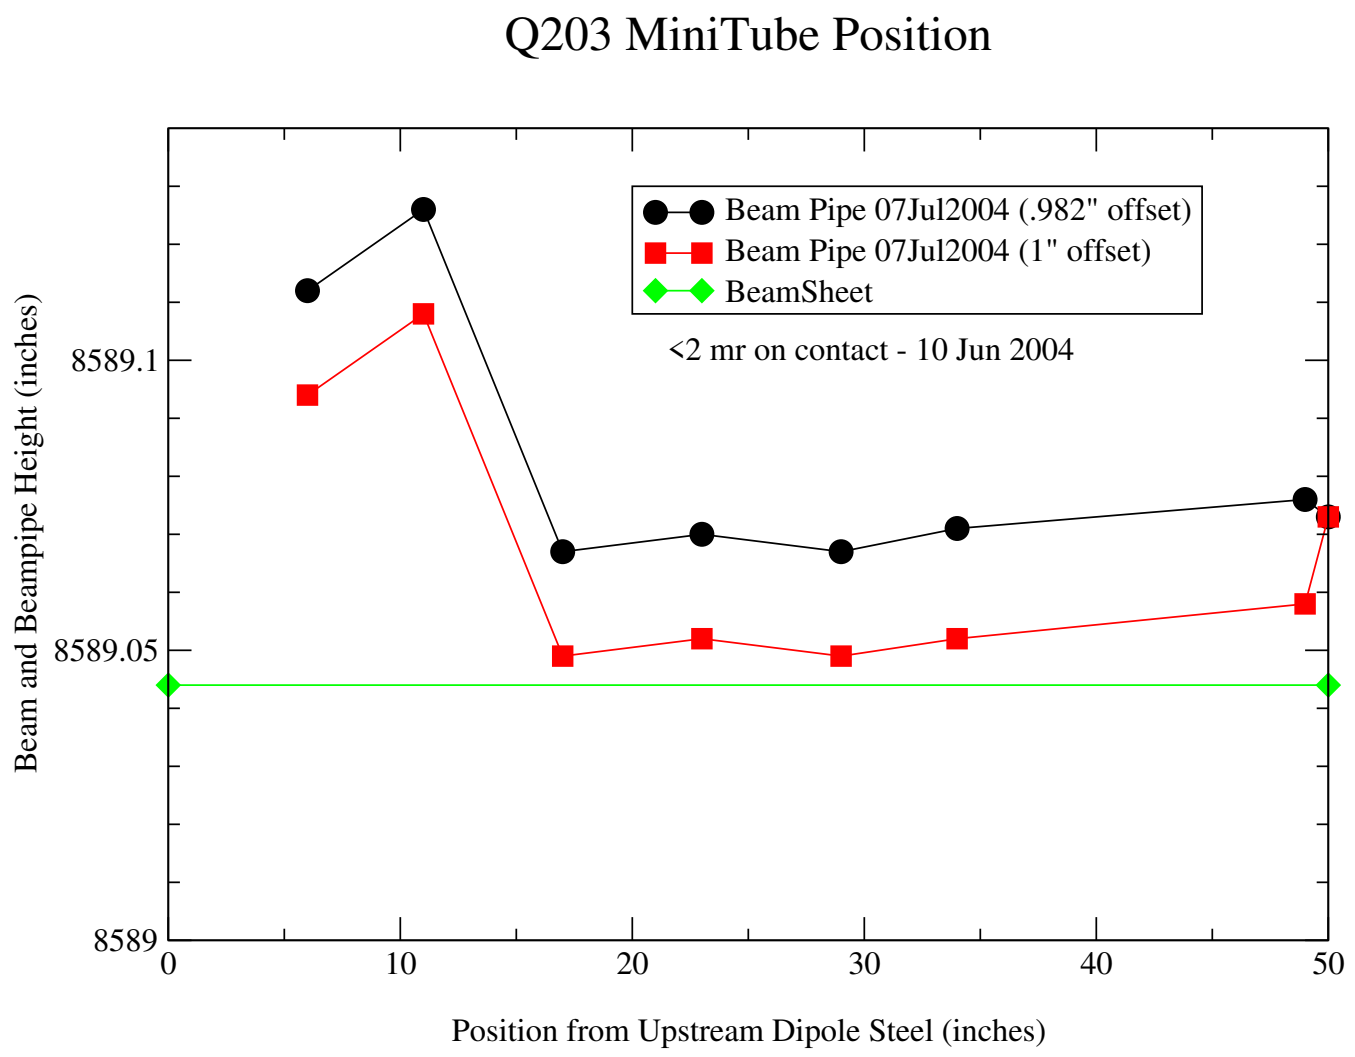
Figure 17: Alignment of Minitube upstream of Q203. Results assuming a constant pipe half height are shown in black and red. Expected Dipole and Quadrupole elevations from the Main Injector Beam Sheets are shown in green.

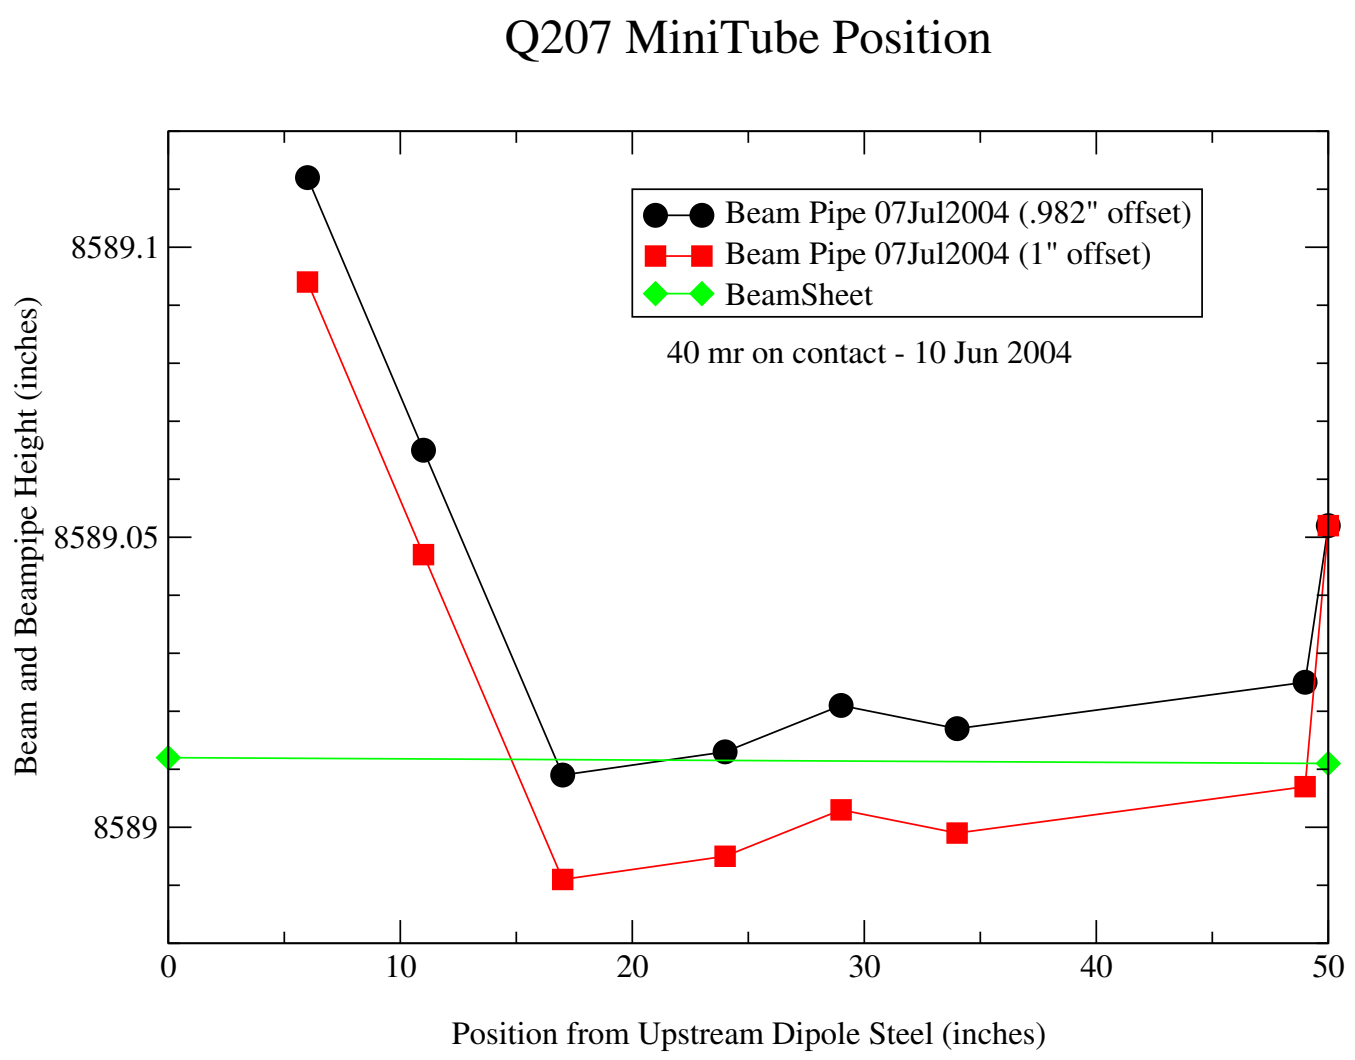
Figure 18: Alignment of Minitube upstream of Q207. Results assuming a constant pipe half height are shown in black and red. Expected Dipole and Quadrupole elevations from the Main Injector Beam Sheets are shown in green.

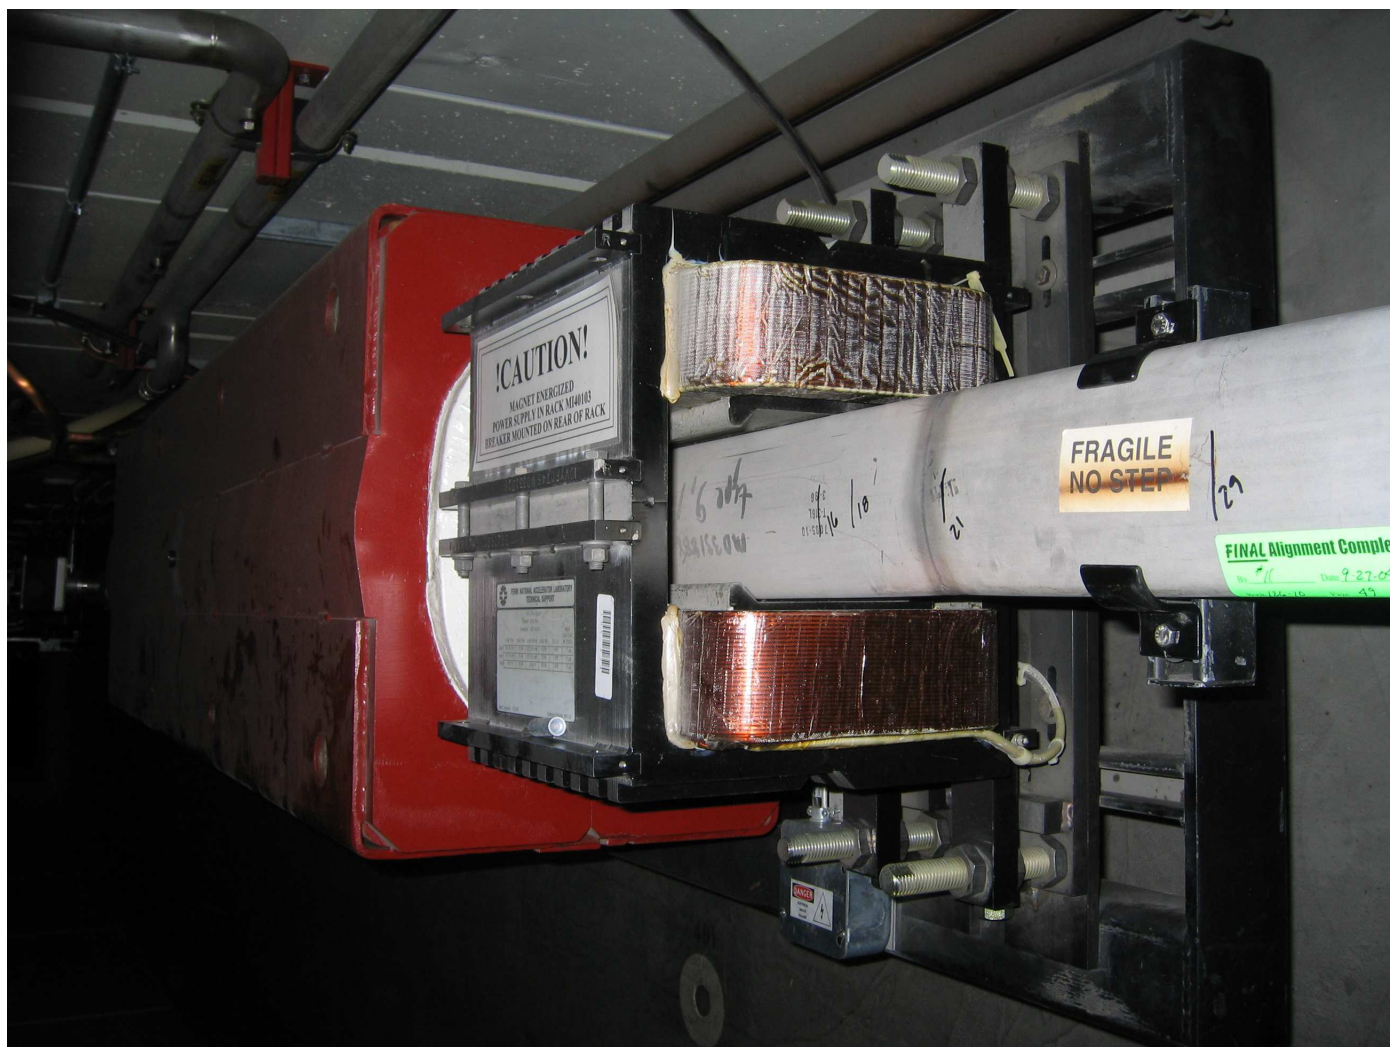
Figure 22: Image of upstream minitube at Q401 showing radiation damage to tape.

and these tags provide a visual representation of the beam loss. The are usually discolored where the radiation is high, not discolored where it is low and the image reveals a band indicating the limited horizontal extent of the beam. At Q321, the offset due to the requirement that the beam reach the off-centered field free region of the Lambertson is quite apparent (in the tunnel if not in the picture). Figures 19,20, 21 and 22 were photos taken in Summer 2004.
