CM1 Thermal Cycle

Fermilab

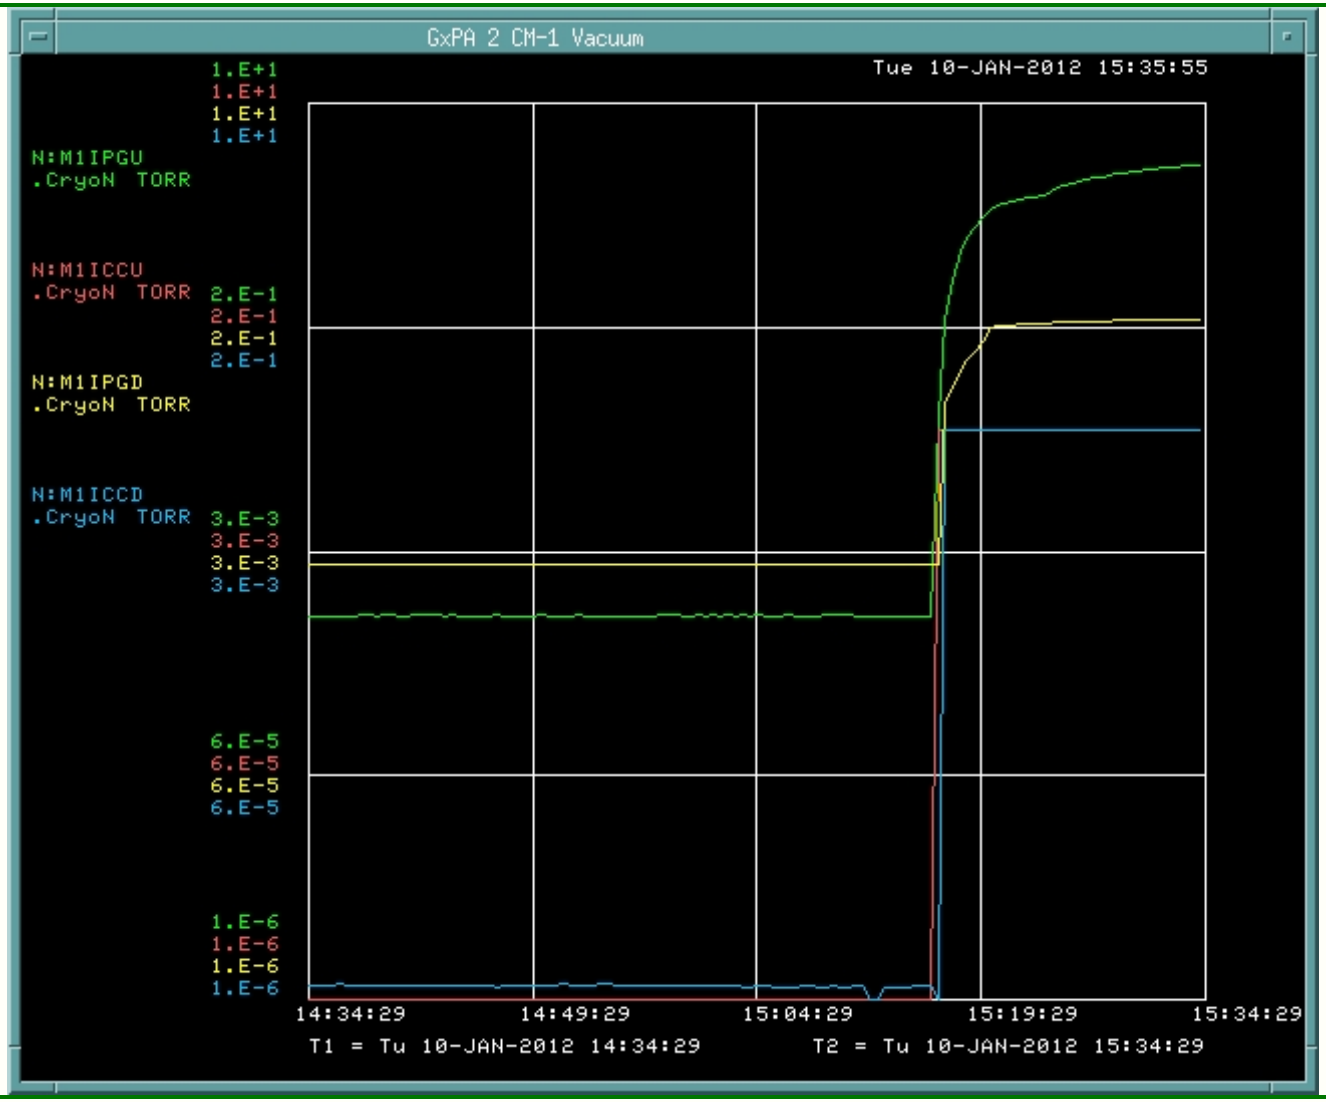
Plot of Vacuum Event

- **CM1 Warmup**
  - 1/4/12 (Wed.) to 1/6/12 (Fri.) (~50 hours)
  - Verified turbo interlock system works
- **CM1 Cooldown**
  - Began 1/9/12 (Monday)
  - At 15:16 on 1/10/12 a vacuum burst occurred while Nitrogen Shields were at ~ 120K and the insulating vacuum suddenly declined from 1E-6 to 3 Torr.
  - Safety interlock system closed gate valves, protecting turbo pumps and RGA.

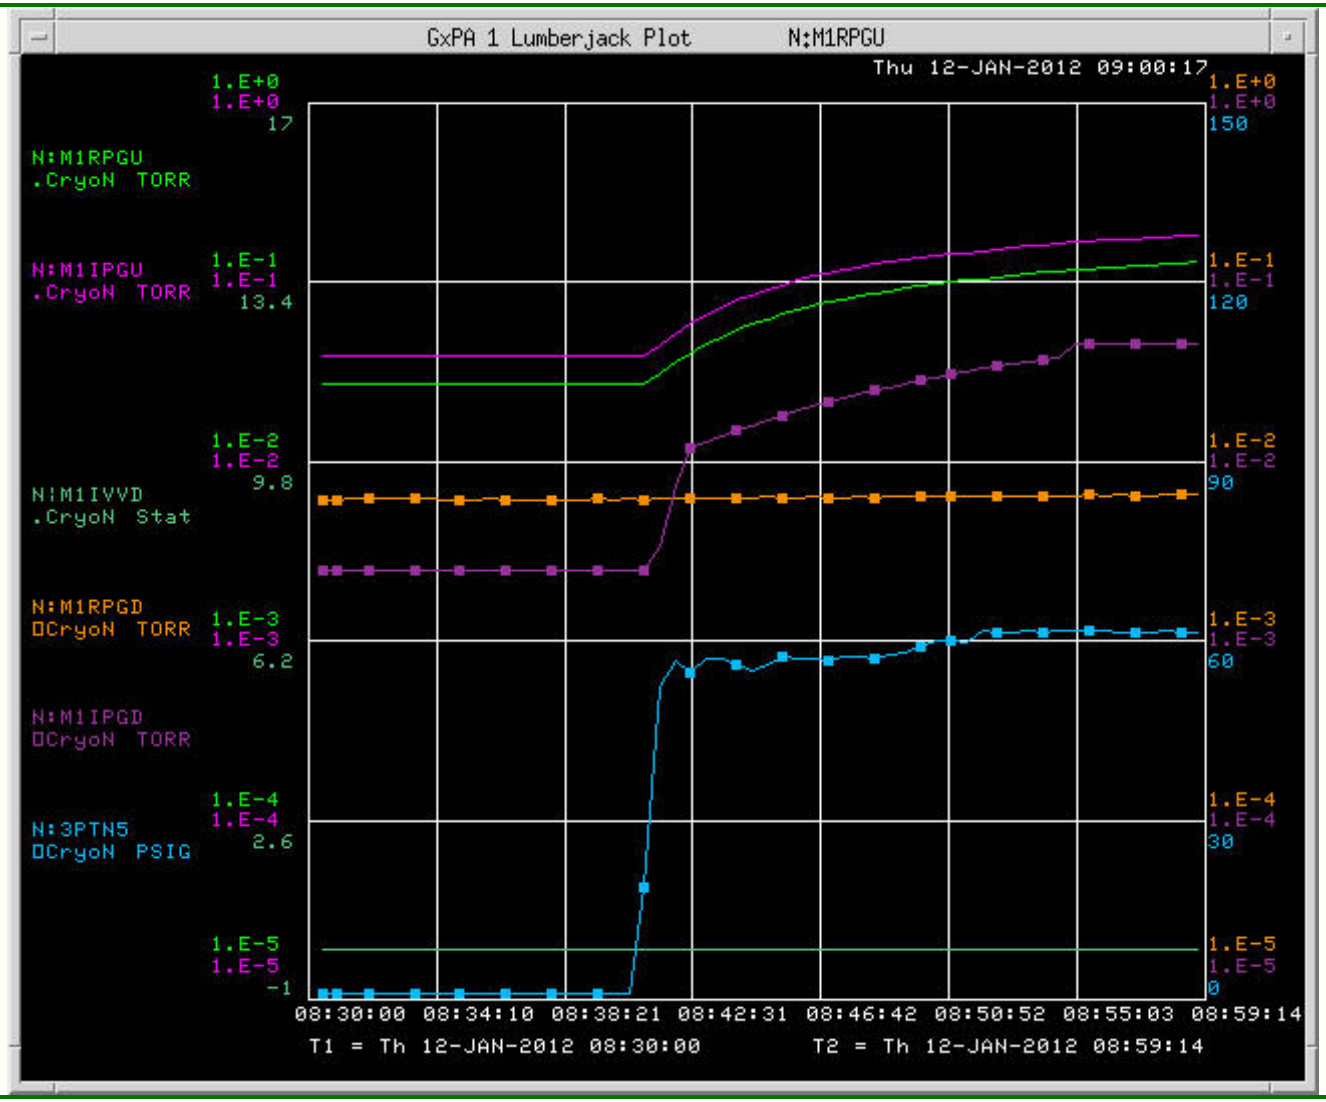
Pressurizing Nitrogen

- **Investigation**
  - 1/10 evening shift and 1/11 day shift conducted studies that determined it was a leak from Nitrogen circuit to insulating vacuum
    - Installed roughing pumps on insulating vac. and connect RGA via bypass line to insulating vacuum space.
    - Used RGA and vacuum gauges to test each of the circuits (2 He. And 1 Nitrogen)
- **Results**
  - Both Helium circuits showed no response (Good)
  - Nitrogen circuit showed a direct vacuum and RGA response
  - Vacuum was worse at upstream end of CM1

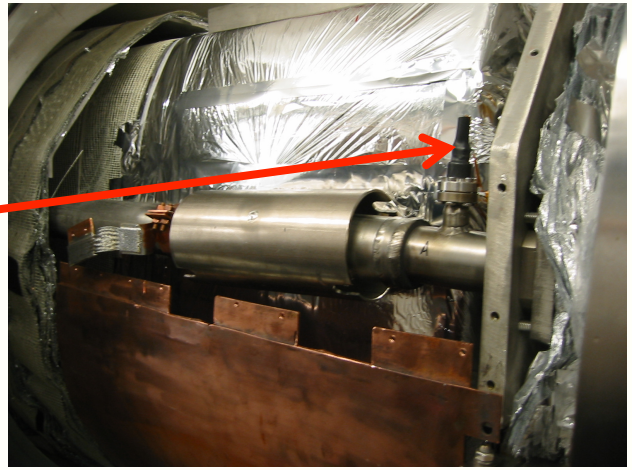
- **Large bellows on upstream end was opened and insulation and shields were removed.**
  - **Initial visual inspection did not show any obvious problem.**
  - **Leak check of Nitrogen circuit by pressurizing with Nitrogen and using "Snoop" showed a leak at the supply side temperature sensor feedthrough.**
- **Upstream Supply and Return temp. probes were removed and flanges blanked. New surface mounted sensors were installed at each location.**
- **Helium leak check was conducted to verify there were no leaks in Nitrogen circuit, and feedthru flanges were thermal shocked using liquid Nitrogen to verify they are leak tight.**

Leak indicated by bubbling “Snoop”
