CM1 Thermal Cycle

Repair – Update (1/27/12)

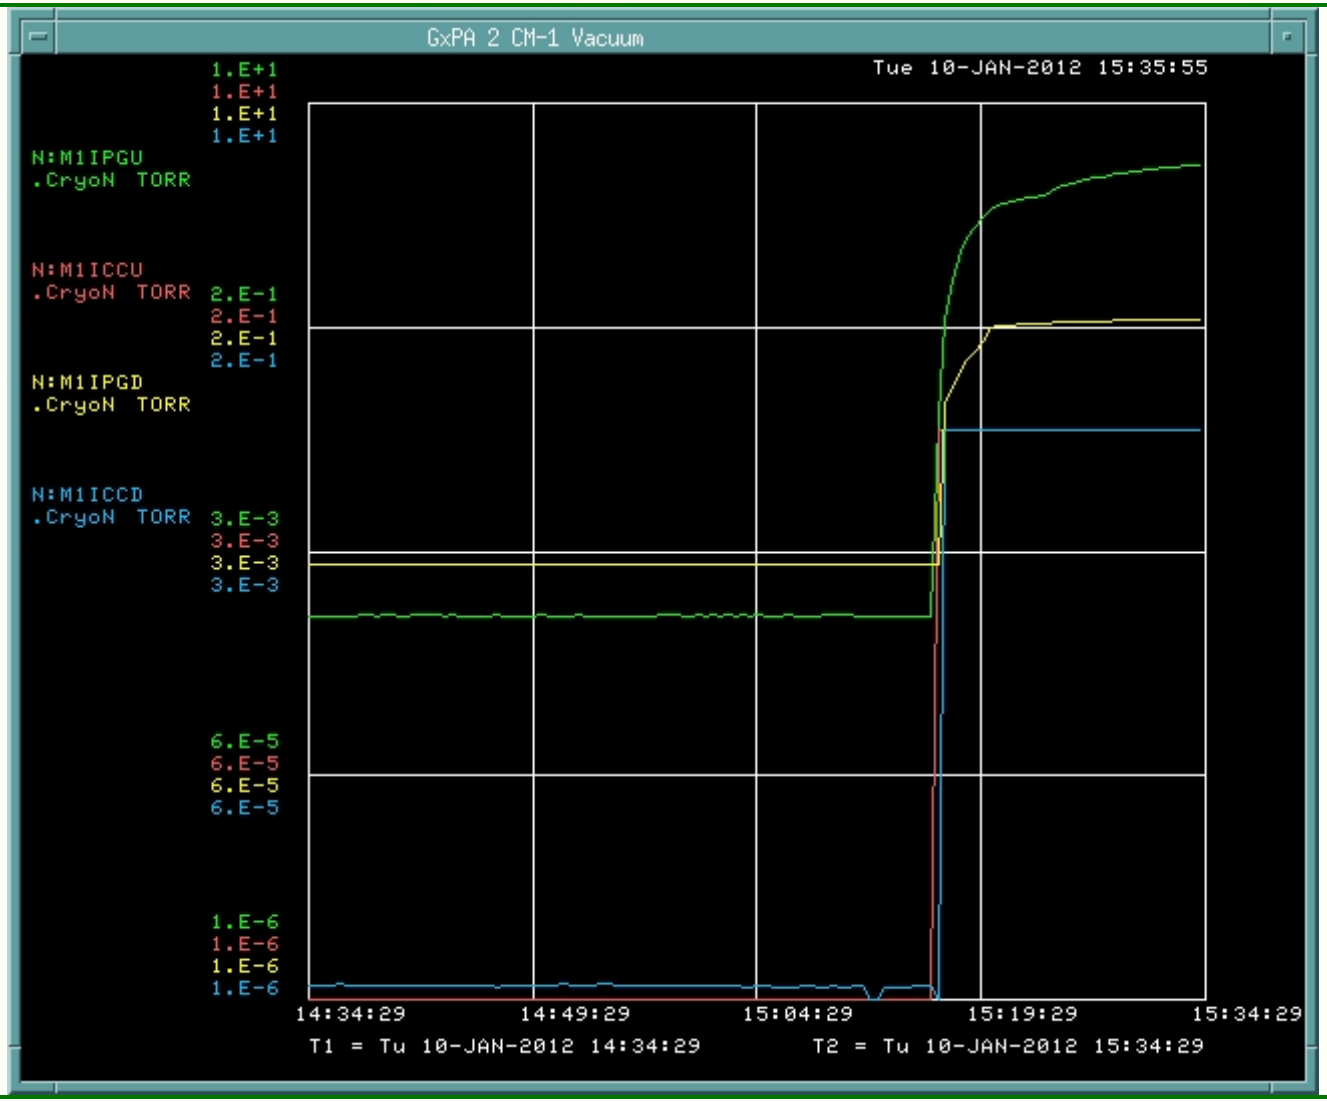
Plot of Vacuum Event

- **CM1 Cooldown**
  - Began 1/9/12 (Monday)
  - At 15:16 on 1/10/12 a vacuum burst occurred while Nitrogen Shields were at ~ 120K and the insulating vacuum suddenly declined from 1E-6 to 3 Torr.
  - Safety interlock system closed gate valves, protecting turbo pumps and RGA.

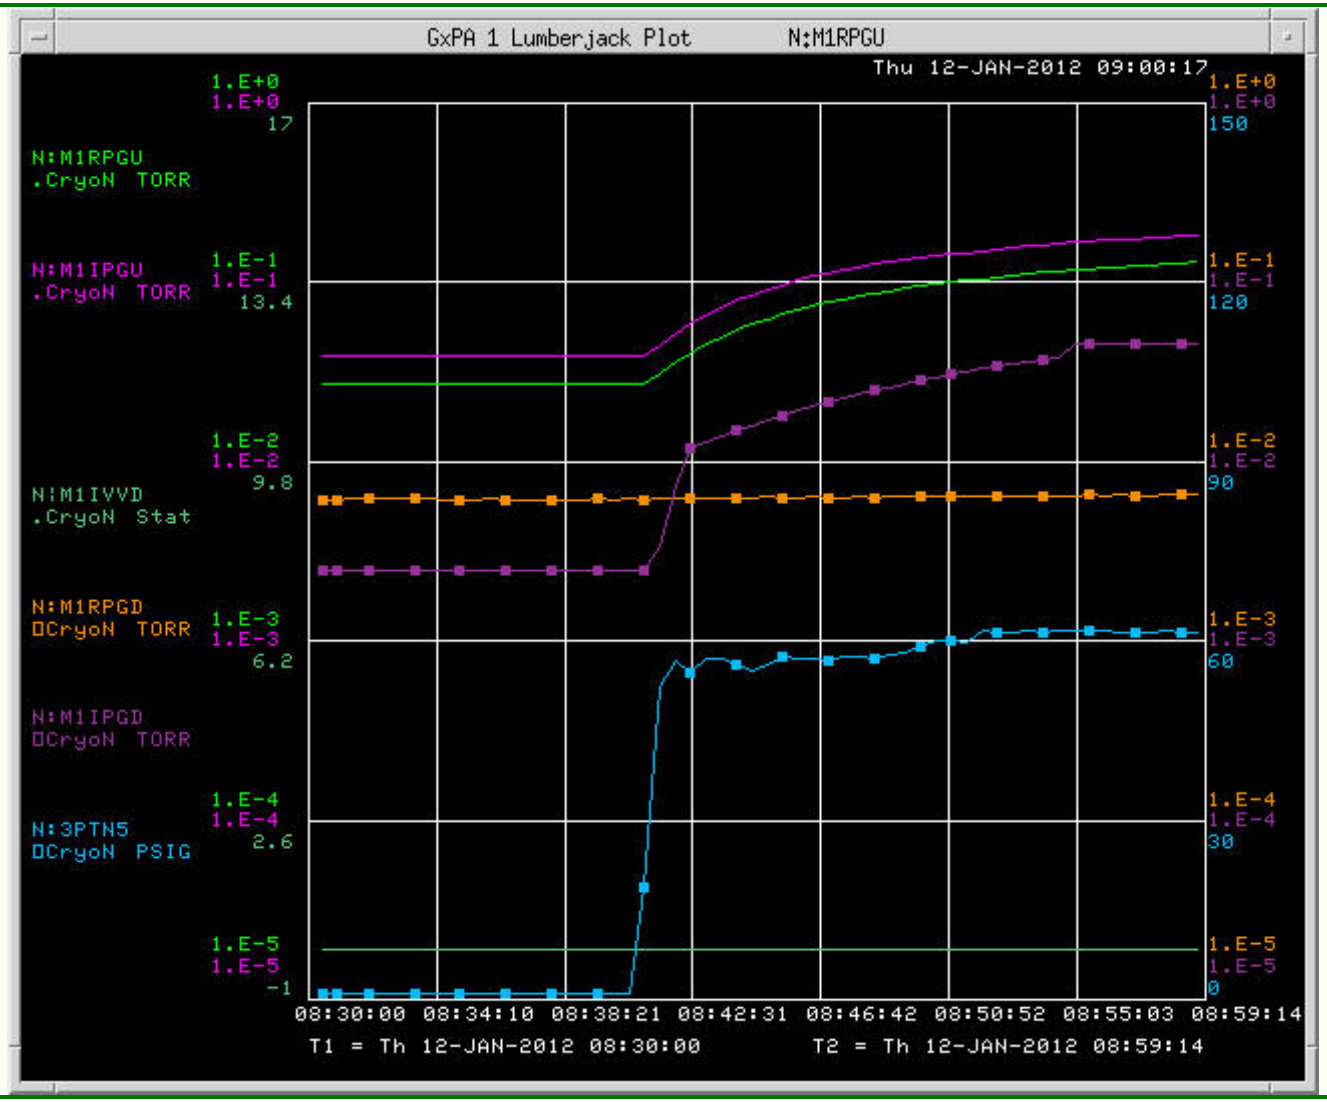
Pressurizing Nitrogen

- **Investigation**
  - 1/10 evening shift and 1/11 day shift conducted studies that determined it was a leak from Nitrogen circuit to insulating vacuum
    - Installed roughing pumps on insulating vac. and connect RGA via bypass line to insulating vacuum space.
    - Used RGA and vacuum gauges to test each of the circuits (2 He. And 1 Nitrogen)
- **Results**
  - Both Helium circuits showed no response (Good)
  - Nitrogen circuit showed a direct vacuum and RGA response
  - Vacuum was worse at upstream end of CM1

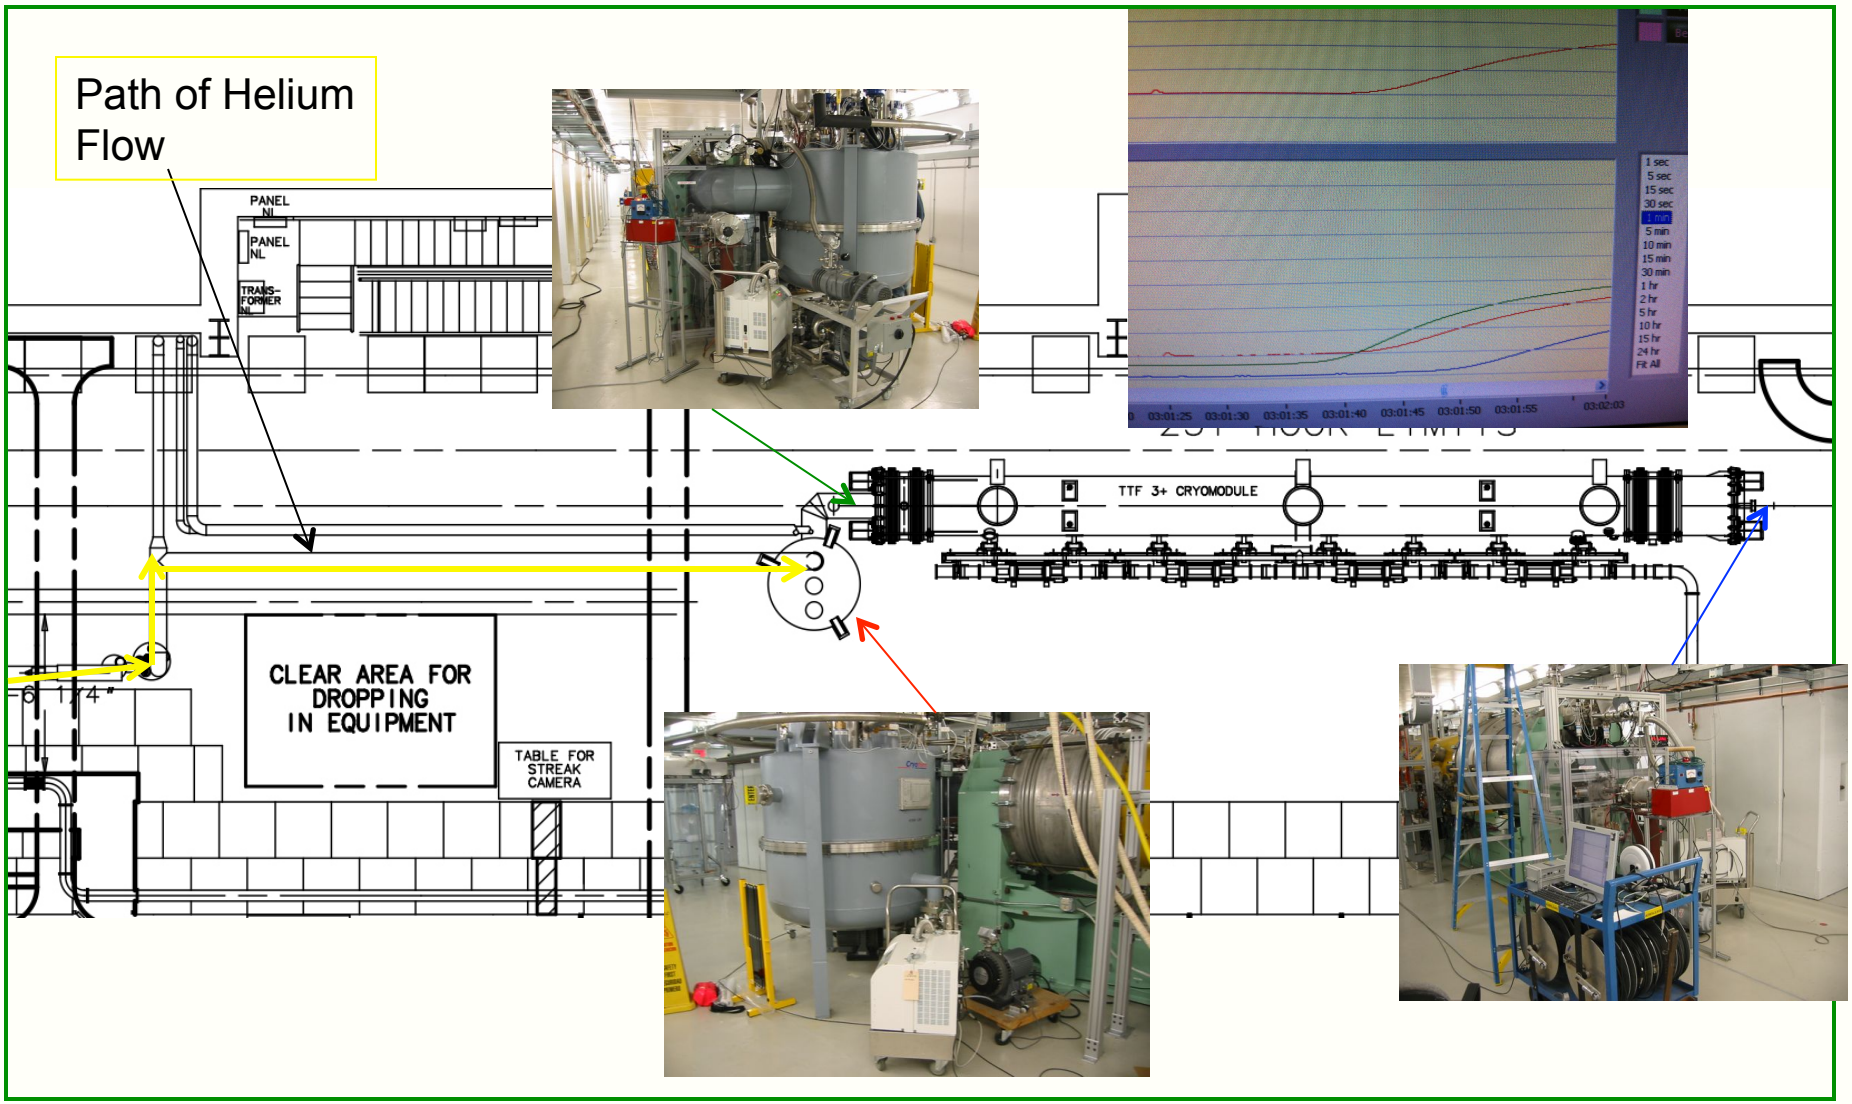
Leak Check of CM1

- **Pinpoint Leak**
  - Cryo (Jerry Makara), TEV (Scott McCormick), and NML vacuum (Ron Kellett) experts led leak checking and repair efforts.
    - At Room temp., first verified warm leak, then connected (3) leak detectors (upstream, downstream, and on feedbox) tied into TEV chart recording cart, to give real-time comparison of response by each detector.
    - Flowed trace amount of helium into Nitrogen circuit from upstream feedbox and monitored response on leak detectors.

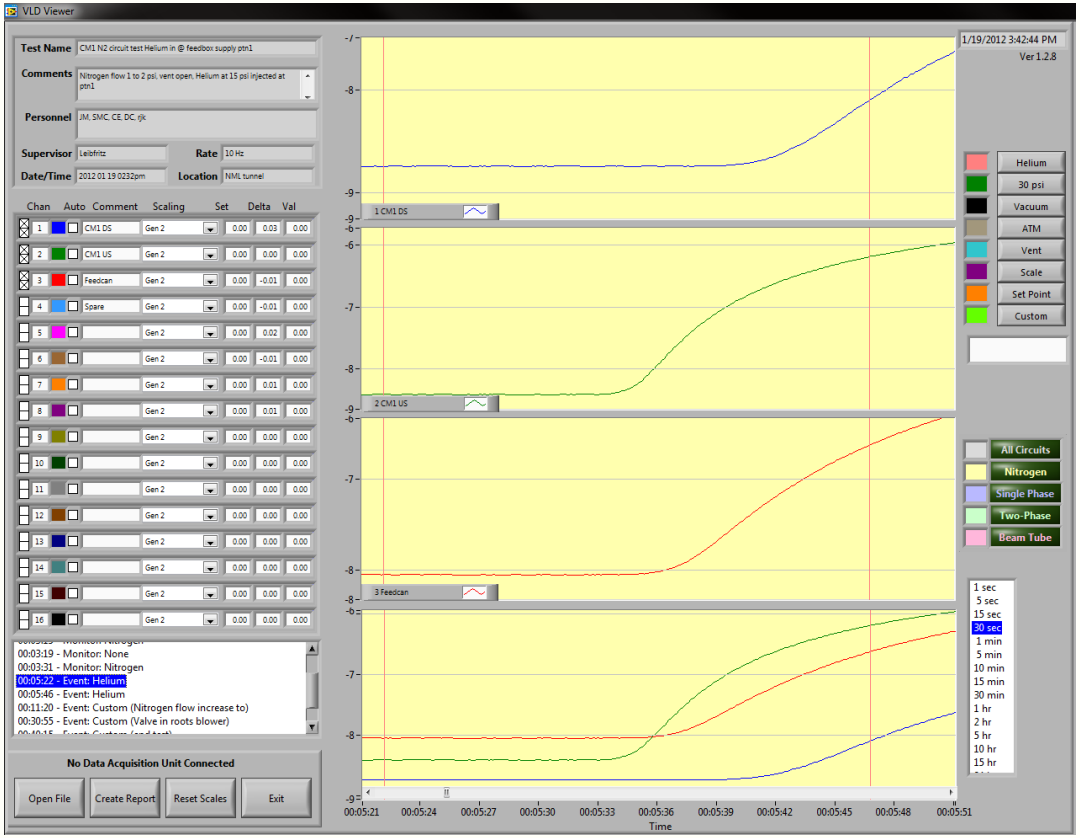
Plot of He Leak Check

- **The leak detector test with helium showed the feed cap interface (green) responding first, followed by the feed can (red), and the end cap (blue). The delay is ~10 sec.**

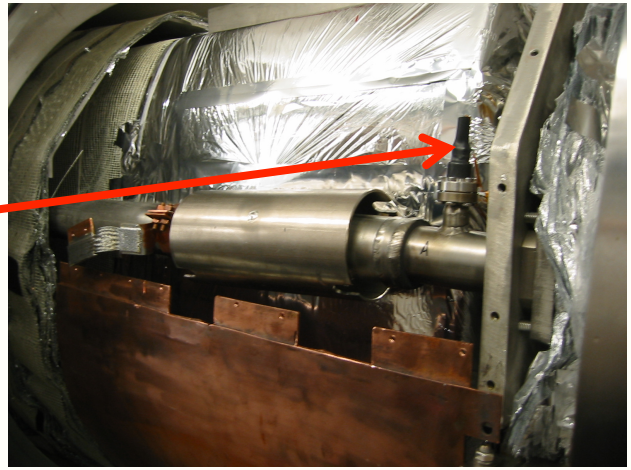
Leak indicated by bubbling “Snoop”

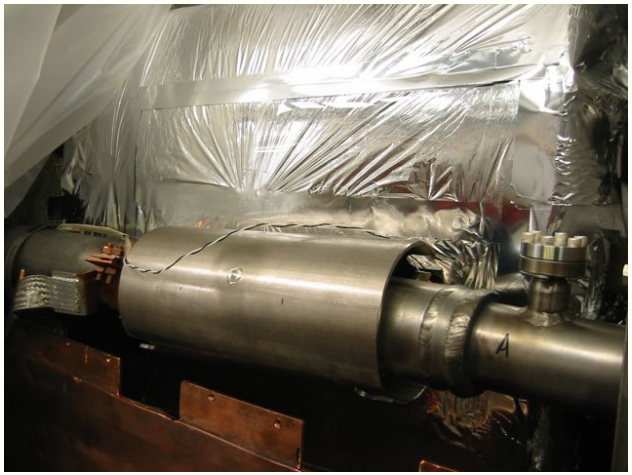
Upstream LN2 Supply Line

- **Large bellows on upstream end was opened and insulation and shields were removed.**
  - **Initial visual inspection did not show any obvious problem.**
  - **Leak check of Nitrogen circuit by pressurizing with Nitrogen and using "Snoop" showed a leak at the supply side temperature sensor feedthrough.**
- **Upstream Supply and Return temp. probes were removed and flanges blanked. New surface mounted sensors were installed at each location.**
- **Helium leak check was conducted to verify there were no leaks in Nitrogen circuit, and feedthru flanges were thermal shocked using liquid Nitrogen to verify they are leak tight.**
