**Status Report of the Tevatron Alignment Task Force
and a
Report on Magnet Survey Activities During the
2003 Summer-Fall Shutdown**

**by the
Tevatron Alignment Task Force**

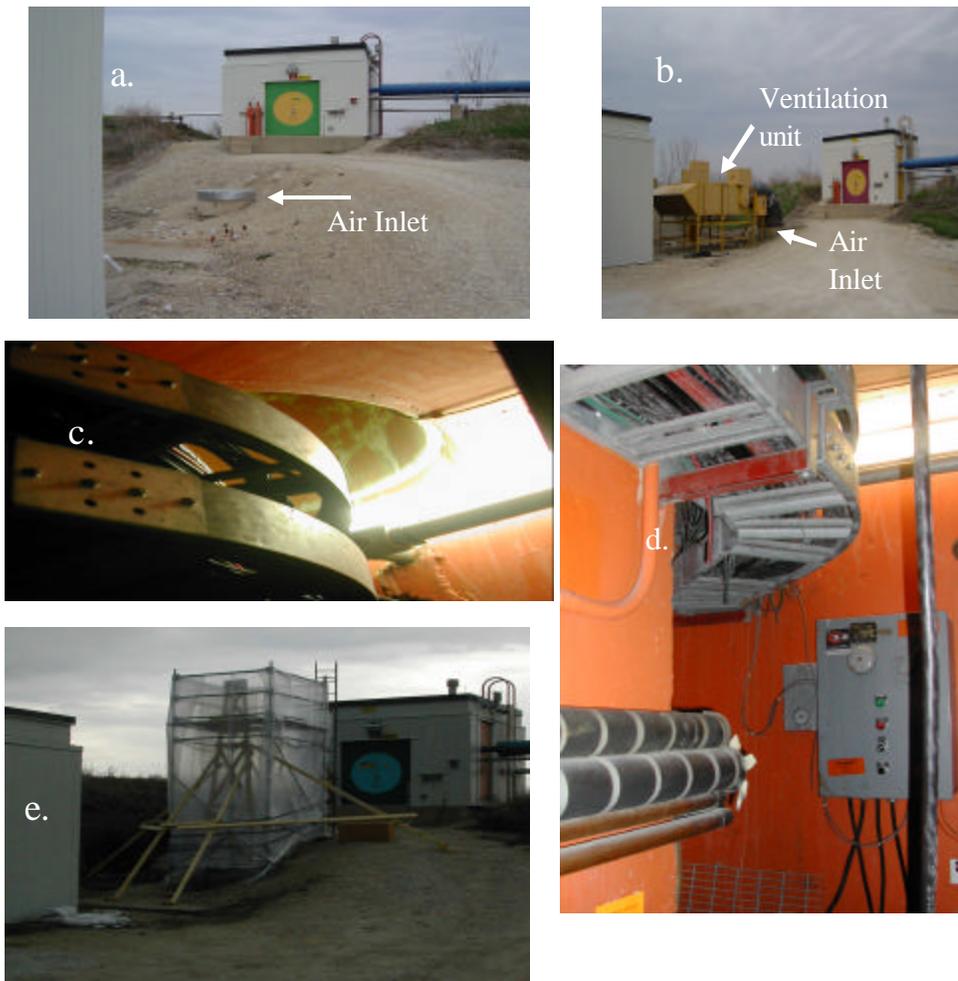
- a) A photograph of an air duct that is not in use. These are found at all of the 2 and 3 numbered houses around the ring.
- b) A photograph of a ventilation unit sitting atop an air-duct. These are seen at the 1 and 4 numbered houses around the ring.

Figure 2: Photographs of air ducts, and towers used during the installation of TevNet.

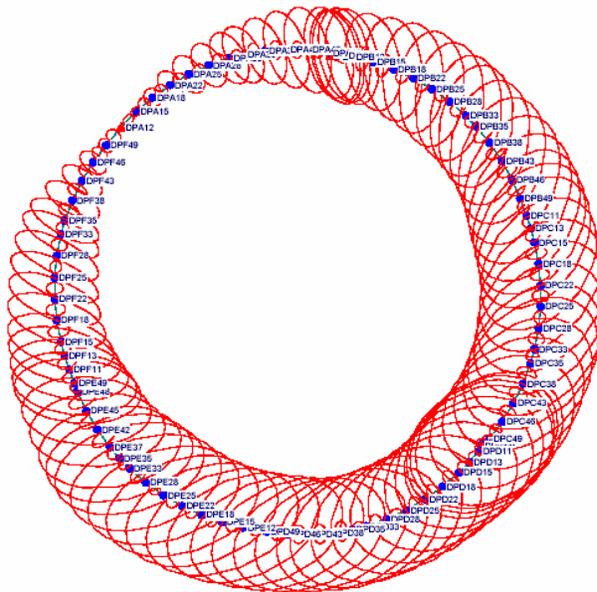
In Figure 4, the set of error ellipses is shown based on the observations made in the tunnel and tied into TevNet. If the location of one station is fixed, the position of all of the remaining stations in the tunnel can be computed with an associated error ellipse. The largest error would be associated with the station directly across the ring from the fixed station, and would have a transverse error on 9 mm. When all 14 stations are used the largest transverse error is about 1 mm.

Figure 4: From the observations taken in the tunnel, an error ellipse can be formed for the location of any station relative to any other station. In this Figure, we plot the error ellipses of each station relative to station A12. The largest error is on the opposite side of the ring at D13, where the ellipse has a semi-major axis of 18mm. When all 14 constraints are used, the error tightens up to about 1 mm.

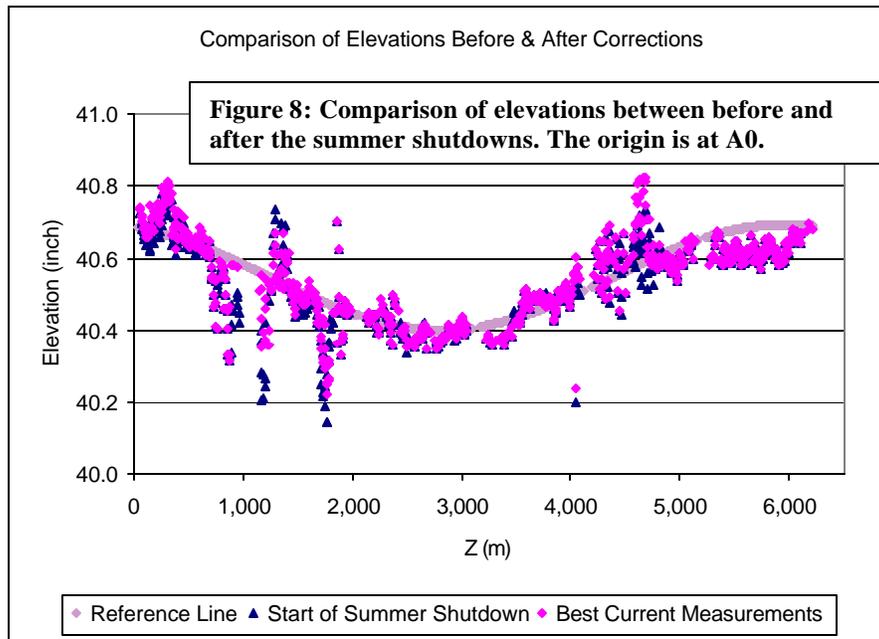
Part of the process of correcting magnet rolls, installing new magnet stands, or correcting horizontal offsets includes local corrections to magnet elevations. These corrections were aimed at smoothing local variations, so that magnets sit on a common line within several cells. A before-after comparison is shown in Figure 8. Some improvement in global variations around the ring is seen in this plot, but because the

corrections are local, the curves appear very similar.

Global elevation corrections will not be carried out until the TevNet results are available and orbit simulations are done to determine the sensitivity of the Tevatron orbit to variations in magnet elevations. Based on operating experience since the shutdown, we might suspect that

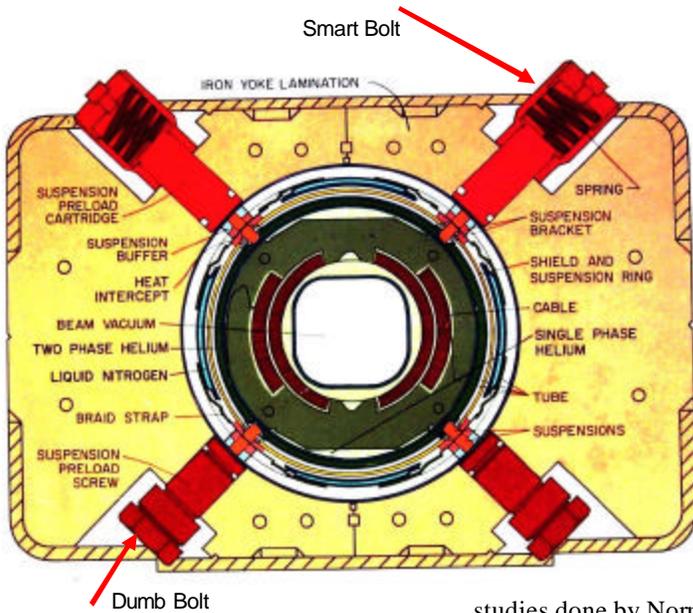
The horizontal and vertical betatron oscillations in the Tevatron were strongly coupled, requiring the skew-quadrupole correction circuits to run at about 60% of the maximum current. Don Edwards and Mike Syphers reported beam measurements that showed the source of the coupling to be distributed fairly uniformly around the ring, rather than concentrated in one or a few locations. Their analysis of several different measurements concluded that the strength of the coupling was consistent with a skew-quadrupole component in each dipole of approximately one "unit" (parts in 10^4 at one inch). A measurement that was also confirmed by the Technical Division, in that one unit of skew-quadrupole component could be attributed to a settling of the cryostat over time.

Figure 9: A cross-sectional view of a Tevatron dipole. The smart bolts are located at the upper corners and are spring loaded. Dumb bolts are located at the lower corners and are not spring-loaded. Three mil shims were placed at the dumb bolt ends to correct for the vertical settling of the cryostat

During the shutdown, 106 dipoles were re-shimmed to remove the skew-quad component of magnetic field. The corrected dipoles corrected are distributed on either side of the intersection regions, namely from A44-2 through B19-5 and from A44-2 through D19-5. The end points on these lists are half way between the last remaining skew quad corrector and the first missing skew quad-corrector. By Norman Gelfand's

calculation, this would reduce the vertical dispersion from 0.5 m to 0.15 m, and Tevatron operation since the shutdown seems to confirm that the machine is now much more easily tuned.
