Results of RFQ “fixes”

C.Y. Tan, J. Schmidt, B. Koubek,
D. Bollinger, P. Karns, R. Tomlin
16 May 2012

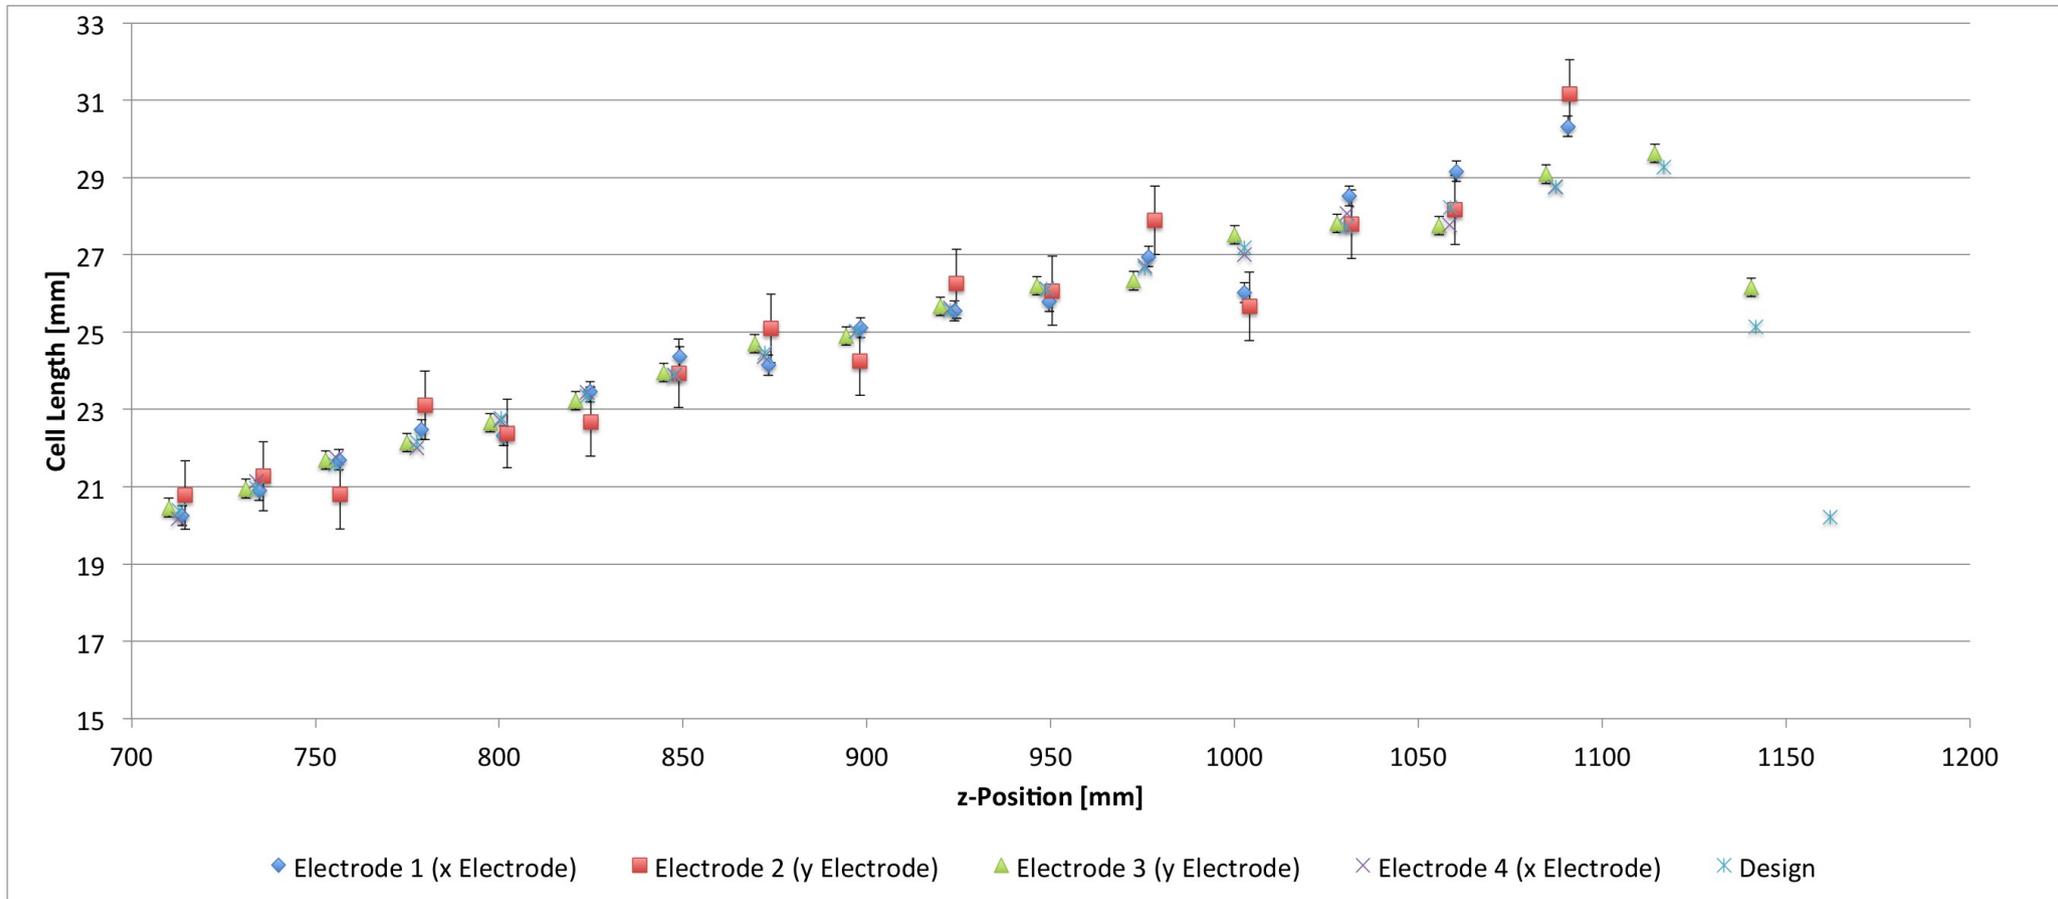
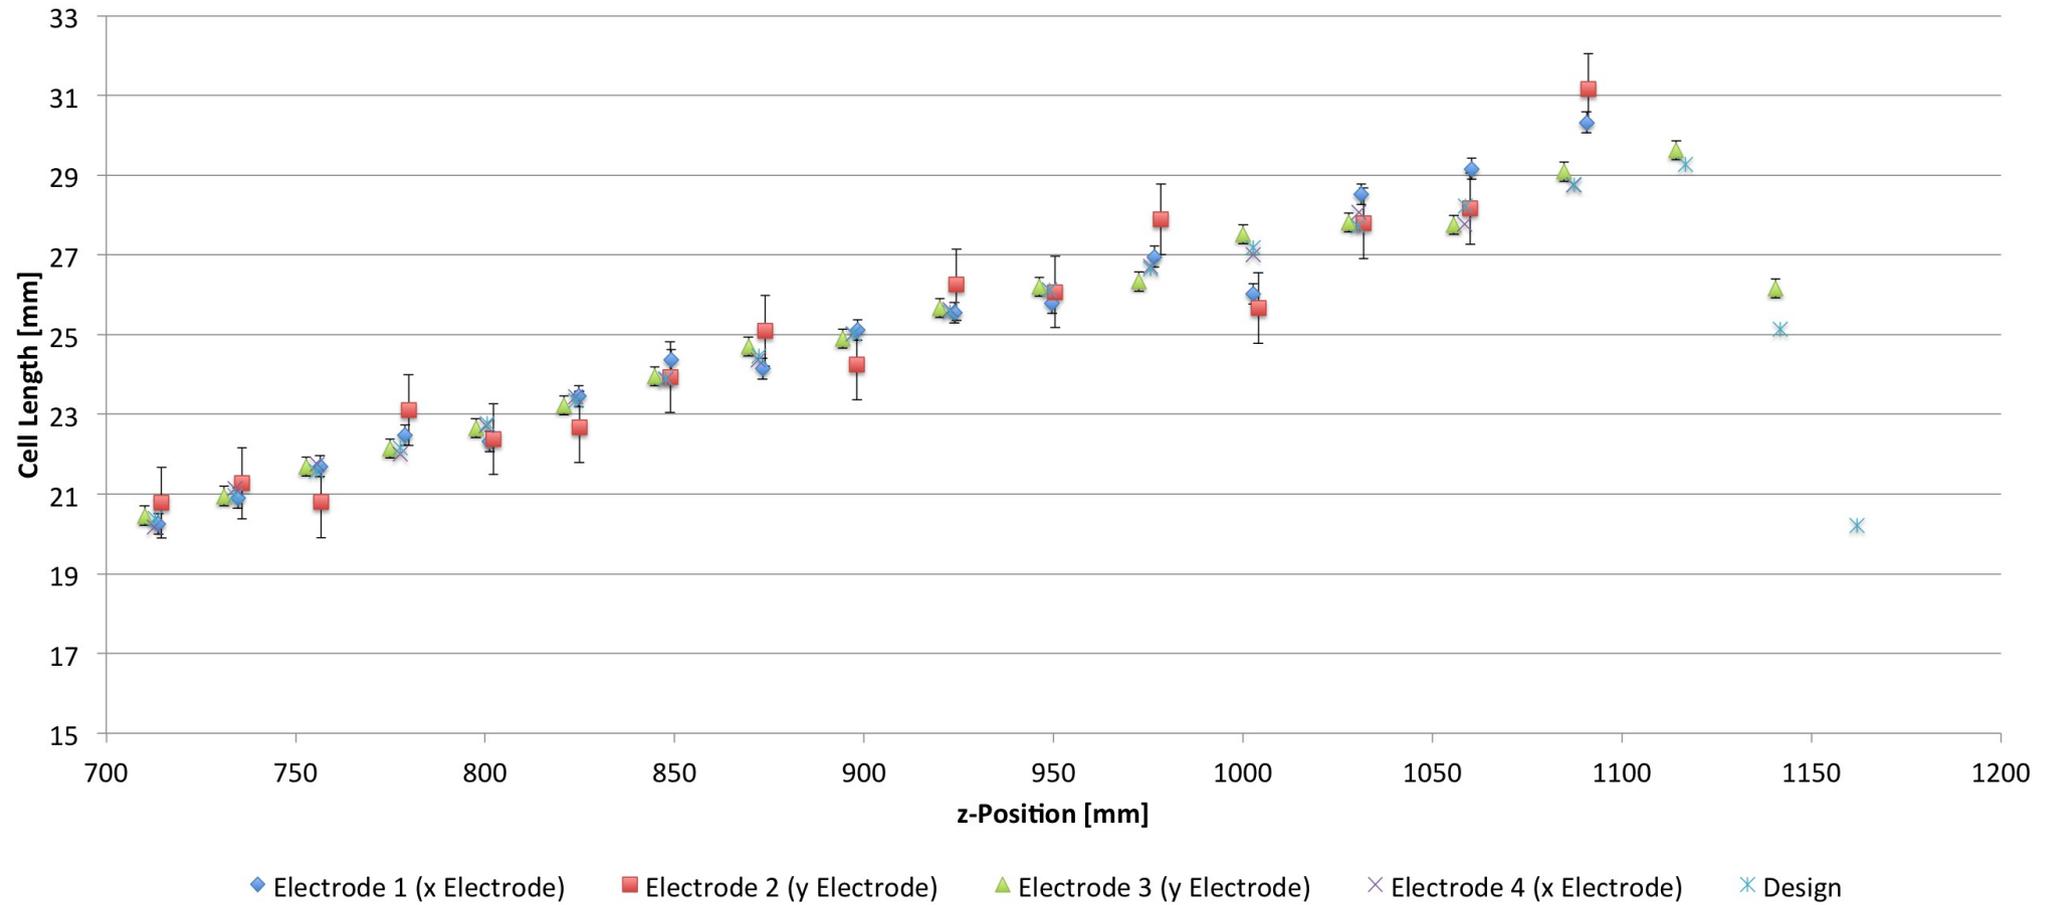
Comparison of Measured Cell Length and Theory

- One more experiment will be done where we flatten the field in the RFQ and to fix the plunger position.
- All roads lead to new rods
 - If the rods are incorrectly manufactured → NEW RODS
 - If the rods are wrong → NEW RODS
