WBS 1.3.4.8 Tevatron Alignment

Ray Stefanski

January 21, 2004

Tevatron Alignment Task Force

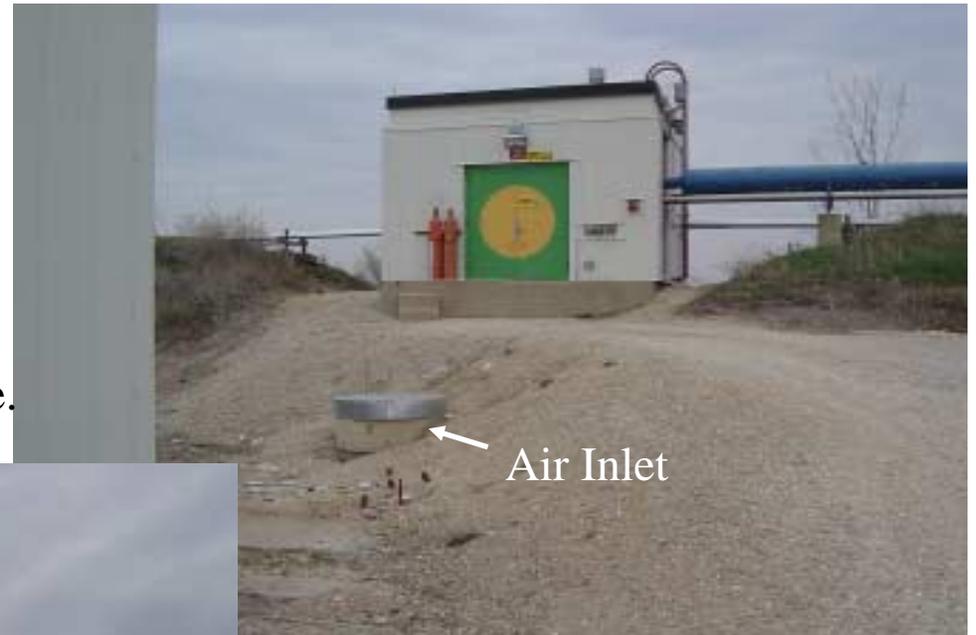
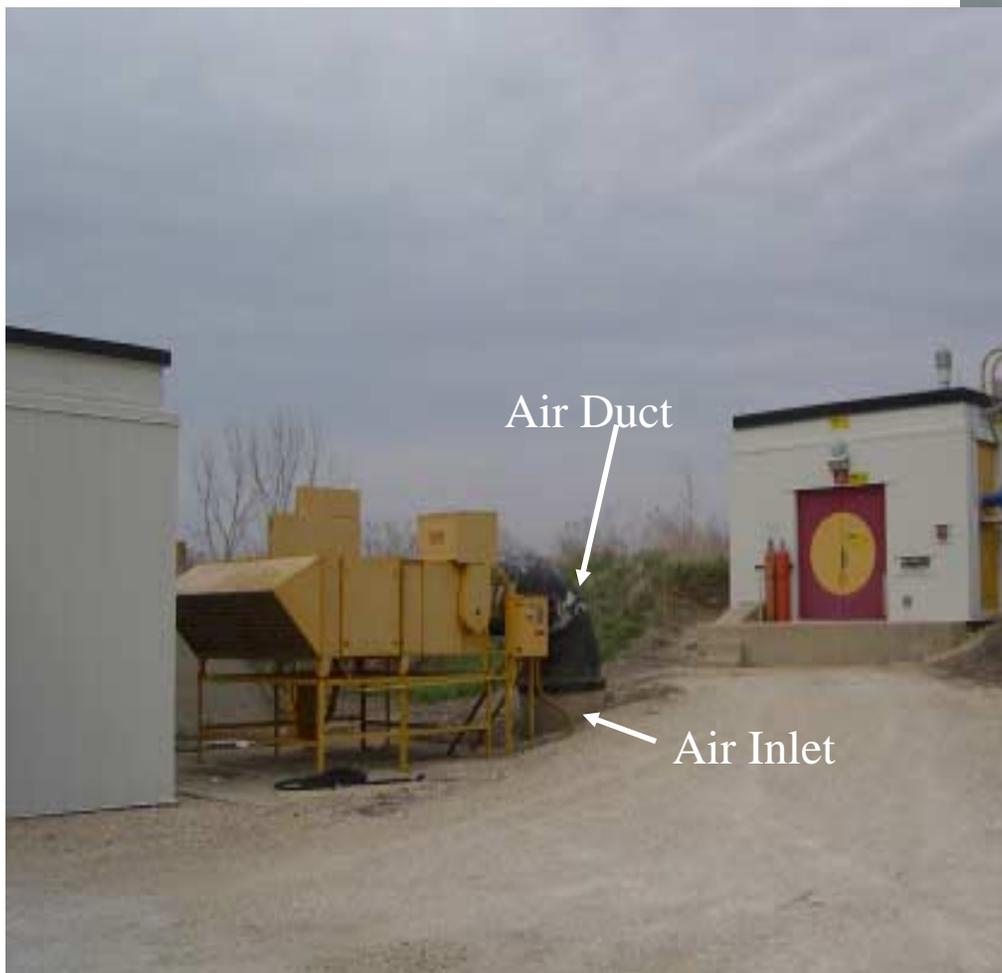
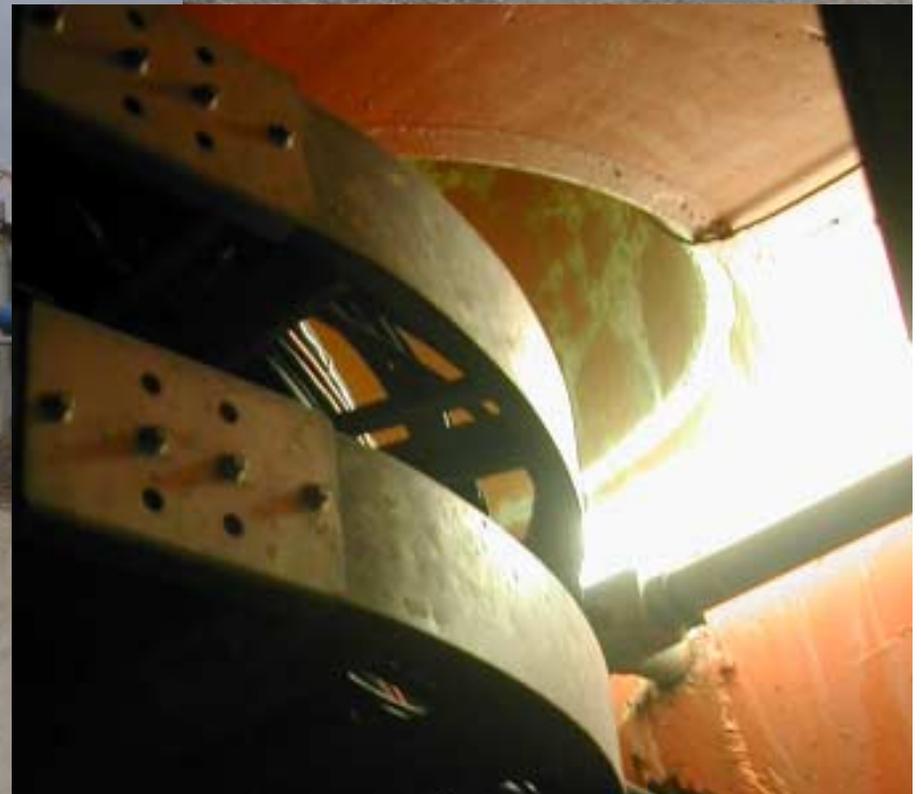
Tower installtion for the TevNet Measurements

1. Modify air vents top side.
2. Build towers over the air ducts/risersers.

This also needs deep rod system installed on site.

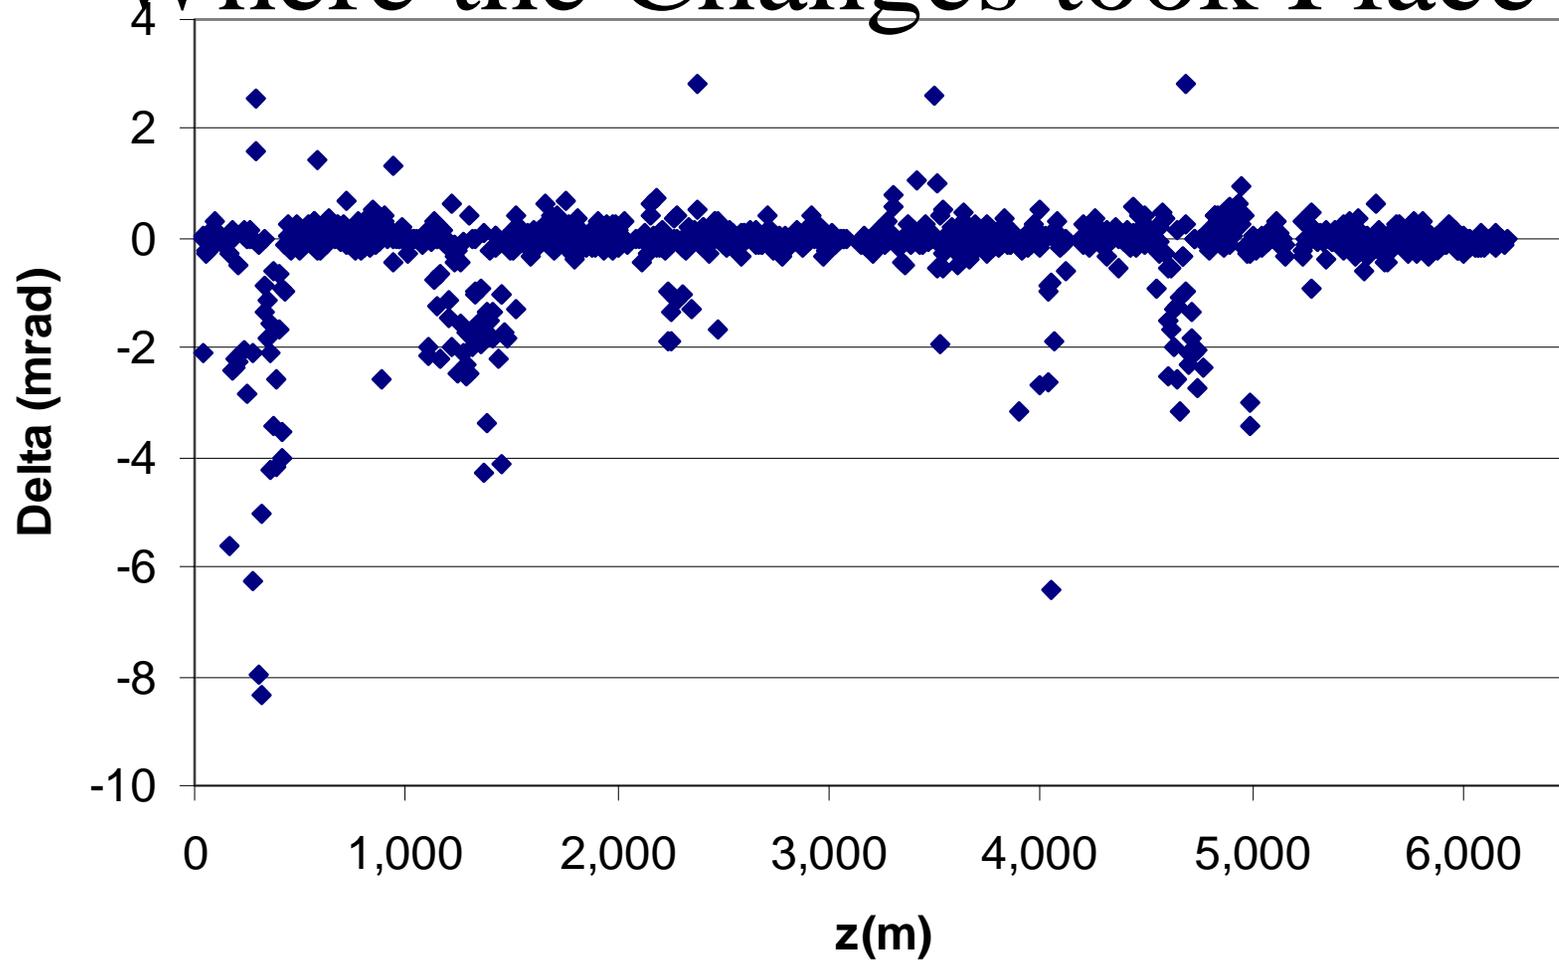
Where the Changes took Place

Changes in Roll Dec-Jan 2003

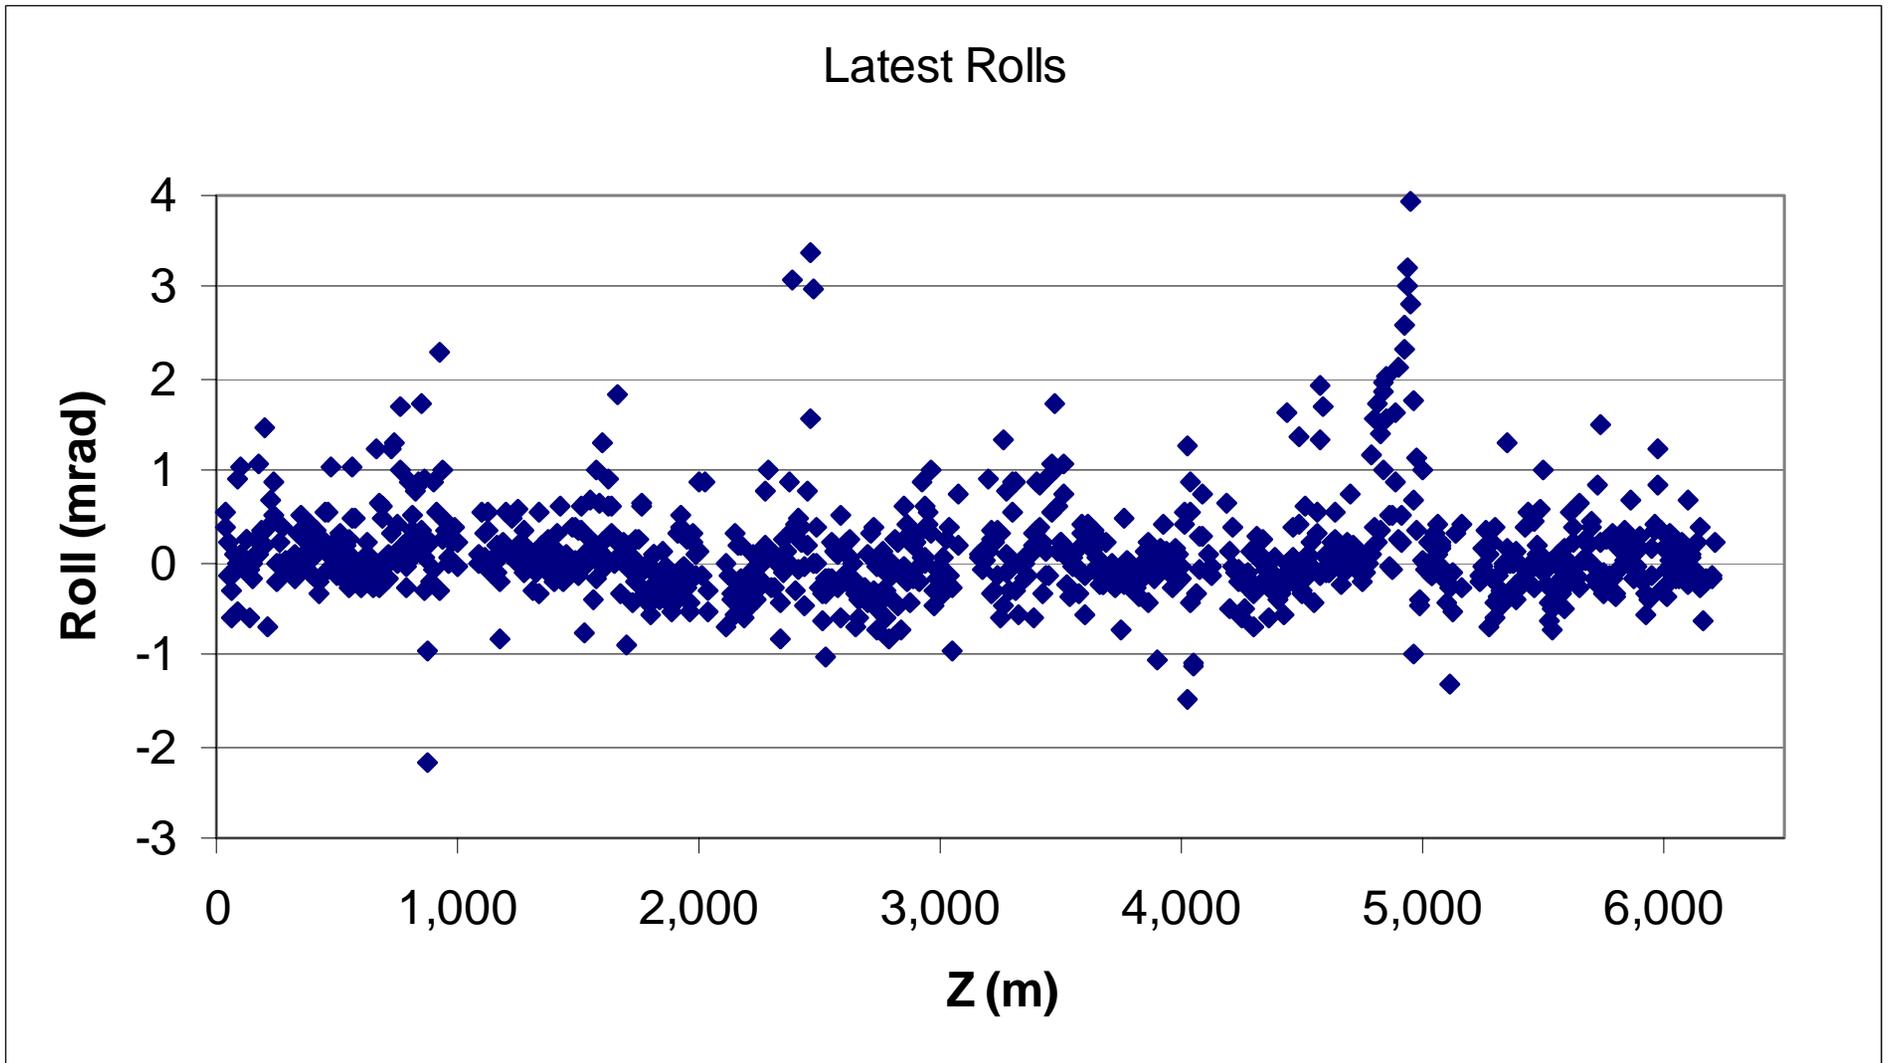
Latest Rolls

>1	>2	>3
All	58	13	5
A Sector	12	2	0
B Sector	2	0	0
C Sector	5	3	2
D Sector	10	0	0
E Sector	25	8	3
F Sector	4	0	0

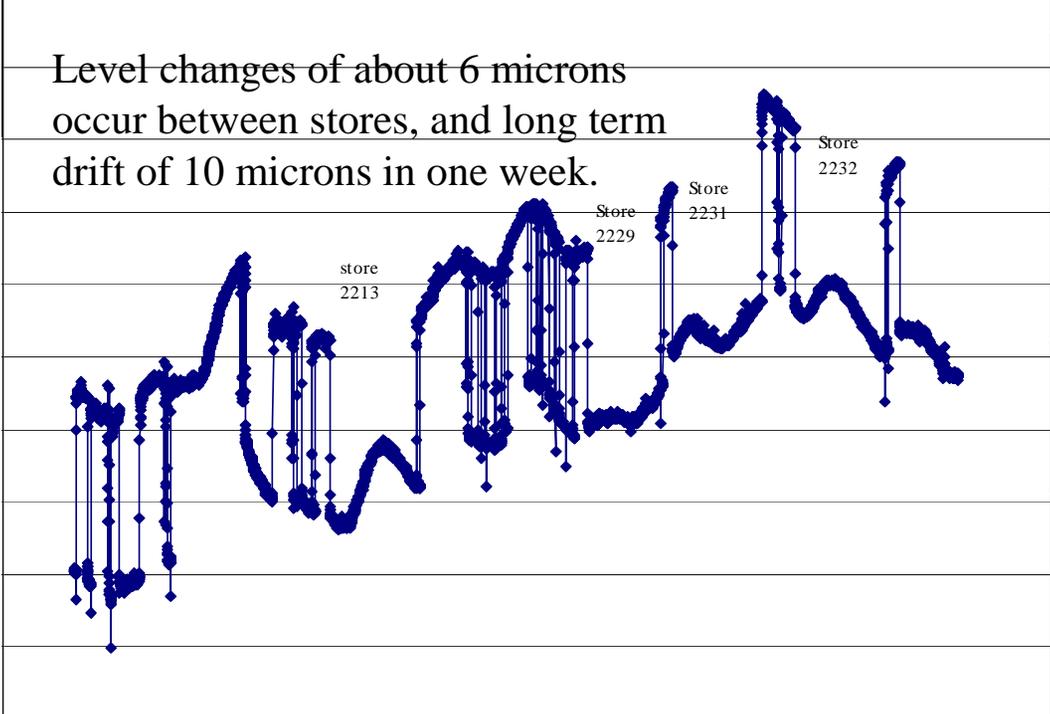
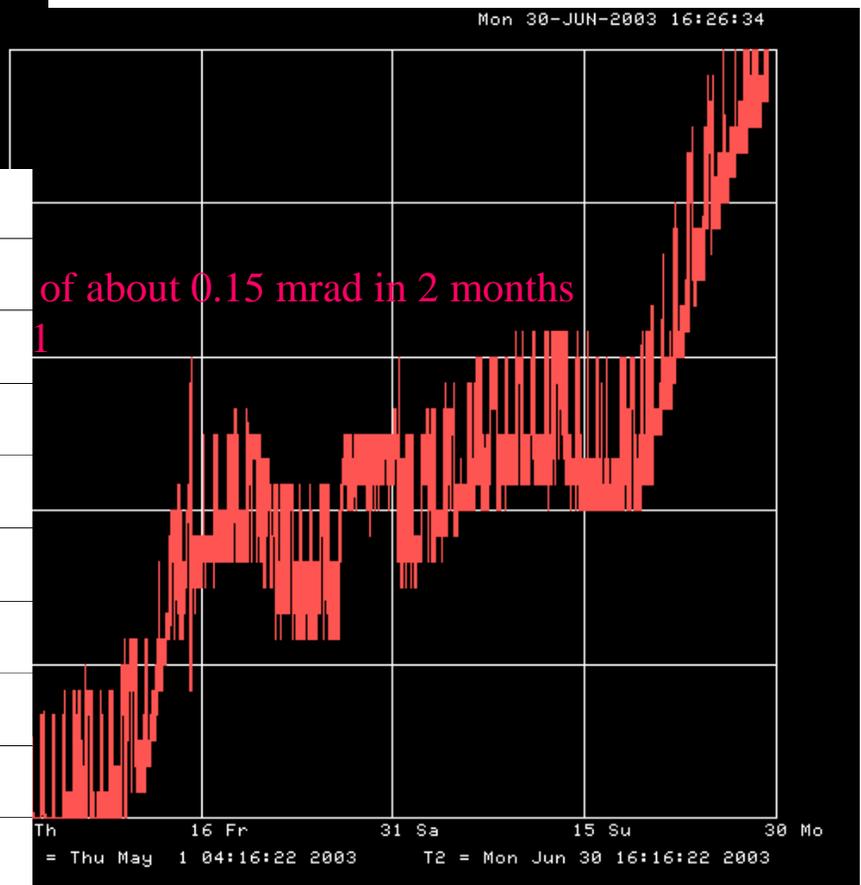
Tilt Monitor Data Detectors

Tilt Monitors located in the Tev tunnel indicate that long term changes do occur. Discrete short term motion can also be seen.

Location	Average Roll/Time	Estimated Annual Roll
	$\mu\text{rad/day}$	$\mu\text{rad/year}$
A15-1 Quad	1.10	400
A16-3 Dipole	0.58	210
A21-1 Quad	0.21	77
B17-5 Dipole	1.52	555
B24-1 Quad	0.22	80
C24-1 Quad	1.30	474
E29-1 Quad	1.07	-390
E32-1 Quad	1.77	538
E39-1 Quad	1.18	430

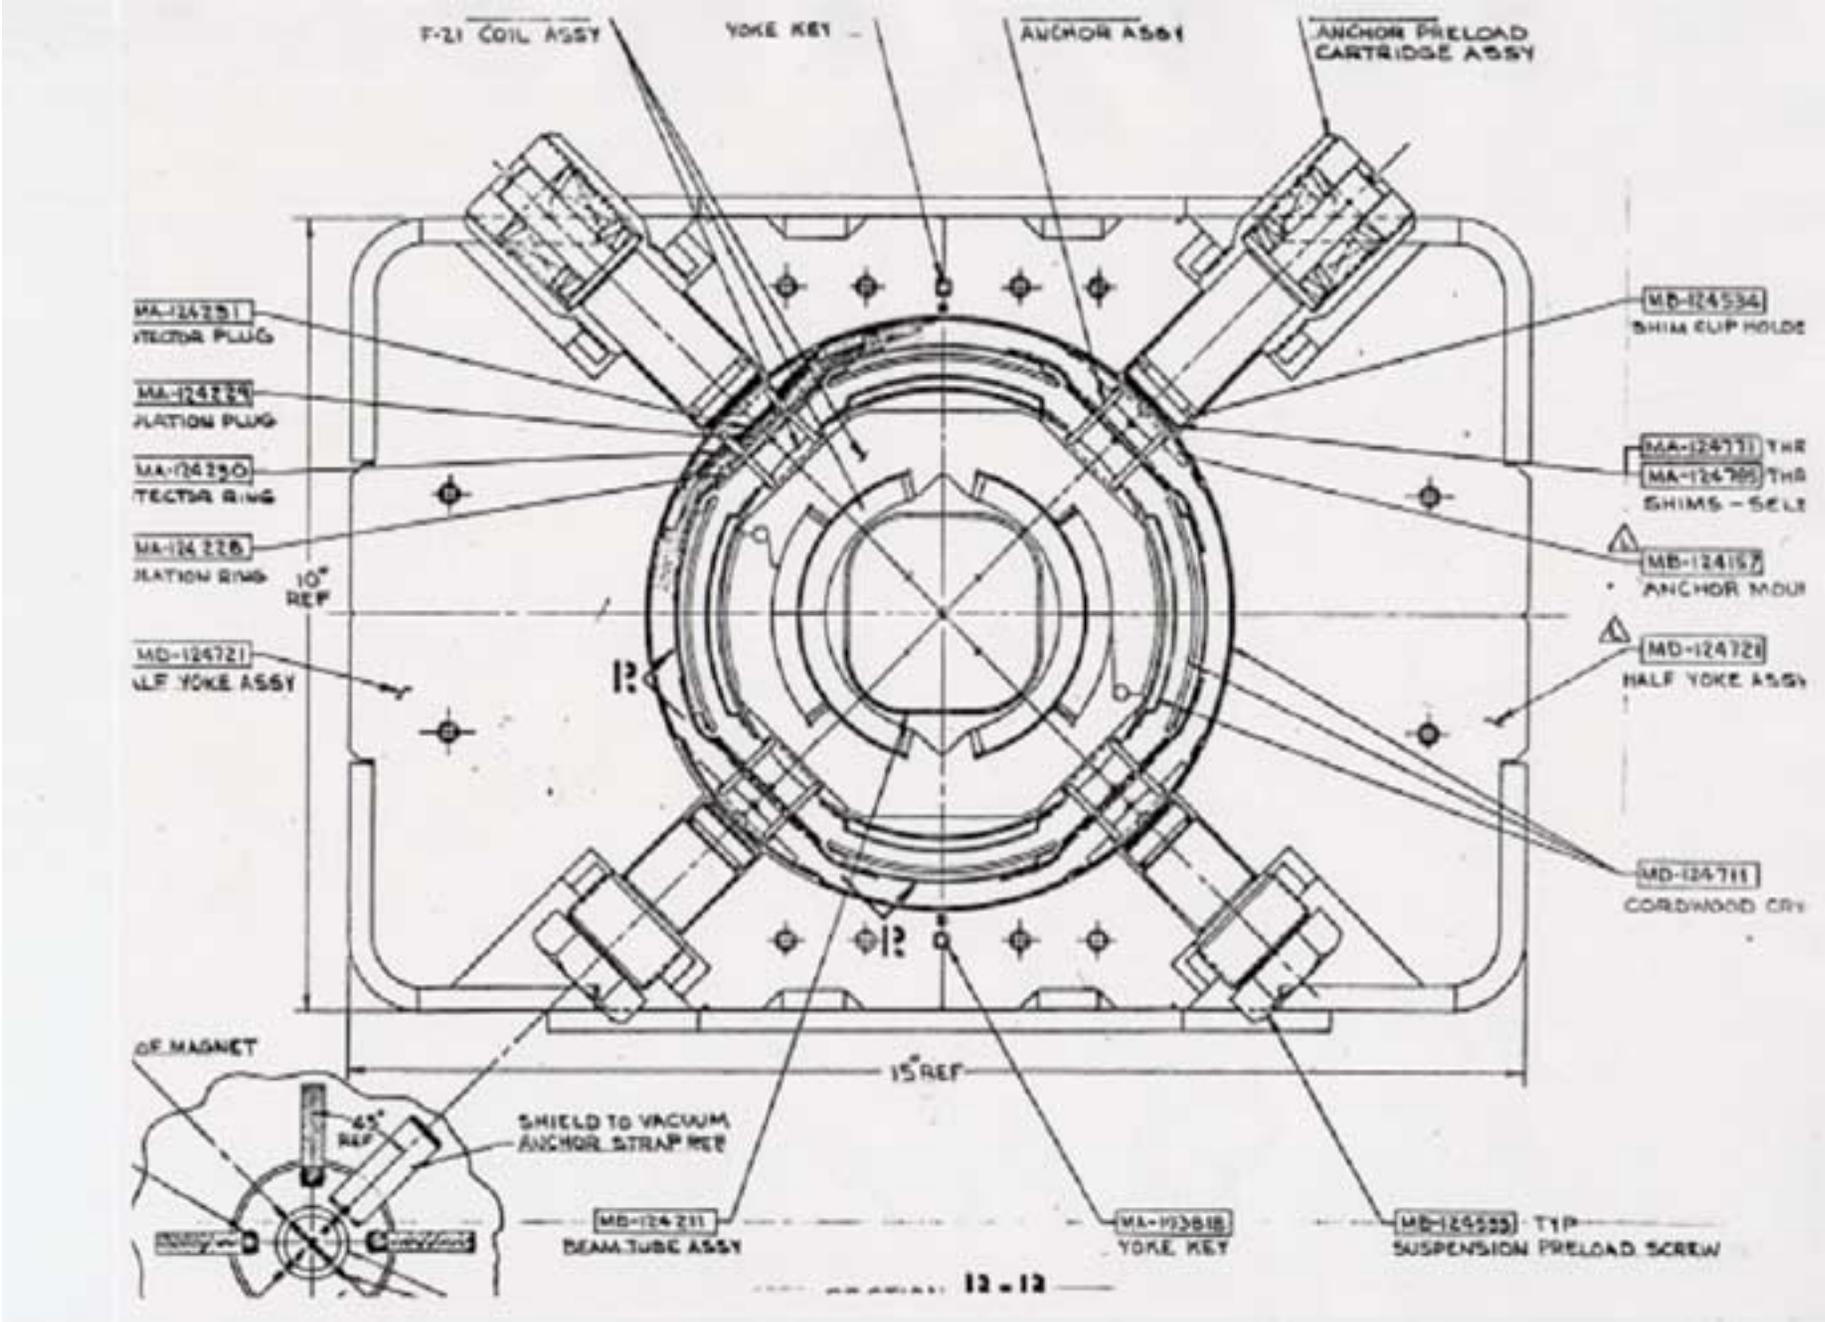
Tev Magnet cross section

106 dipole magnets near the low beta regions were modified for cryostat movement. By concentrating on the magnets that have no nearby skew-quad correctors, the coupling can be reduced by 75 %. Virtually all dipoles were measured in the Tevatron to establish a baseline: to detect future movement if it occurs. Some dipoles show unusual behavior, as if the anchor bolt is broken.

Suspicious magnets are being studied to develop an understanding of this phenomenon.
