**Status Report of the Tevatron Alignment Task Force  
and a  
Report on Magnet Survey Activities During the  
2003 Summer-Fall Shutdown**

**by the  
Tevatron Alignment Task Force**

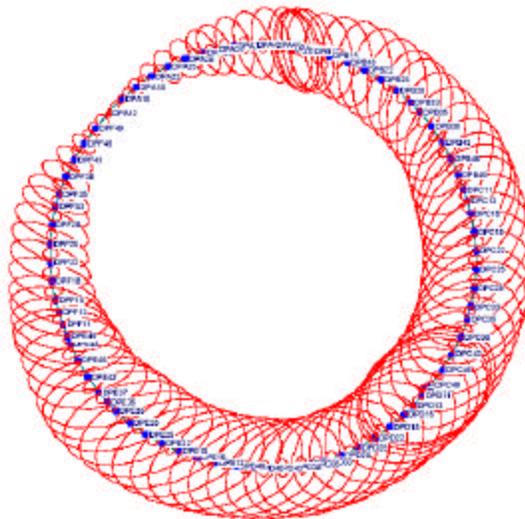
In Figure 4a, the set of error ellipses is shown based on the observations made in the tunnel, and tied into TevNet. If the location of one station is fixed, the position of all of the remaining stations in the tunnel can be computed with an associated error ellipse. The largest error would be associated with the station directly across the ring from the fixed station, and would have a transverse error of 18 mm. When all 14 stations are used the largest transverse error is about 3.8 mm and this is an error at the 95% confidence level. Figure 4b shows the comparable plot.

Figure 4a: From the secondary traverse observations taken in the tunnel, an error ellipse can be formed for the location of any station relative to any other station. In this Figure, we plot the error ellipses of each station relative to station A12. The largest error is on the opposite side of the ring at D13, where the ellipse has a two-sigma semi-major axis of 18mm. This is analogous to the situation before the installation of the network if the best current practices were used. This is the best we could hope for using the Murphy-line.

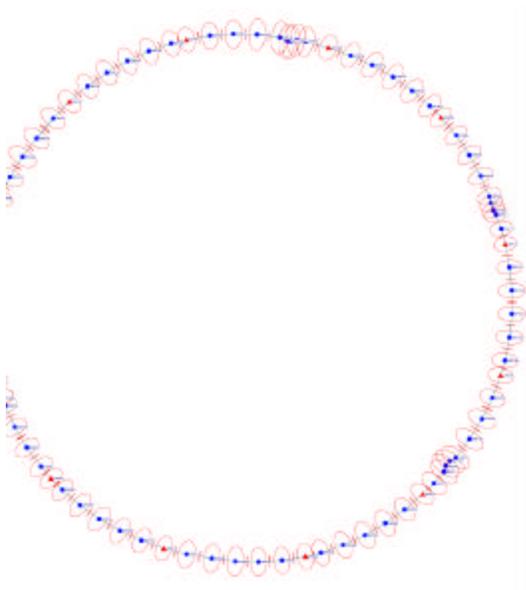
Figure 4b: By using TevNet, and the 14 constraints represented by the site risers, the situation around the ring is much improved. The largest two-sigma error, represented by the semi-major axis of an error ellipse is 3.8 mm. This should be compared to the two-sigma error in Figure 4a of 18mm. This is an improvement of roughly a factor of 25: We quantify the improvement by taking the ratio of the areas of the error ellipses.

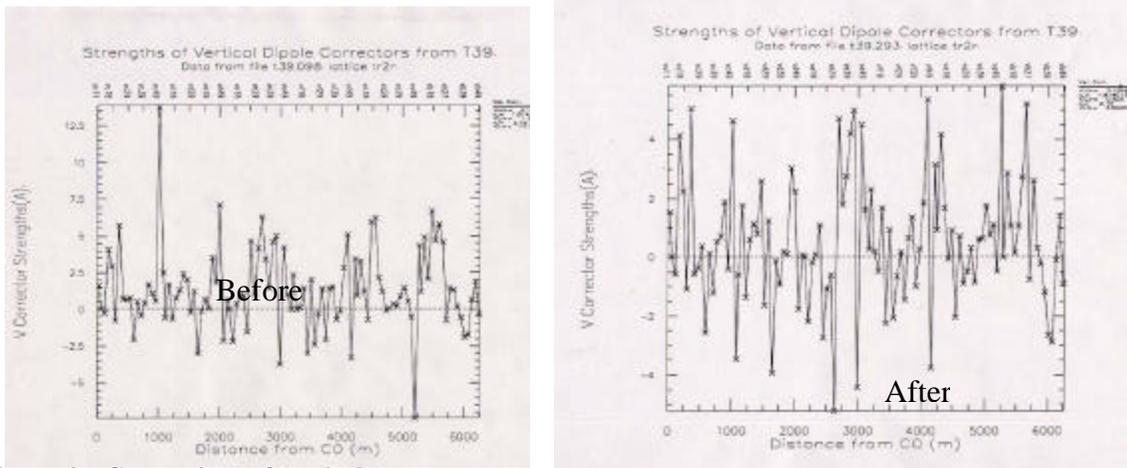
the shutdowns and after is given in Table 2. In particular, all of the magnet rolls greater than 4 mrad have been eliminated. There are now 51 magnets with rolls greater than one mrad that should be corrected, compared to 141 before the shutdowns. (Our present threshold for roll correction is 1 mrad.) The biggest remaining rolls are in A and E Sector. This work had an immediate impact on vertical corrector magnet settings, which had previously run close to capacity. Corrector currents are now running at much more reasonable levels as can be seen in Figures 6a and 6b.

**Figure 6a: Comparison of vertical corrector magnet currents before and after the shutdowns. The origin is at C0. The vertical scale changes from (-6 to 13 amp) before to (-5 to 6 amps) after.**

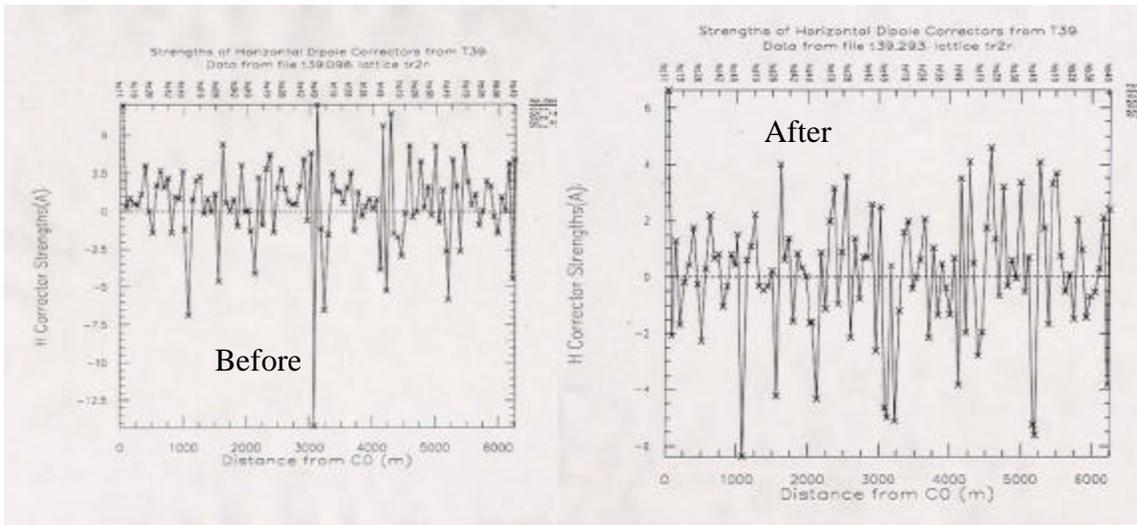
**Figure 6b: Comparison of horizontal corrector magnet currents before and after the shutdowns. The origin is at C0. The vertical scale changes from (-13 to 6.5 amp) before to (-6 to 6.5 amps) after.**

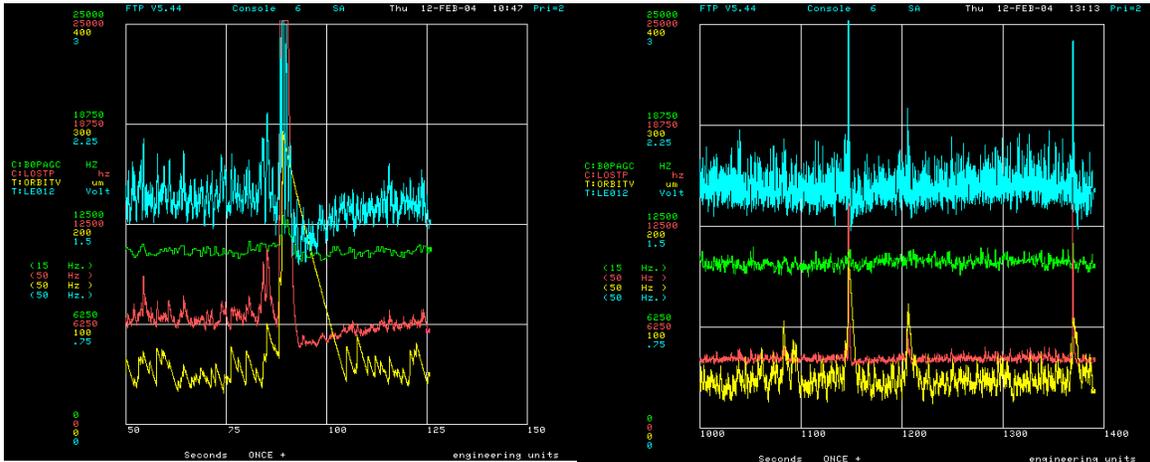
In Figure 12 we shows two graphs of recent data taken with an accelerometer at B0. The vibrations caused by the passage nearby of a 25T tractor/trailer were easily measured, as were also the increase in losses in the Tevatron. In the Figure on the right the passage of a fire-truck nearby causes spikes to occur in a loss monitor. The operational significance of this "fire-truck effect" is shown by the spikes on T:LEO12: This is one of the loss monitors used for feedback by the collimator system. If these disturbances were to occur during halo removal, the collimators would stop prematurely. Additional geophones may be placed on the low betas at CDF during coming shutdowns to further track down the mechanism for this effect.

**Figure 12: Recent measurements made with an accelerometer at B0. The figure on the left shows the effect of a 25 T tractor/trailer passing nearby. The figure on the right shows spikes that occur on loss monitor readout when a fire-truck passes nearby.**
