Pre-injector Upgrade Updates (26 Oct 2011 – 09 Nov 2011)

C.Y. Tan
09 Nov 2011

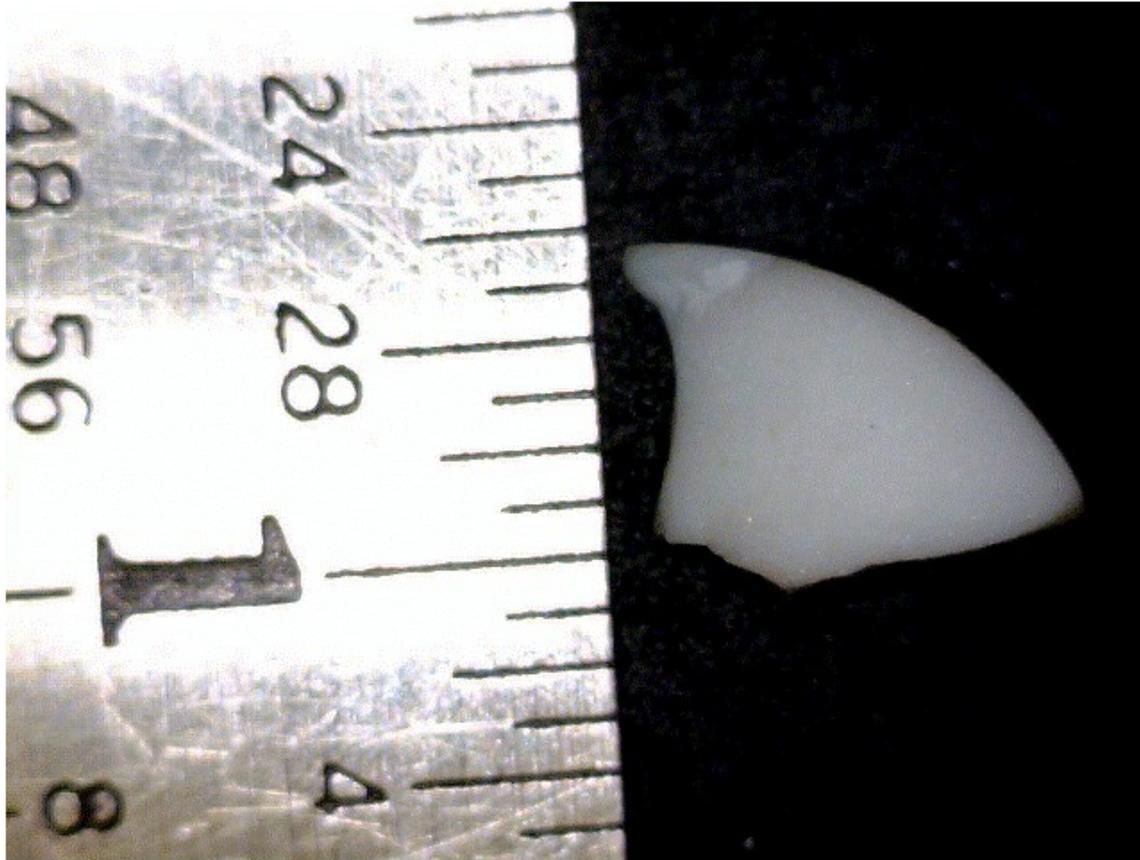
Ceramic Chip in Turbo

Device	Status	Comments
Bottom source turbo	OFF Repaired (08 Oct)	ceramic standoffs broke. Pieces may be in the turbo. Removed and inspected 08 Oct
