# WBS 26.4.8 Tevatron Alignment

February 25, 2004

Run II Review – Tevatron Alignment  
Ray Stefanski

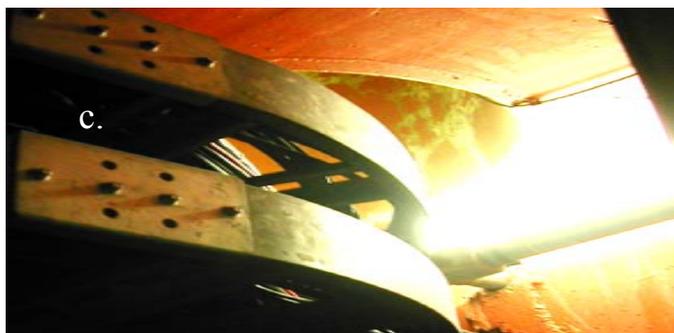
c) At the bottom of each of the 24 air ducts sits a cable tray that obstruct a clear view into the alcove. A special device was designed by Mike McGee to bring the line-of-sight around the cable tray.

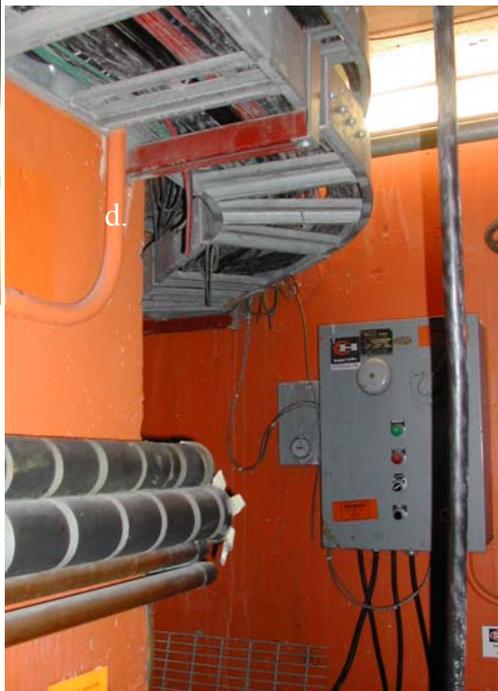
d) A photo of the alcove at the bottom of the air ducts, showing also a cable tray. The AMG used twelve air ducts for the installation of TevNet. Those used were located at the 1 and 3 houses.

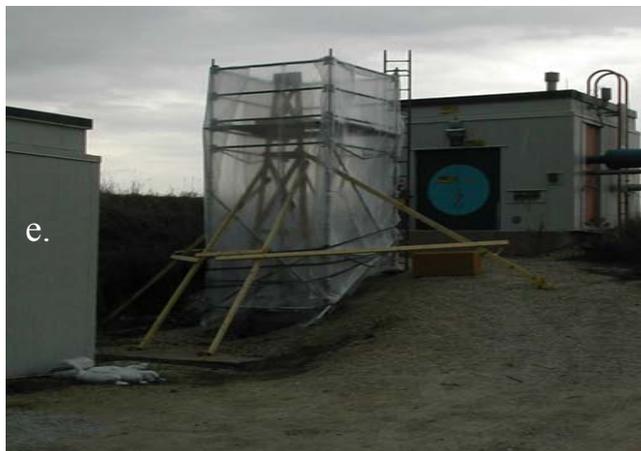
e) A photograph of one of twelve towers constructed above the air-shafts, this one at C3. From the top of the tower, which extends above the surrounding structures, readings taken at the surface can be transmitted down the sight-riser, nee air-duct.

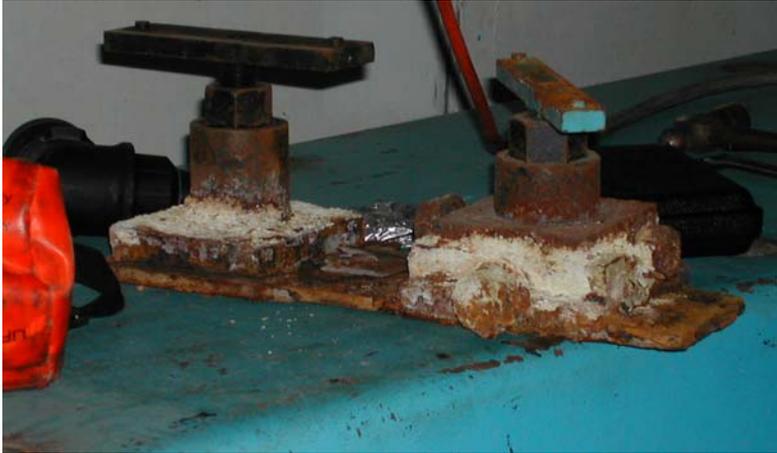
# Magnet Stand Replacement

A-1	2	D-1	0
A-2	15	D-2	0
A-3	0	D-3	0
A-4	0	D-4	2
A-Sector	17	D-Sector	2
B-1	15	E-1	0
B-2	5	E-2	12
B-3	0	E-3	5
B-4	0	E-4	1
B-Sector	20	E-Sector	18
C-1	1	F-1	0
C-2	1	F-2	0
C-3	2	F-3	0
C-4	0	F-4	0
C-Sector	4	F-Sector	0
		All	61
