## Appendix G:

### Metallurgical Evaluations of Corroded Pipe Samples

**FERMI LABORATORY  
MAIN INJECTOR COOLING WATER SYSTEM  
CORROSION EVALUATION**

**December 5, 1997**

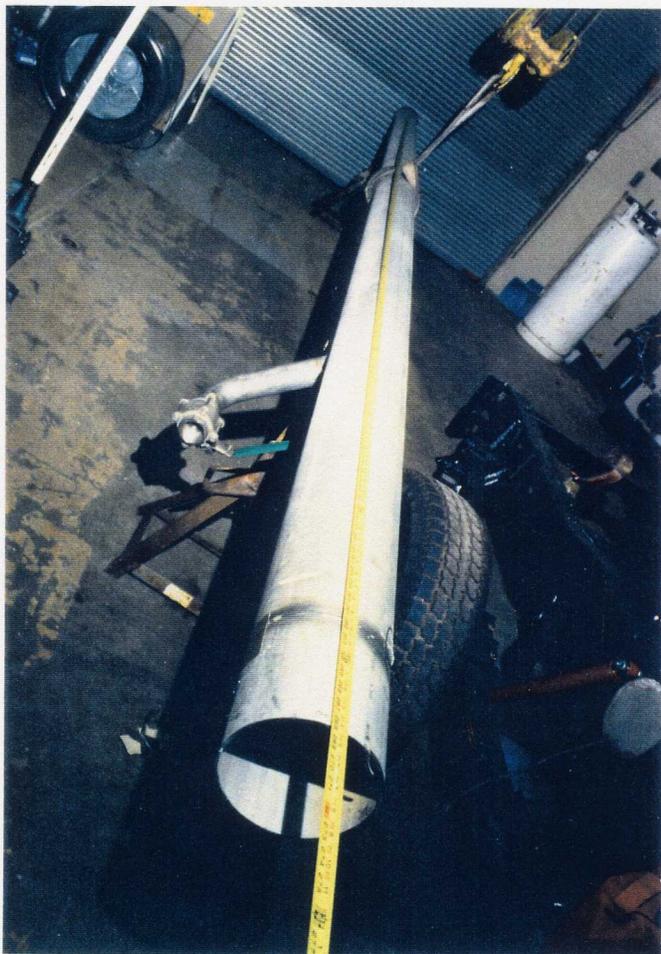
**Plate 1**  
As-received section of piping.

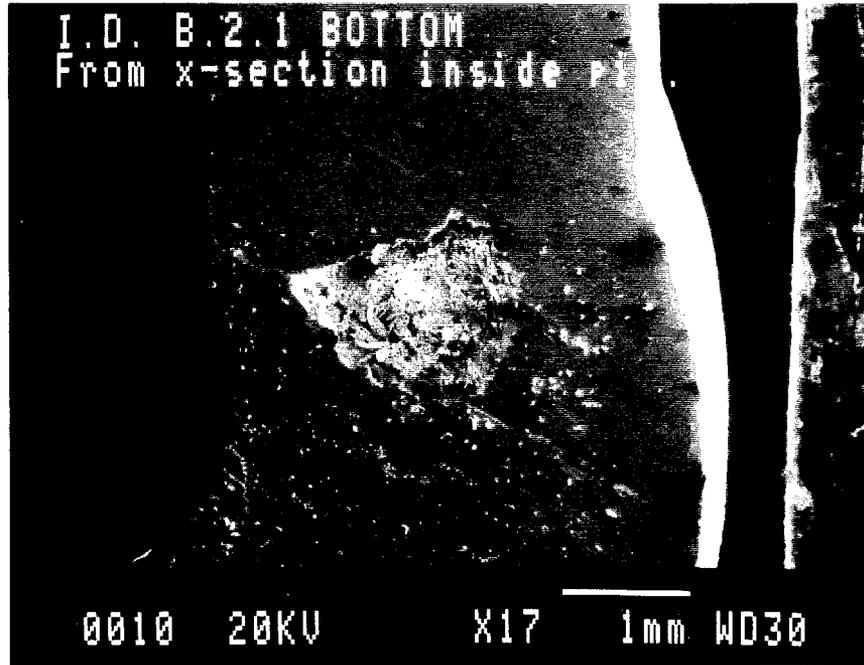
Plate 14

Areas that contained the heaviest corrosion nodules were sectioned longitudinally through the center to expose a cross-section of the weld at that point. In each case an internal cavity was exposed that was filled with debris. Energy dispersive spectroscopy (EDS) elemental analysis of the residue recorded the presence of notable concentrations of carbon, oxygen and sulfur. Refer to Plates 12 through 15 for typical photomicrographs, and Figures 1 and 2 for the EDS analyses.

SEM photomicrographs of another cavity still filled with residue.  
Magnification: 17X (top); 50X (bottom)

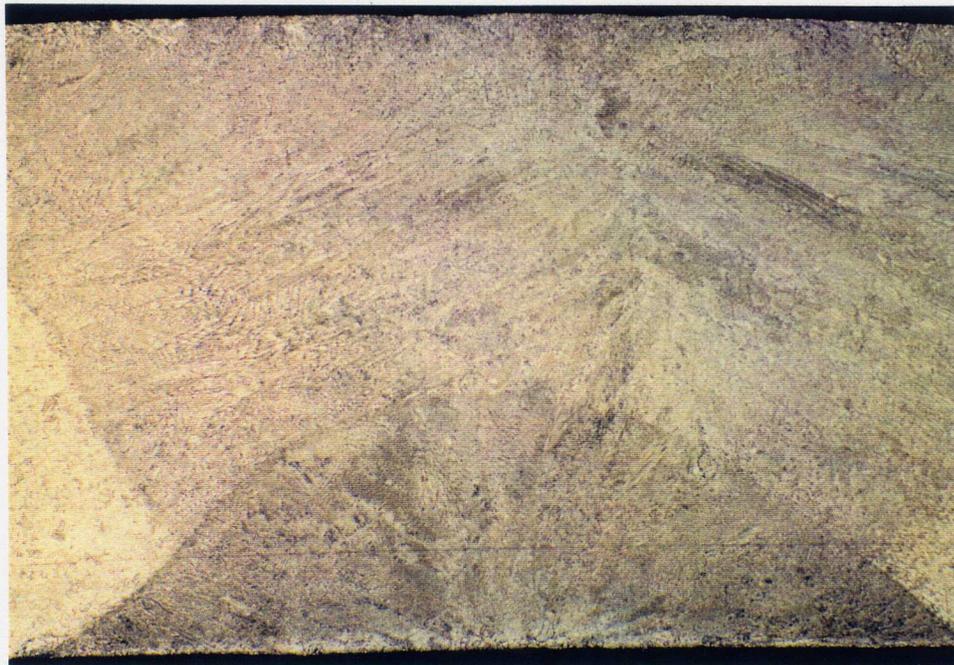
Figure 18  
Microstructure of the Longitudinal Seam Weld in Pipe  
Magnification: 25X Etchant: Electrolytic Oxalic

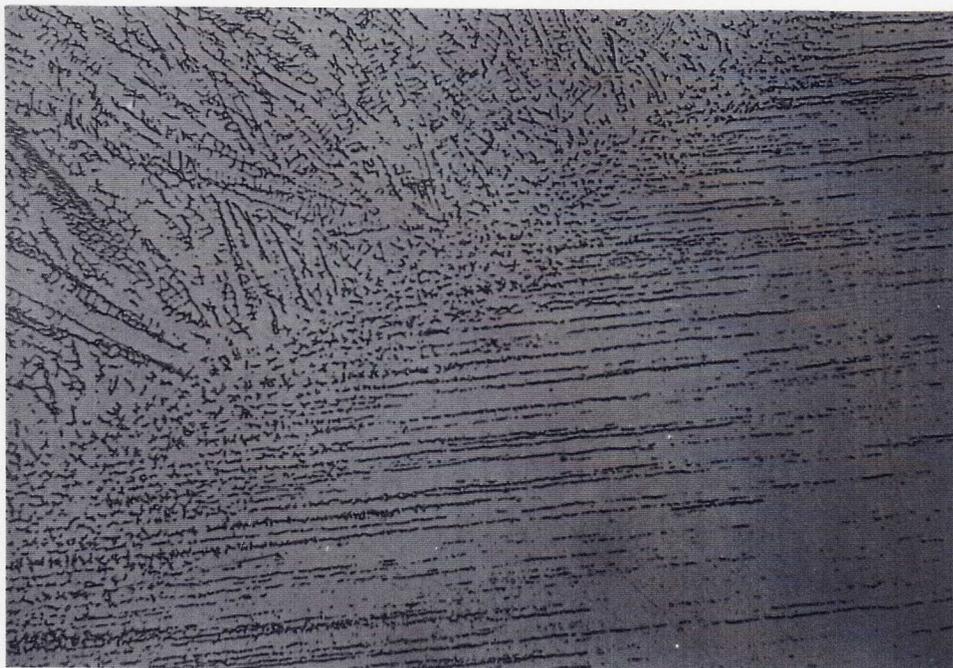
Figure 20  
Close-up of the Microstructure of the Circumferential Weld  
Magnification: 100X Etchant: Electrolytic Oxalic

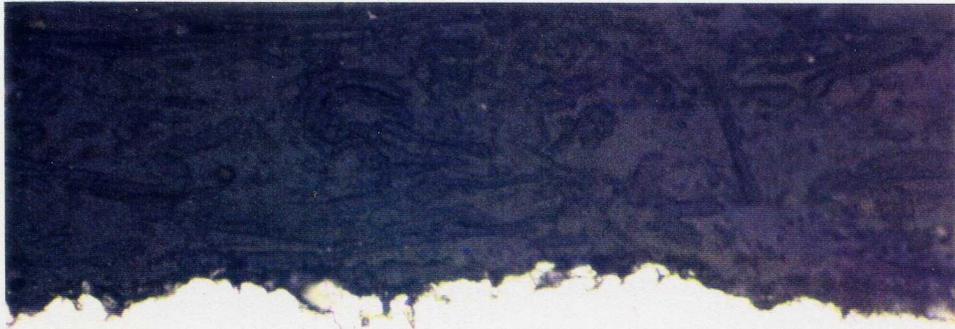
Figure 21  
External Surface of a Pipe Located Away  
From the Circumferential Weld  
Magnification: 500X Etchant: None

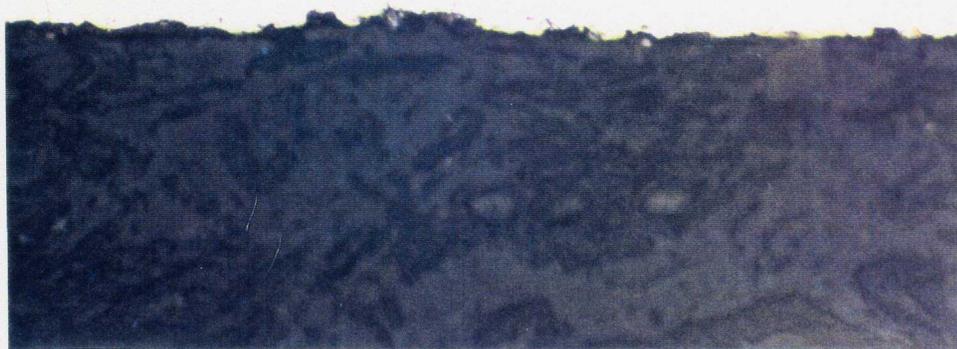
Figure 22  
Internal Surface of a Pipe Located Away  
From the Circumferential Weld  
Magnification: 500X Etchant: None

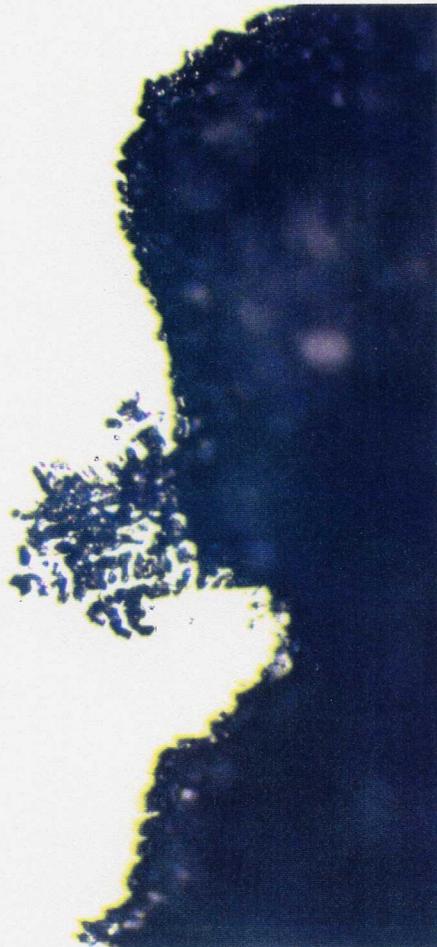
Figure 27  
Edge of Pit in Figure 26 Showing Preferential Attack  
Of the Dendritic Phase  
Magnification: 200X Etchant: Unetched
